CAPE LOOKOUT NATIONAL SEASHORE
Cape Lookout Lighthouse

Keeper's Dwelling (1907)

**HISTORIC STRUCTURE
REPORT**

2002
Historic Structure Report
Cape Lookout Lighthouse Keeper's Dwelling
(1907)
Cape Lookout National Seashore
LCS#: 091838

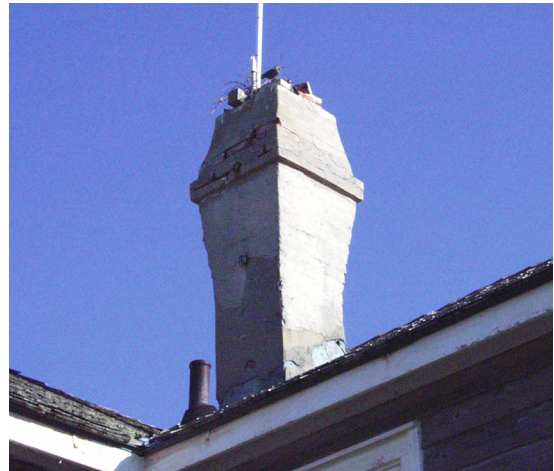
Figure 4 View of chimney. (NPS-SERO-CR, 2002)

Chimney: The house was constructed with a single brick chimney stack that originally served a fireplace in the sitting room (Room 101) and a cook stove in the kitchen. When the house was moved, the foundation of the chimney was lost, but the original fireplace and chimney stack were moved intact and reset on a concrete block foundation. The chimney is

- Match original foundation brick, if located, or, if not, match brick on existing historic chimney.
- Remove stucco from chimney, repair chimney as necessary.

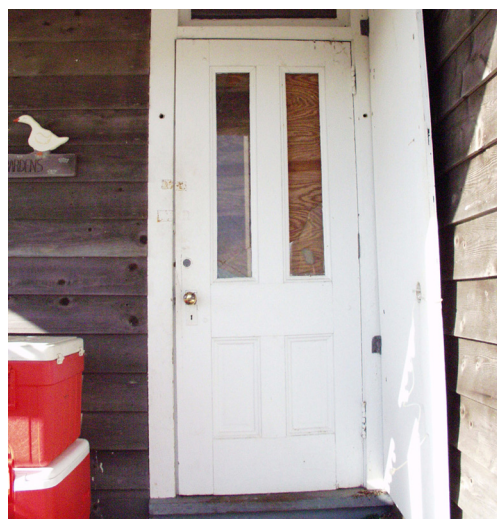
Figure 8 View of back door. Original front door was of a similar design. (NPS-SERO-CR, 2002)

The original front door, which was similar to the existing back door, has been lost. The present front door is a modern, solid- core, wooden door, 3'-0" by 7'-0". The back door opening is 2'-8" by 6'-6" and has a single- light transom 15" by 32". The door, which is 1-3/4" thick, has two, molded, vertical panels below two narrow, vertical lights. The presence of an added 1"- thick strip of wood along the outside stile of the door and alterations to that side of the door frame may be indications that the door is not original; but all of these changes

may simply be the result of old damage and repairs to the door, which closely resembles the door indicated on the original architectural drawings for the house. Vandals recently broke one of the back door's beveled- glass lights.

- Repair and preserve all existing window sash.
- Repair and preserve all wood- framed window screens; where missing, install new wood- framed screens.
- Repair and preserve back door.
- Replace modern front door with replica of original.
- Remove plywood shutters on porches if the added security is unnecessary.

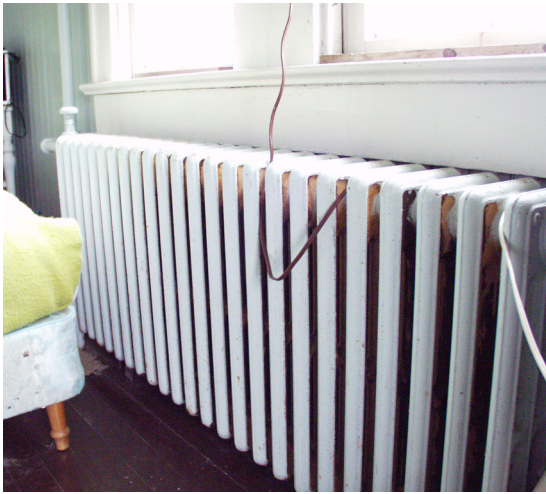
Figure 35 View of radiator in Room 203, which was typical of those installed in the 1930s. (NPS-SERO-CR, 2002)

Since the house was moved, there have been few other alterations to the historic structure, except for replacement of the 1930s cedar shingle siding with cedar clapboards in recent years. In addition, part of the wall built in the kitchen in the 1930s to house the water tanks for the heating system has been removed and the front door and part of the toilet have been replaced. There have also been some modifications to the building's electrical system, and the boiler, tanks, and most of the radiators from the 1930s heating system have been lost.
