CAPE LOOKOUT NATIONAL SEASHORE  
GUTHRIE- OGILVIE HOUSE  
**HISTORIC STRUCTURE  
REPORT**

**Historical Architecture, Cultural Resources Division  
Southeast Regional Office  
National Park Service**

**2004**

2004  
Historic Structure Report  
Cape Lookout National Seashore  
Guthrie- Ogilvie House  
LCS#: 09t829

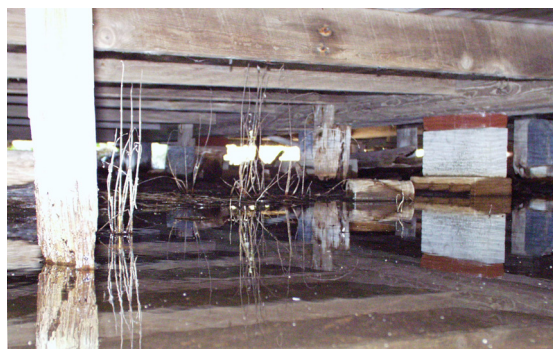
**Figure 16** View to south from rear of house, showing standing water several days after rain. (NPS-SERO-CR, 2003)

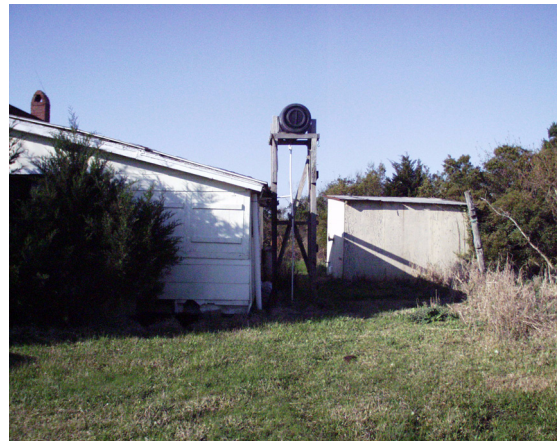
A wood- framed, plywood- covered storage building, constructed since 1977, is located a few feet west of the house, and there is a water tank elevated on a wood frame at the rear of the house. The condition of both structures is only fair.

**Figure 18** View southwest showing modern storage building and water tank. (NPS-SERO-CR, 2003)

- Clear crawl space beneath house of all trash and debris.
- Remove storage building and elevated water tank.
- Follow recommendations of Cultural Landscape Report in determining additional treatment of the surrounding landscape.

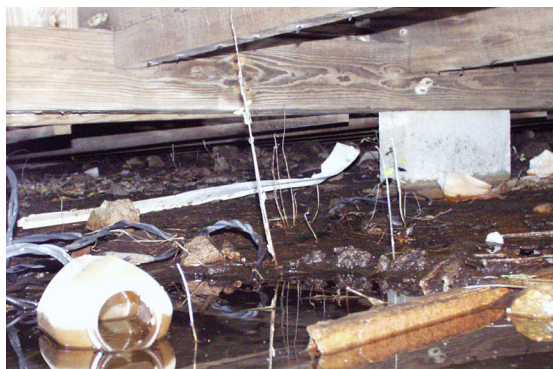
The house is set on wooden piles sunk to an indeterminate depth. The piles are very low, elevating the house less than a foot from the ground. Some have rotted away from the sills, leaving the building's sill and frame unsup-

ported at several locations. All are in poor condition.

**Figure 19** View south under Room 101, showing front sill of house. (NPS-SERO-CR, 2003)

- Replace foundation piers.
- Raise finish floor level to accommodate changes in grade that are recommended for improved drainage.

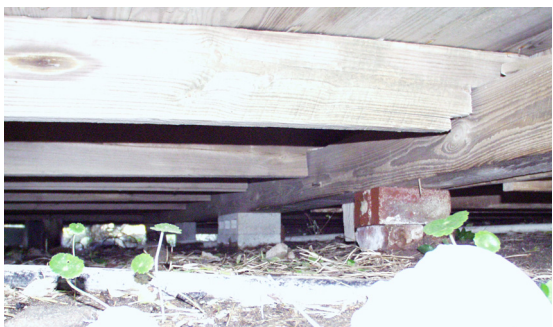
**Figure 20** View west under Room 101. (NPS-SERO-CR, 2003)

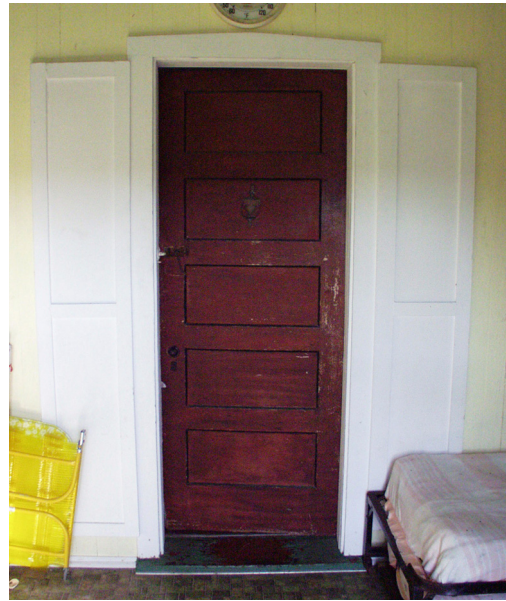
**Figure 22** View of front door. Shutters and possibly the shaped header are modern additions. (NPS-SERO-CR, 2003)

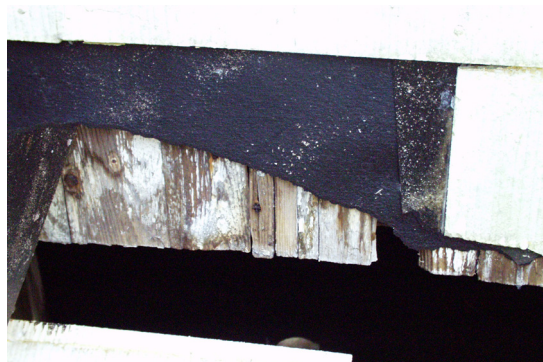
**Figure 24** View of typical wood siding and asbestos-cement siding. (NPS-SERO-CR, 2003)

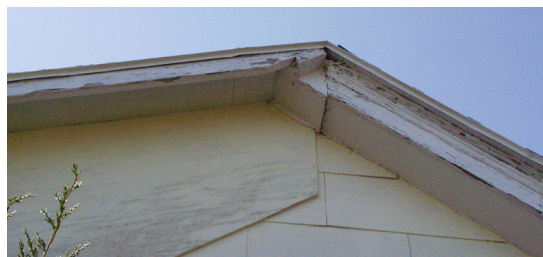
**Figure 25** View of typical boxed cornice at right and modern alteration to front shed of roof at left. (NPS-SERO-CR, 2003)

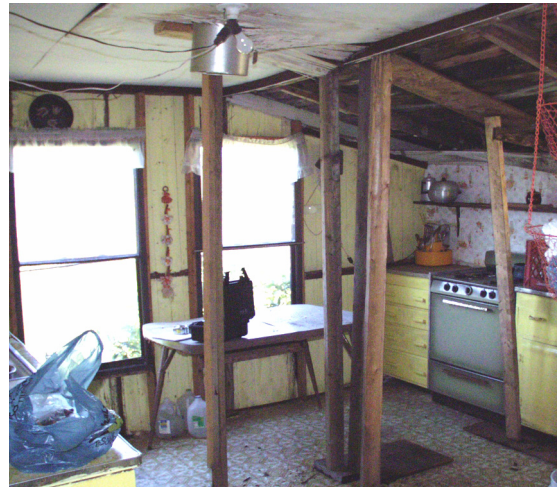
Framing is in generally fair condition in most of the house, but there has been major water dam- age to roof, floor, and wall framing on the northwest (rear) side of Room 103. In addition, parts of the rear of the house were originally framed for porches, which were later enclosed. With later repairs and alterations, the framing in these areas is very irregular and in generally poor condition.

**Figure 35** View west in Room 103, showing deteriorated shed-roofed addition that was combined with this room after World War II. (NPS-SERO-CR, 2003)

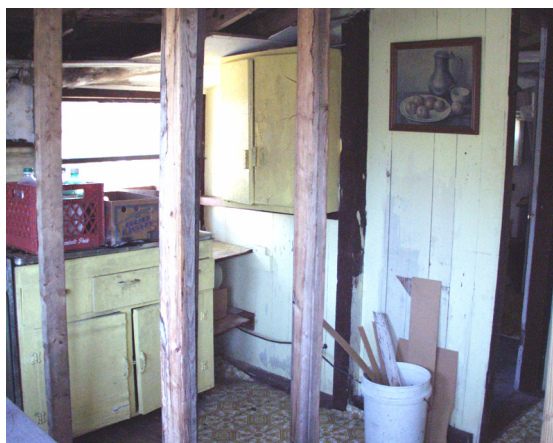
**Figure 38** View to north in Room 103. Posts in foreground have been added to stabilize roof structure where wall was removed. (NPS-SERO-CR, 2003)
