CAPE LOOKOUT NATIONAL SEASHORE
Cape Lookout Lighthouse

Keeper's Dwelling (1907)

**HISTORIC STRUCTURE
REPORT**

2002
Historic Structure Report
Cape Lookout Lighthouse Keeper's Dwelling
(1907)
Cape Lookout National Seashore
LCS#: 091838

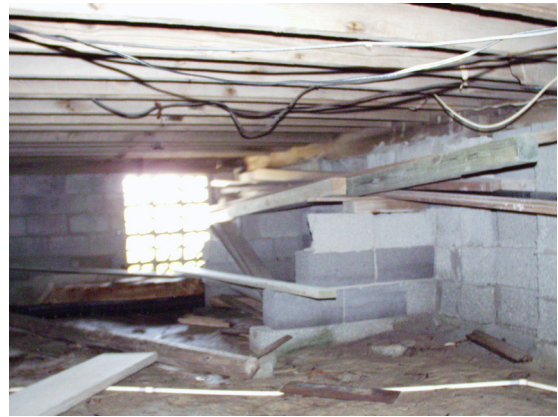
The house, which was originally built on 17"-square brick piers, is now set on a continuous foundation of concrete block that elevates the house about four feet above grade, which approximates its original elevation. Porches are supported by concrete block piers about 16" square. The character of the footings for the walls has not been documented. On the north-east side of the house, a section of the foundation is constructed with open concrete block that allows floodwaters to pass unobstructed through the crawl space. Without such openings, the foundation would be susceptible to major damage from the force of flood water against it. A small opening in the foundation on the south side of the kitchen wing provides access to the crawl space.

Figure 3 View north in crawl space, showing lattice block used to allow floodwater to pass through the building. (NPS-SERO-CR, 2002)

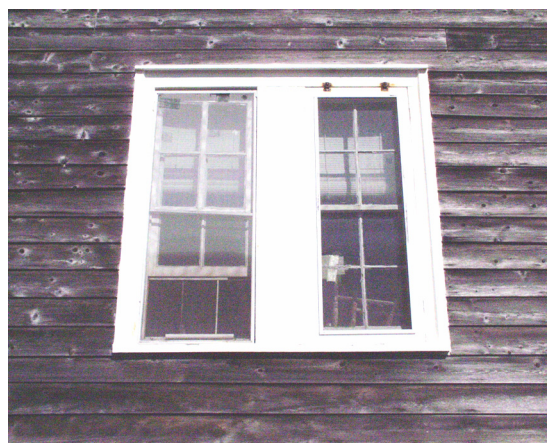
All of the present window and door openings on the house are historic, with all but two of those being a part of original construction. However, a number of the original sash have been replaced, although the original muntin pattern was maintained. Double windows are used on both stories of the three gable ends of the house, with single windows present elsewhere. Double window sash are four- over- four, 2'-1" by 5'-2" on the first floor and 2'-1" by 4'-6" on the second floor. Single window sash are six- over- six, 2'-10" by 5'-2", on the first floor and 2'-10" by 4'-6" on the second floor. Most of the sash are in generally good condition, except for paint, which is beginning to fail.

Figure 9 View of typical double windows. (NPS-SERO-CR, 2002)

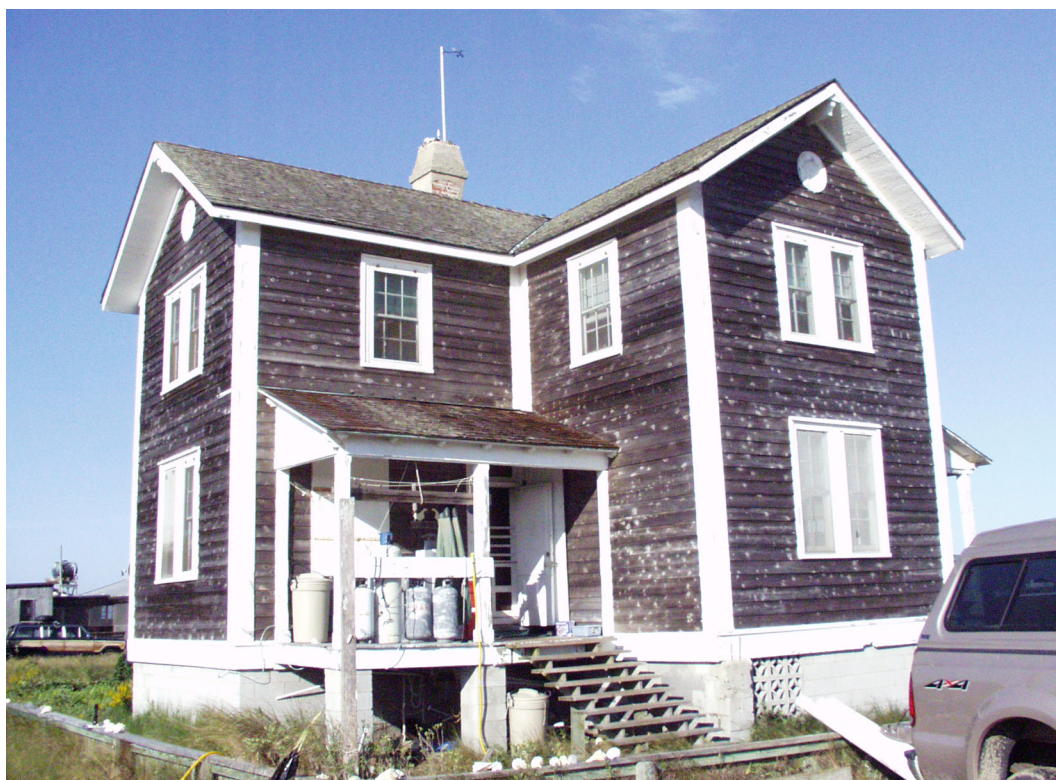
may simply be the result of old damage and repairs to the door, which closely resembles the door indicated on the original architectural drawings for the house. Vandals recently broke one of the back door's beveled- glass lights.

Figure 10 View to west of rear of Barden House. (NPS-SERO-CR, 2002)

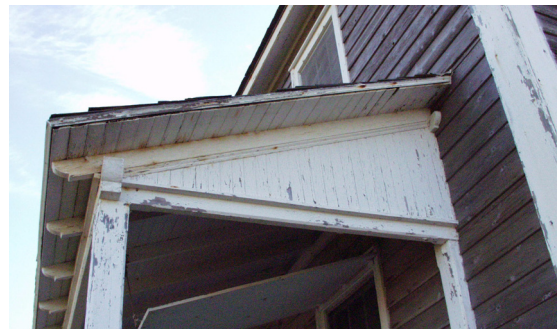
Most of the material on the two porches is historic, except for the front porch floor framing, which has undergone major repairs. Floor joists are typically 2" by 4" on about 18" centers. Flooring is tongue- and- groove, 1-1/8" by 3", except on the west end of the front porch where the flooring is around 1-1/8" by 2-1/2". Posts are 5-3/4" by 5-3/4", nearly 8' tall, and have chamfered edges. Headers also have chamfered edges and measure around 2-3/4" by 6". The ends of the headers project beyond the

Figure 12 View of west end of front porch. (NPS-SERO-CR, 2002)

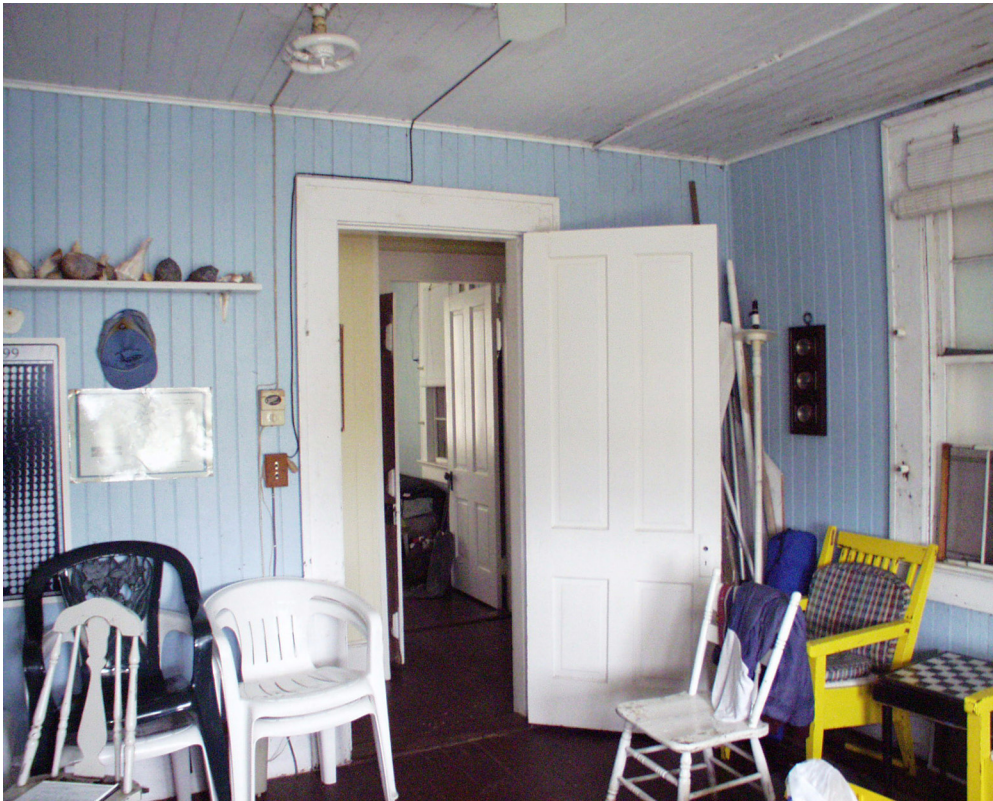
Doors: The door from the hall is 2'- 6" by 7'- 0" by 1- 3/8" with four vertical panels. A mortise lock is present but the knob is missing. In addi-

Figure 23 View to west in Room 102. (NPS-SERO-CR, 2002)

tion, the door has been damaged and the hinges bent, with the damage only partially repaired.

Windows: The upper sash in the front (north-west) window appears to be an original sash. The remainder are replacements but should be treated as historic.

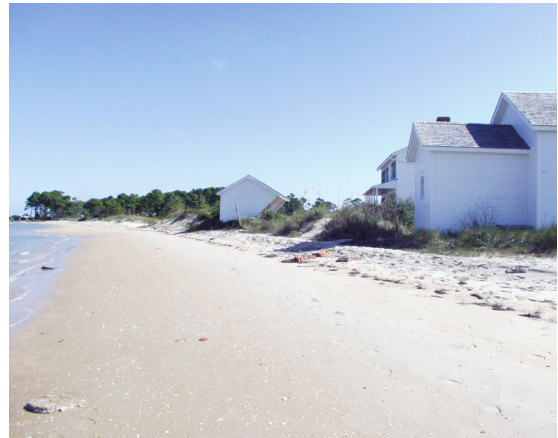
Storms exposed the foundation of the Coal House in 1999, and comparison of the site today with historic photographs makes clear the threat that exists to the entire complex. Over two thousand square feet of the historic light station compound is now below the high water mark, and there are no signs that the erosion is abating. Only periodic beach replenishment by the Army Corps has kept the remainder of the light station complex intact.

Figure 39 View to northeast showing present shoreline of Cape Lookout Bight at lighthouse station. Summer kitchen is at right and coal and wood shed is at center. (NPS-SERO-CR, 2002)
