CAPE LOOKOUT NATIONAL SEASHORE  
GUTHRIE- OGILVIE HOUSE  
**HISTORIC STRUCTURE  
REPORT**

**Historical Architecture, Cultural Resources Division  
Southeast Regional Office  
National Park Service**

**2004**

2004  
Historic Structure Report  
Cape Lookout National Seashore  
Guthrie- Ogilvie House  
LCS#: 09t829

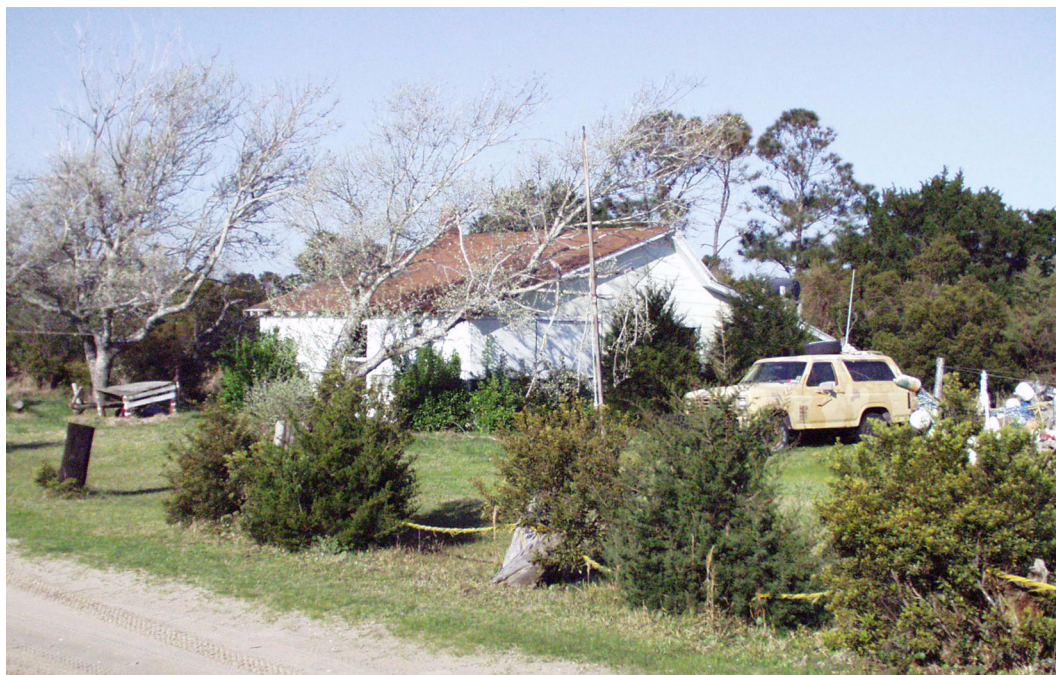
**Figure 15** View to west of Guthrie-Ogilvie House. (NPS-SERO-CR, 2003)

Two large deciduous tree, probably Carolina poplar (*Populus canadensis*), were planted in front of the house in the 1970s. A shallow-rooted tree, one is leaning precariously over the eastern corner of the house. Eunonymous planted around the front porch has begun growing through the shutters into the porch. Smaller cedar and myrtle are found elsewhere on the property, most of which is grassed.

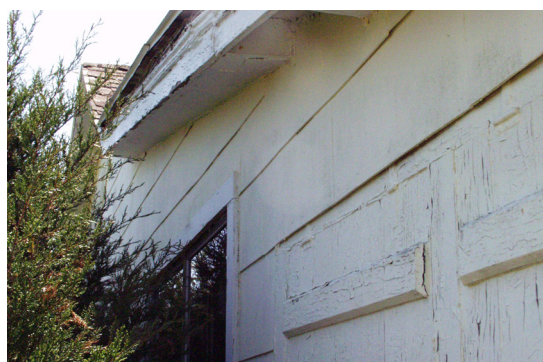
**Figure 26** View of typical exterior finishes including top-hinged shutters from original back porch. (NPS-SERO-CR, 2003)

- Remove existing front porch and reconstruct historic front porch.
- Remove bathroom, partition, and enclosure from back porch and restore historic porch.
- Preserve shutters at northeast side of back porch and use as model for replicating missing shutters.

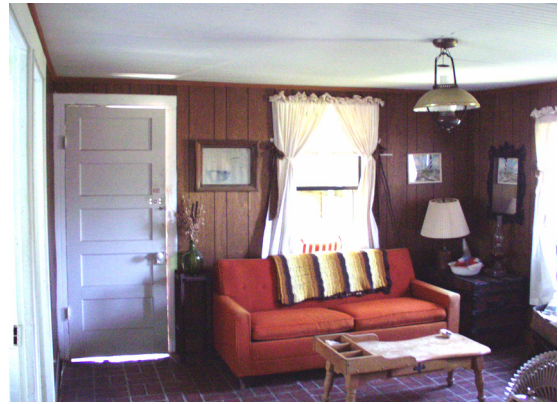
*Floor:* The floor is covered with a modern, brick- patterned, sheet- vinyl floor covering. Original flooring remains underneath and is typical tongue- and- groove, 3- 1/2" wide.

*Walls:* Walls are now covered with 4' by 8' sheets of plywood paneling. What appears to be the original wall finishes- - 4- 1/2" double- beaded, tongue- and- groove boards, are visible beneath this paneling on the north wall and

**Figure 27** View to southeast in living room or Room 100. (NPS-SERO-CR, 2003)

- Remove sheet paneling in Room 100 and restore historic tongue- and- groove siding.
- Finish walls and ceilings of new bathroom and rehabilitated kitchen with dry wall or sheet paneling.
- Use trim in Room 101 as model for missing trim in Room 100.
- Remove modern floor coverings and preserve samples of historic floor coverings.
- Repaint interior as desired.

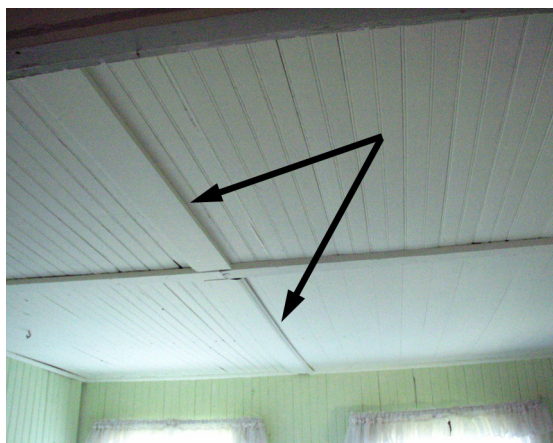
**Figure 30** View of ceiling in Room 101, with arrows indicating location of wall that originally divided the space. (NPS-SERO-CR, 2003)

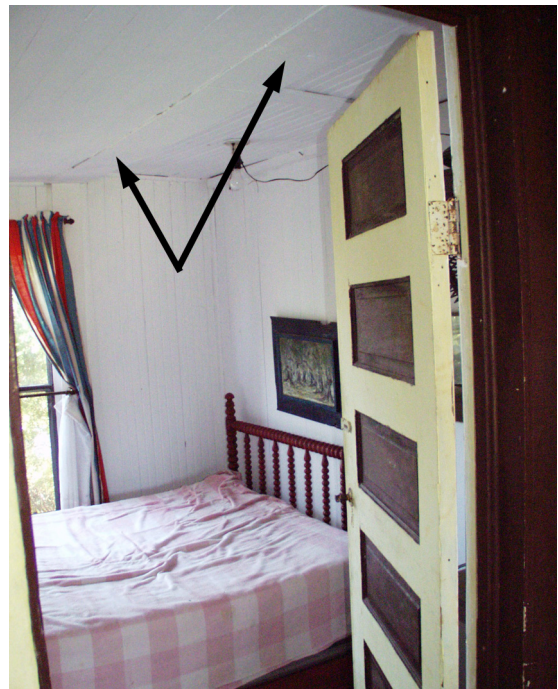
Measuring 9'-2" by 9'-6", this room was created in the late 1920s or early 1930s by enclosing a portion of an earlier porch and relocating what is now the southeast wall of the room to take in about 2-1/2' of what is now Room 101.

**Figure 32** View east in Room 102, with arrows indicating line of wall that was relocated to create this room. (NPS-SERO-CR, 2003)

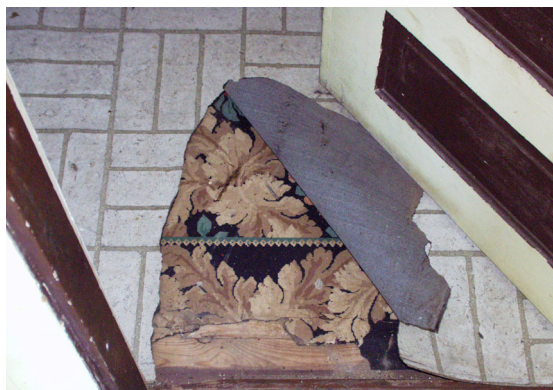
*Floor:* Flooring is typical 3-1/2" tongue- and-groove boards covered with an early, floral- patterned, linoleum- type floor covering that itself is overlaid with modern, brick- patterned, sheet vinyl. The lack of discoloration and wear on

**Figure 33** View of linoleum-type floor-covering underneath modern vinyl in Room 102. (NPS-SERO-CR, 2003)

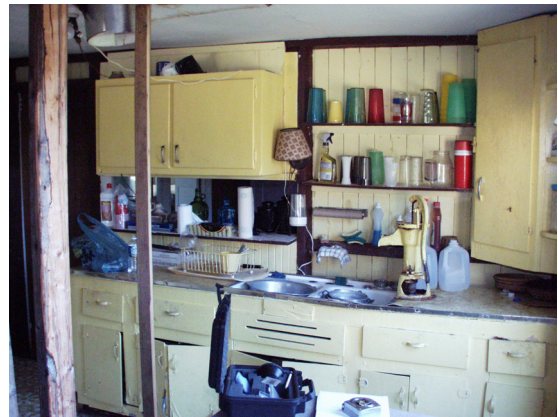
**Figure 36** View of kitchen counter and cabinets in Room 103. (NPS-SERO-CR, 2003)

about 5'-7" along the outside wall, there is no finish material on the ceiling at all. Significant water damage has occurred to the ceiling at the rear of the room, and removal of the separating wall between the two rooms weakened the

- Reconstruct missing wall and repair framing in Room 103.
- As piers are replaced, inspect and repair sills and floor joists as necessary.
- Where feasible, improve connections of framing members to reduce the possibility of significant damage from high winds.
- Augment floor framing with added support beams as necessary.
- Remove addition to front porch and restore historic porch enclosure.
- Restore original roof line.

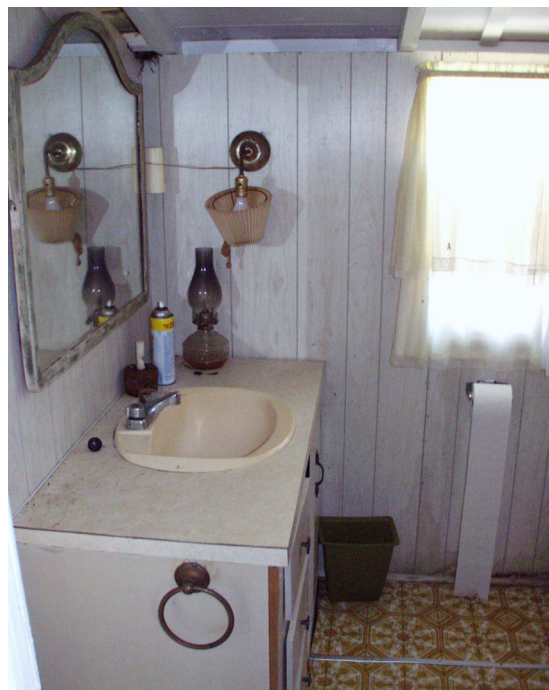
**Figure 39** View northwest of bathroom. (NPS-SERO-CR, 2003)

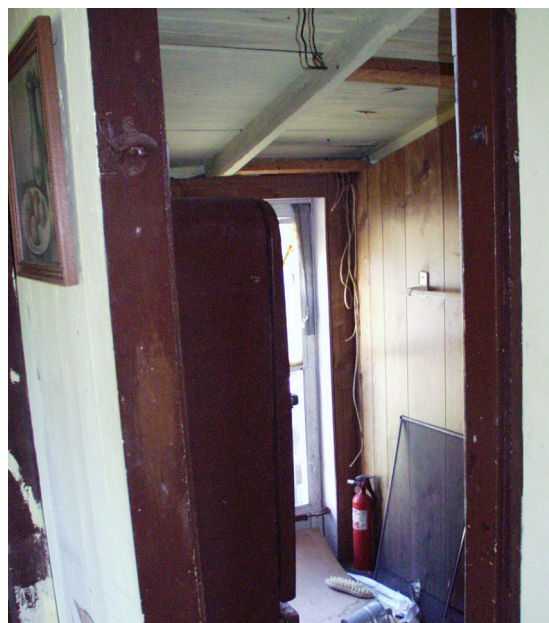
**Figure 40** View to north of Room 105. (NPS-SERO-CR, 2003)

*Doors and Windows:* The back door, which is 2'- 8" by 5- 4", is a metal storm door that has

been broken by vandals. The door to the bathroom is a modern hollow- core, flush door, 2'- 0" by 6'- 7". The bathroom window opening is a modern creation and is covered by a storm window.
