Carl Sandburg Home National Historic Site  
Connemara Main House  
**Historic Structure Report**

September 2005

Historical Architecture, Cultural Resources Division

2005  
Historic Structure Report  
Connemara Main House  
Carl Sandburg Home National Historic Site  
Flat Rock, NC  
LCS#: 05146

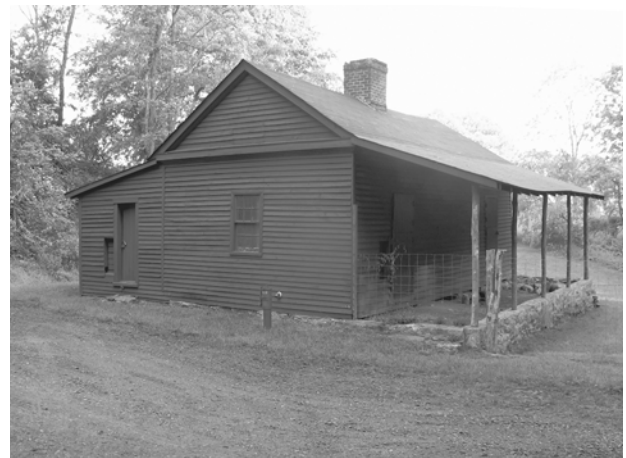
FIGURE 8. The so-called Buck House, probably built in the second quarter of the nineteenth century as an overseer's house. (T. Jones, NPS-SERO-CR, 2004)

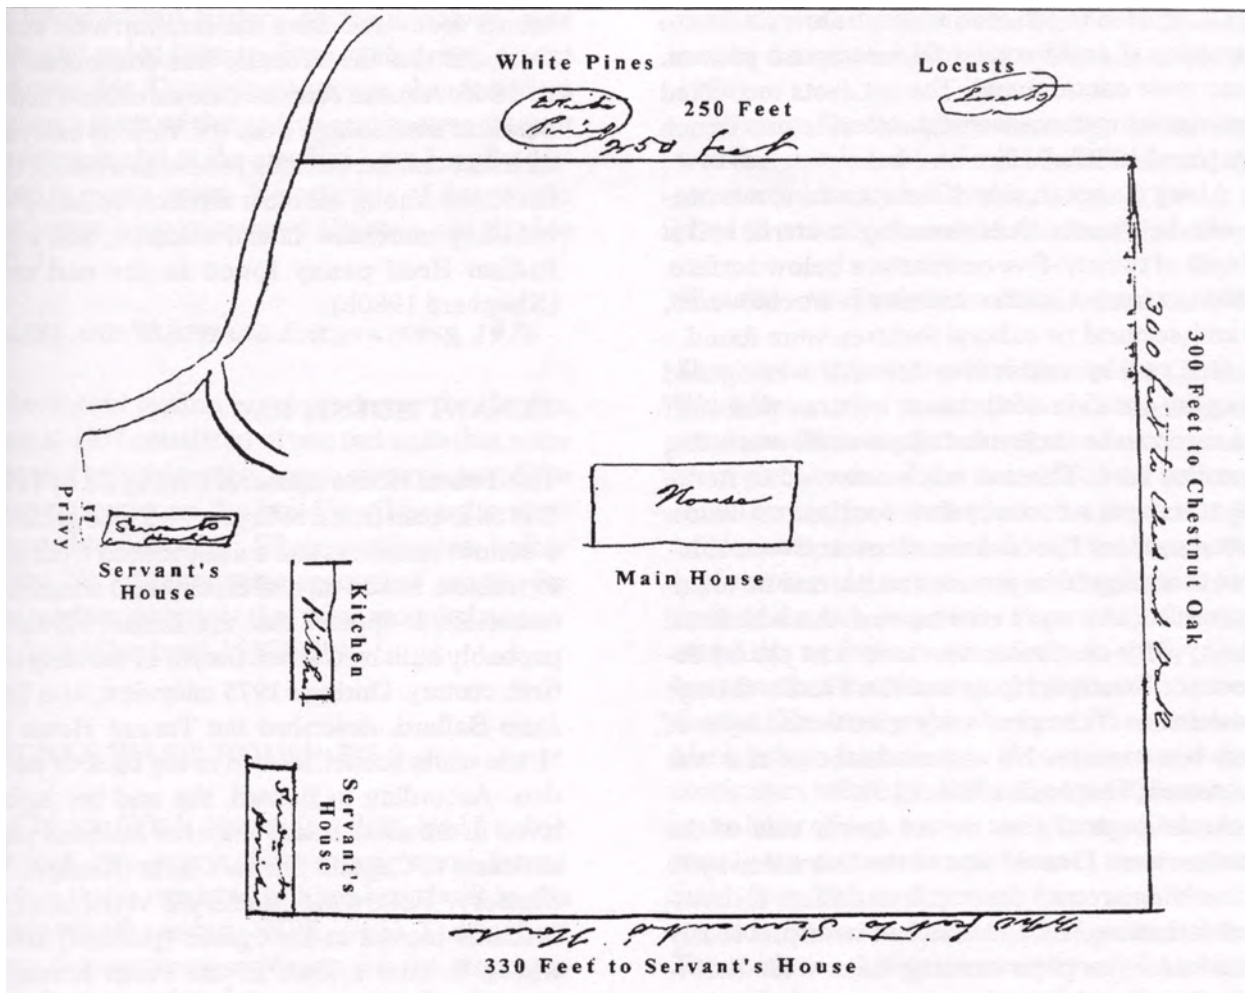
FIGURE 12. Sketch of Rock Hill in Memminger's account book, c. 1852, annotated for legibility. (taken from Pence, *Archeological Overview and Assessment*, 1998)

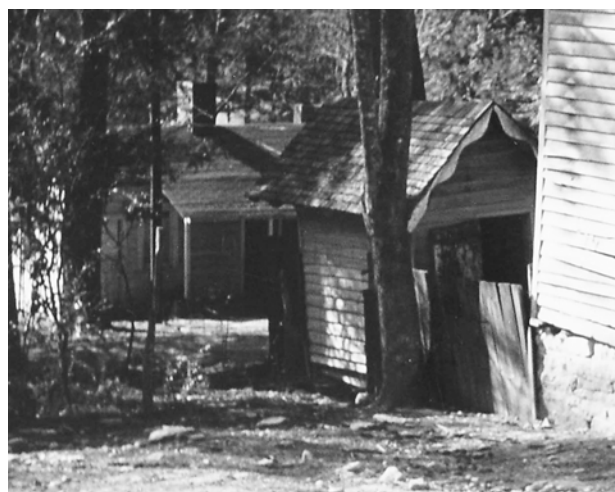
FIGURE 13. View of privy at west end of Swedish House, with Tenant House in background. (CARL3000/17/4P)

to use the privy just down the hill at the west end of the Swedish House (see Figure 13).<sup>161</sup> Entered only from the back porch, the bathroom appears to have been added by enclosing part of the back porch and occupied more or less the same position as the present bathroom (Room III) off the Dining Room. The bathroom or a simple water closet could have been added by the Greggs, but because the room and its fixtures no longer exist, it is impossible to attribute this bathroom to them or to the Smyths.

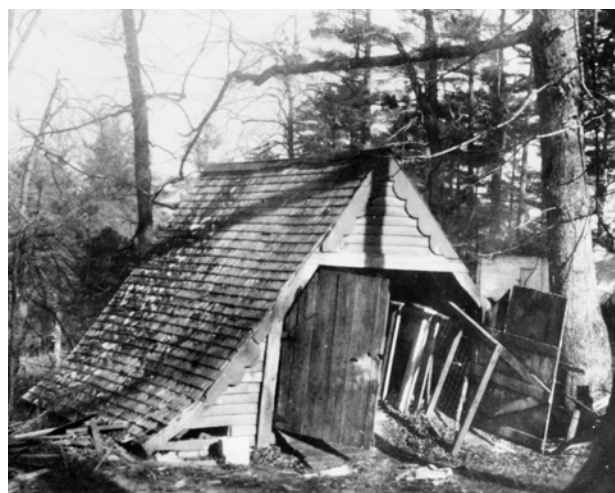
FIGURE 14. View of Ice House about 1950, constructed by Memminger in 1847. The circular, subterranean portion of the building is still evident on the landscape just southeast of the Farm Manager’s House. (CARL3000/29/1P)

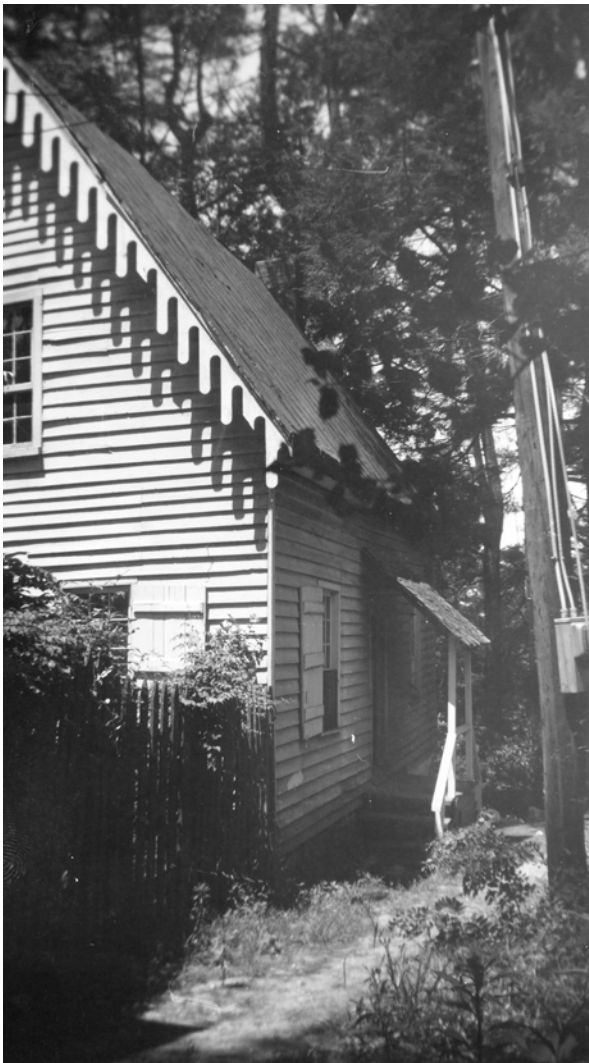
FIGURE 16. View, c. 1960, of the Swedish House, constructed by Memminger as a servants' house in the early 1850s. (CARL3000/17/1P)

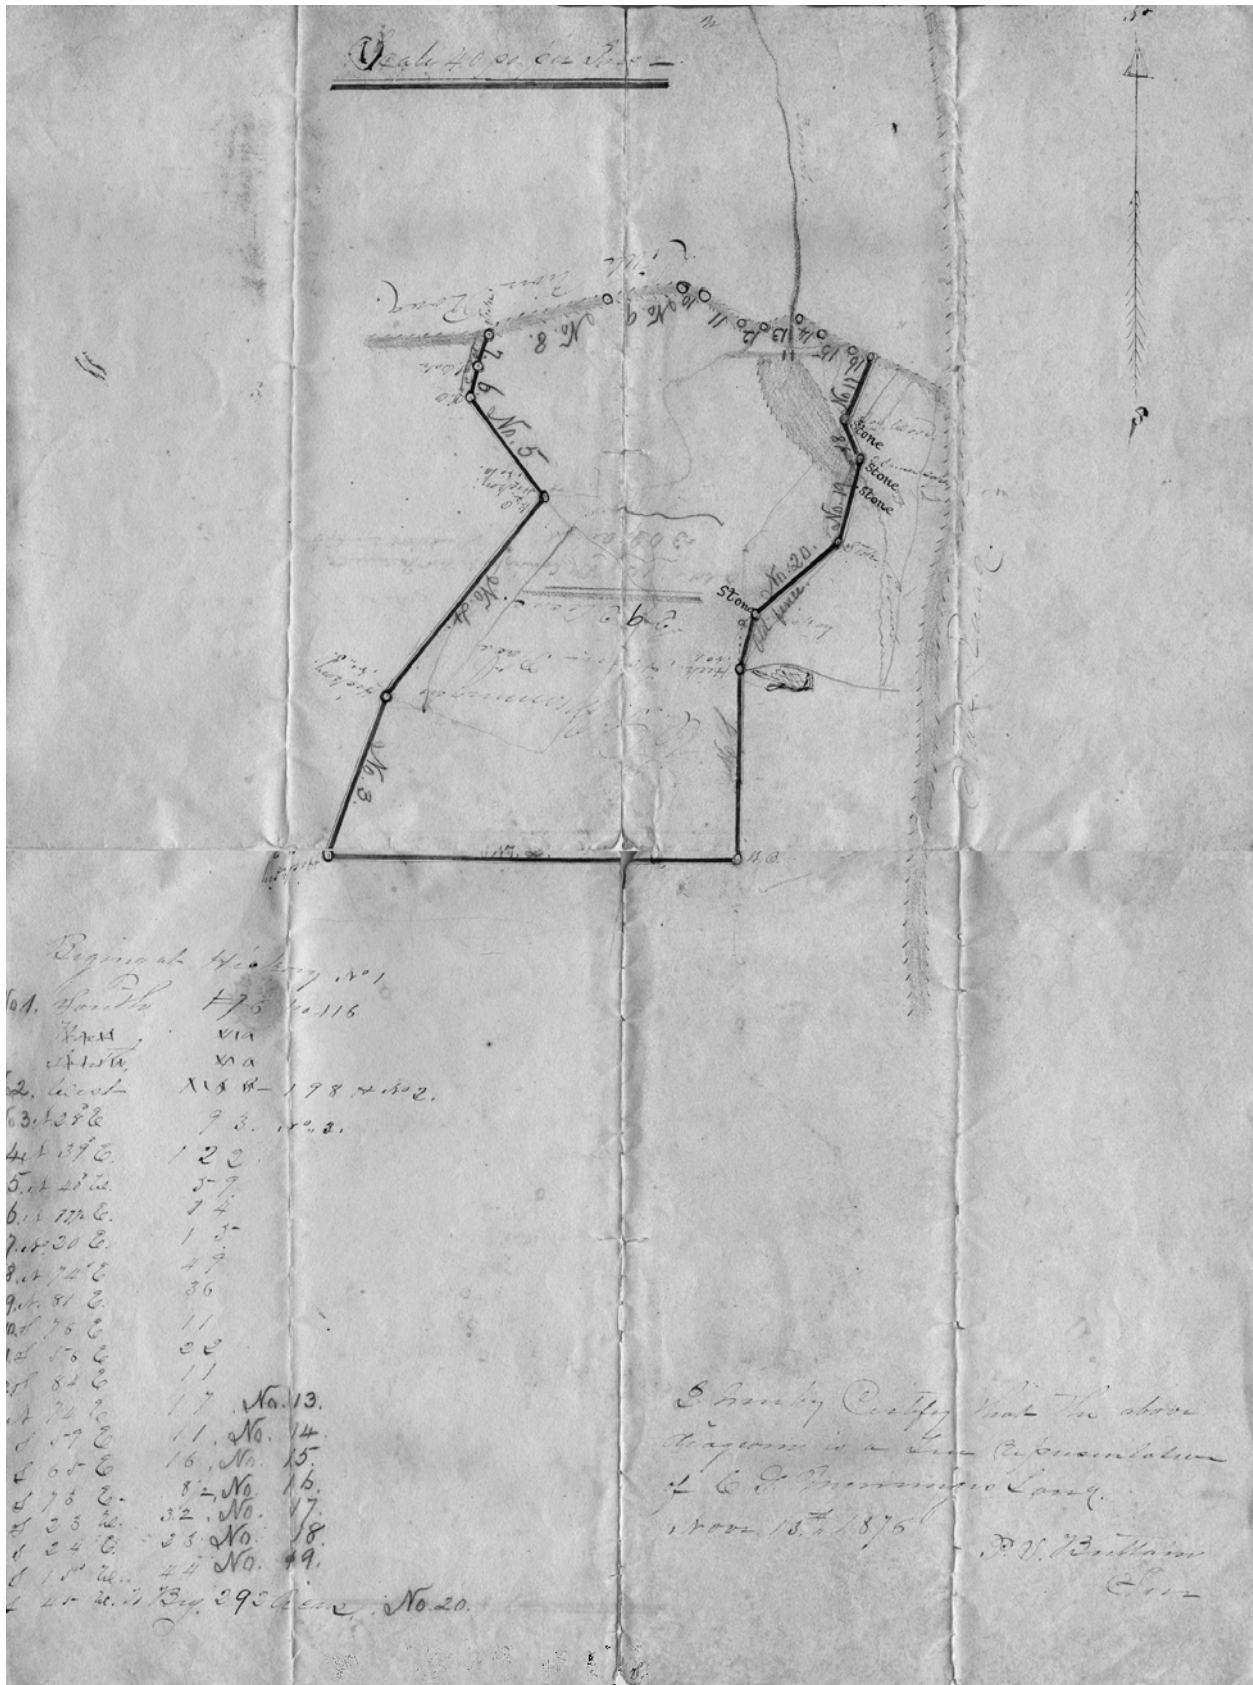
FIGURE 18. A plat of Rock Hill, 1876. (CARL 3005)

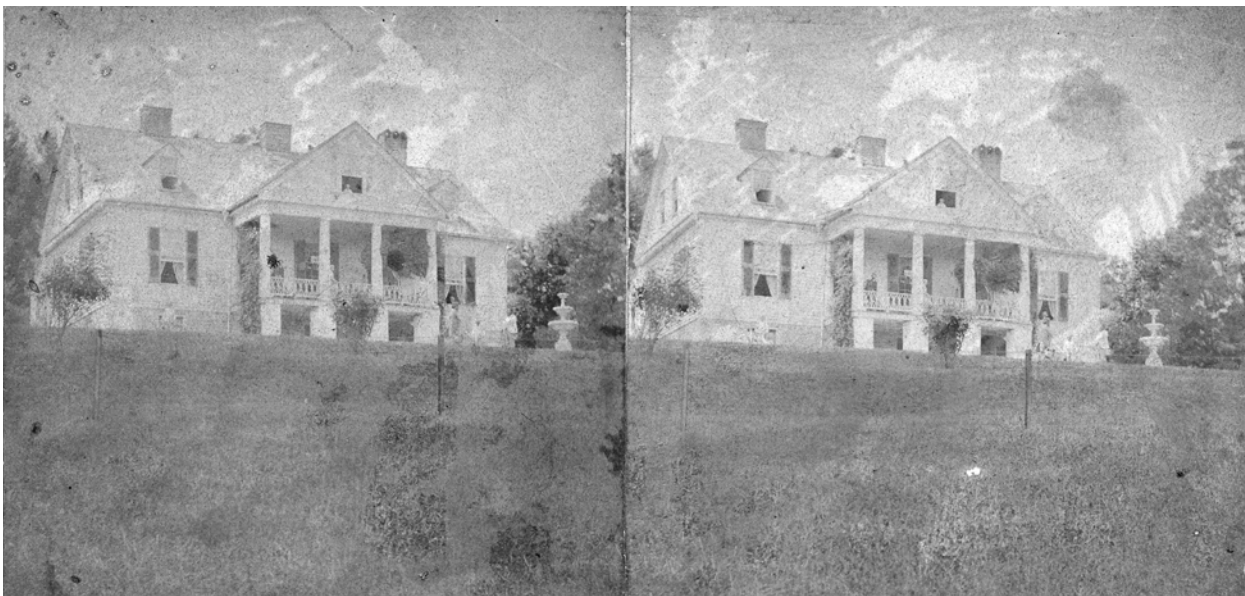
**FIGURE 19.** Stereographic view of Rock Hill, probably 1870s, the earliest image of the house yet located. (CARL 28466)

Alterations to the chimneys are apparent in comparing the two earliest images of the house, both images made before the addition of the east porch and the west bay. The Memminger stereographic image (Figure 19), which may have been made as early as the 1870s, shows the center chimney and the east chimney with simple corbeled courses at the top, but the west chimney has a trio of arched, brick flue covers. By the time the next photograph of the house was taken (Figure 20), most likely in the 1880s, the other chimneys had similar covers.

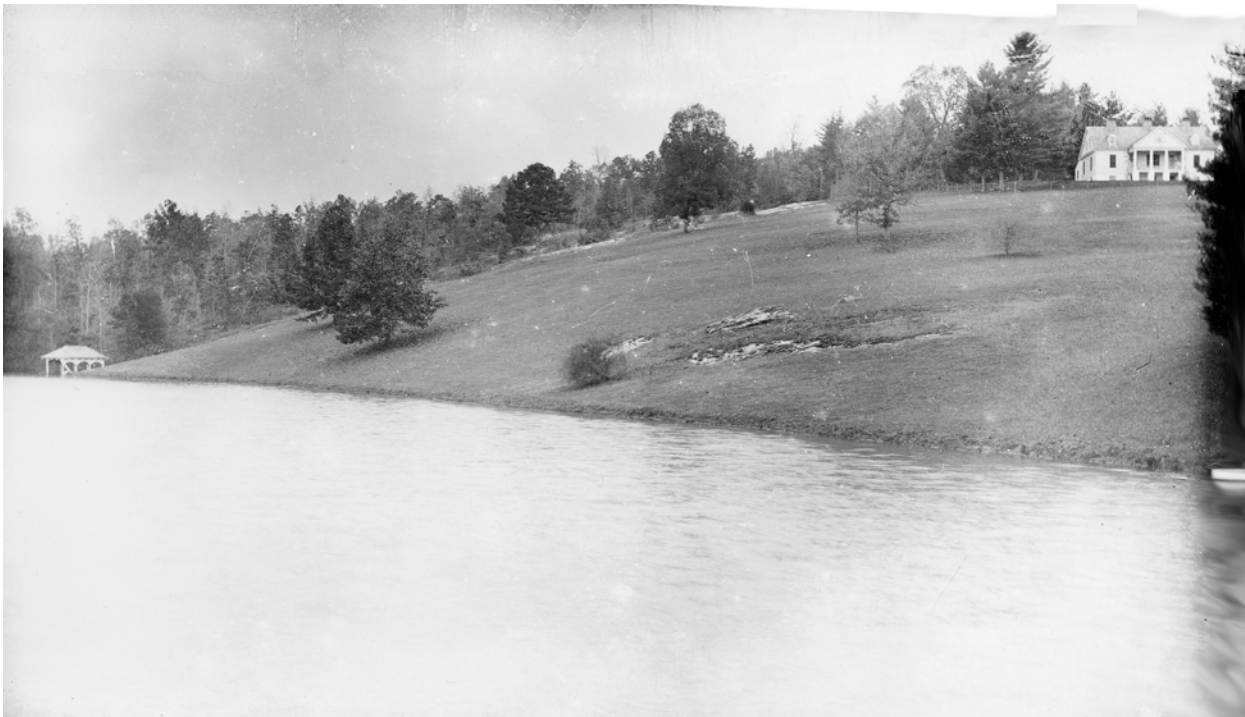
FIGURE 20. View of Rock Hill, prior to the late Victorian additions and alterations that were made about 1890. (CARL3001/01/48P)

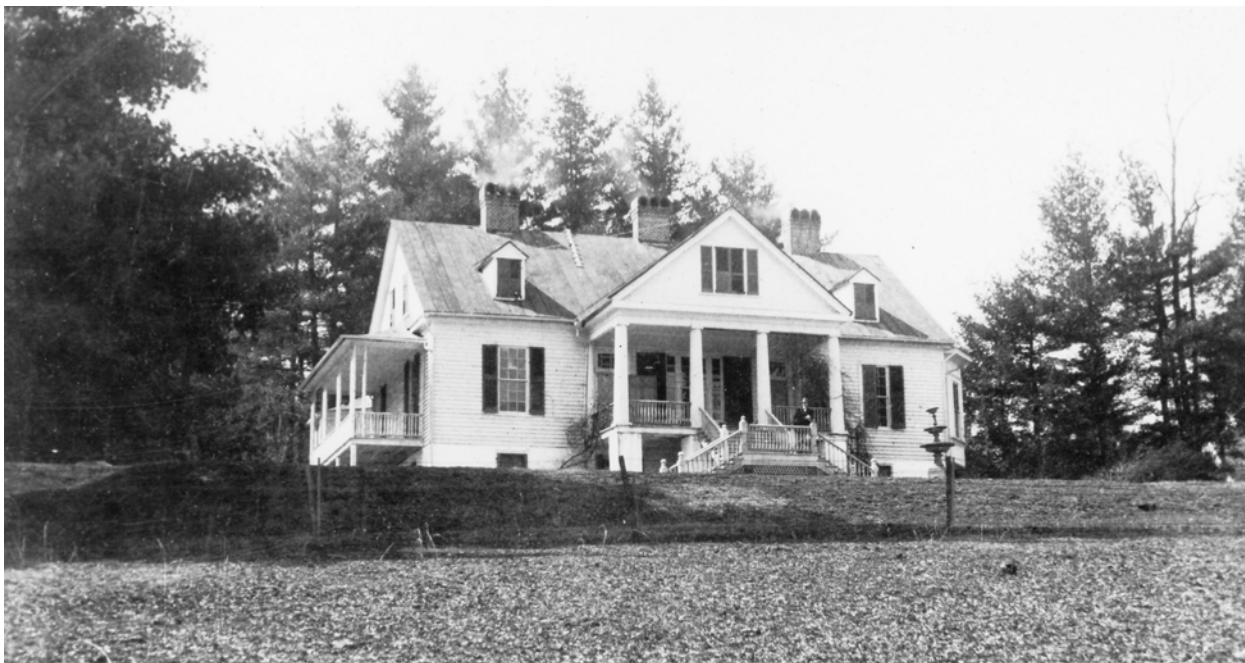
FIGURE 25. View of Connemara in late winter or early spring 1901. Image shows East Porch, the bay window on the west side of the house, and the new front steps, all apparently added by the Greggs around 1890. (CARL3001/01/04P)

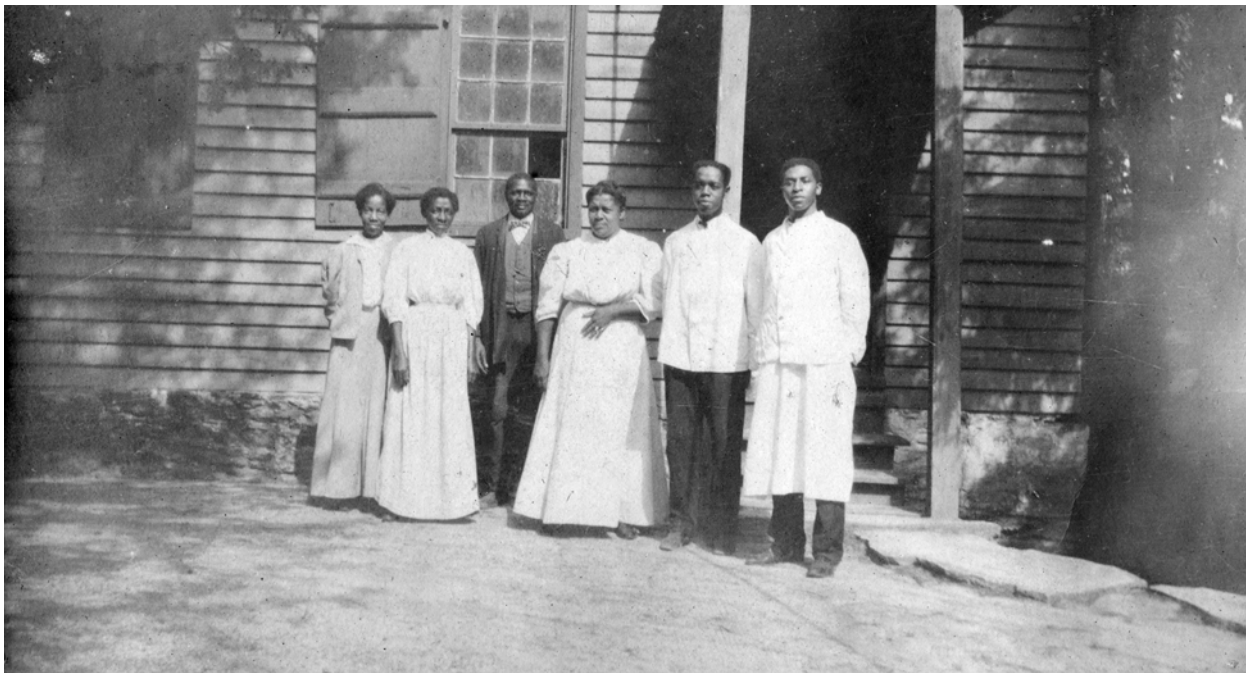
FIGURE 29. The Smyths’ servants in front of the kitchen, c. 1910. The building may have been rebuilt by Smyth in the 1920s and was drastically altered when the Sandburgs turned it into a garage in 1945. (Collection of William McKay, Smyths’ great-grandson.)

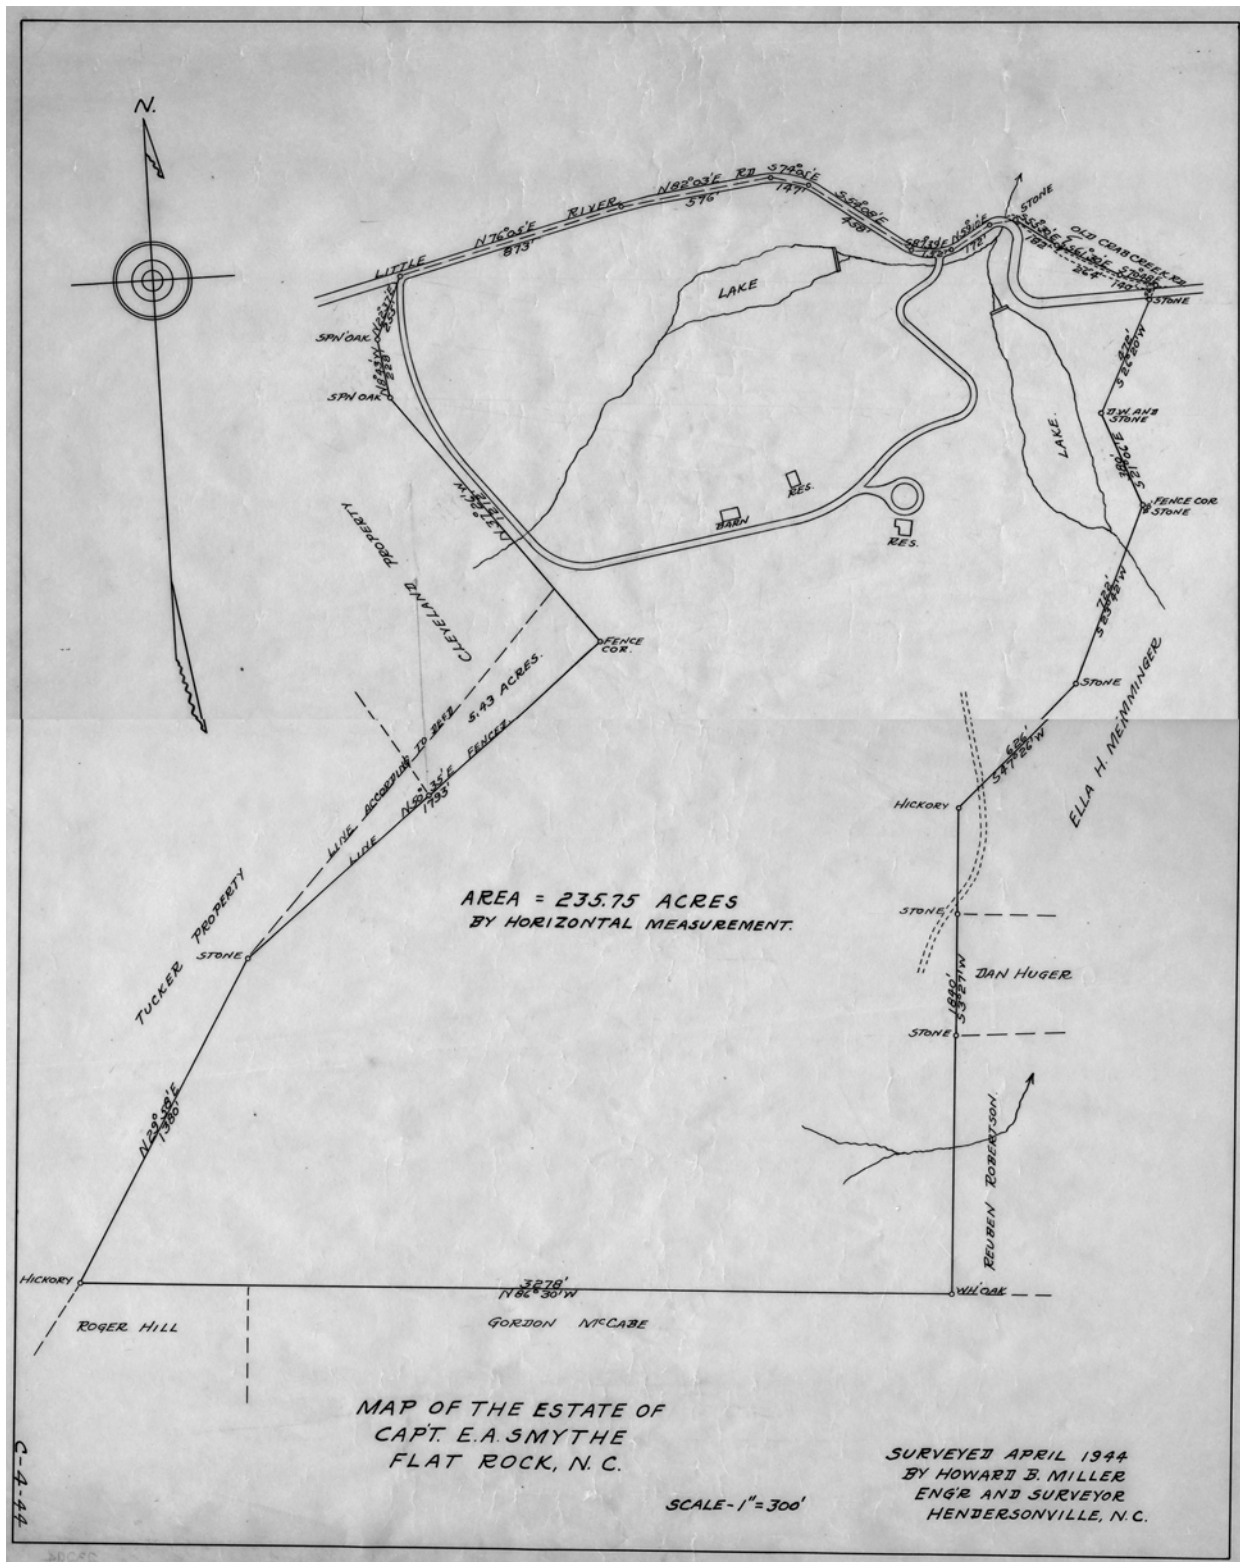
FIGURE 37. Plat of the Smyths' Connemara in 1944. (CARL 23294)

235. See CARL Photo #109107 in Figure 37.

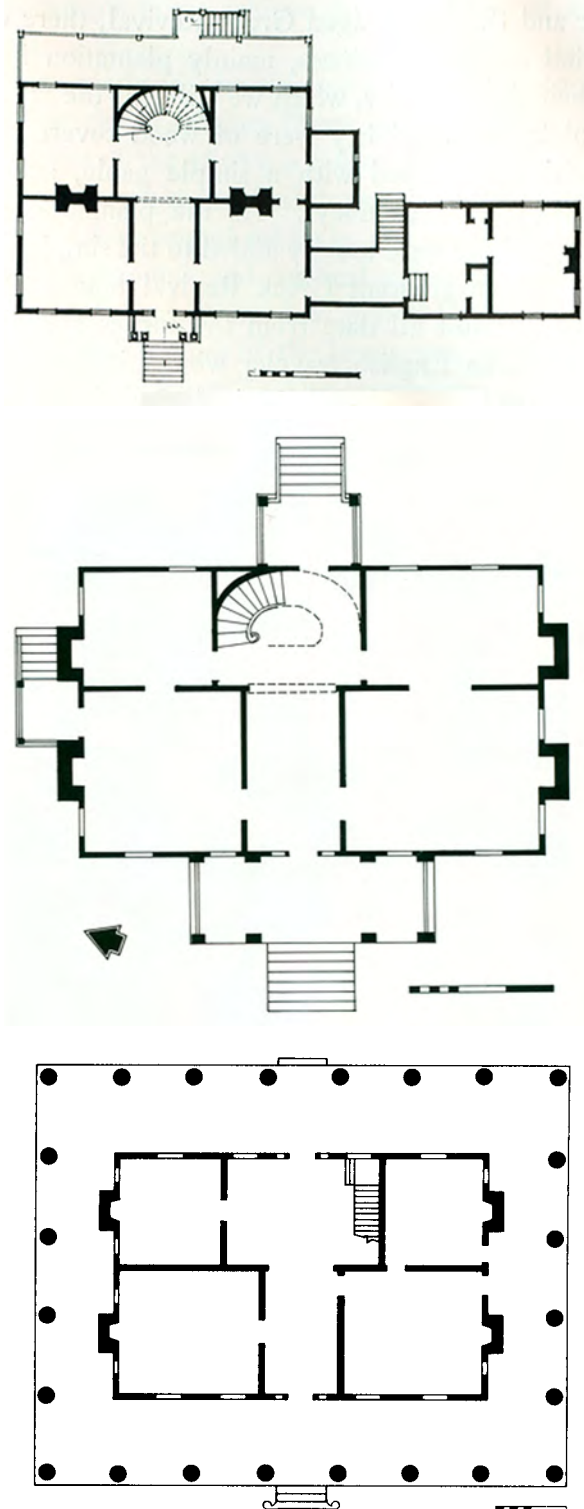
FIGURE 61. The floor plan that Reichardt originally designed for Memminger might have been similar to these, although without the curving stair. Top, Lowther Hall (1822), Clinton, Georgia; center, Brown-Sandford House (1822), Milledgeville, Georgia; bottom, Jackson House, Gaines, Alabama (1830)

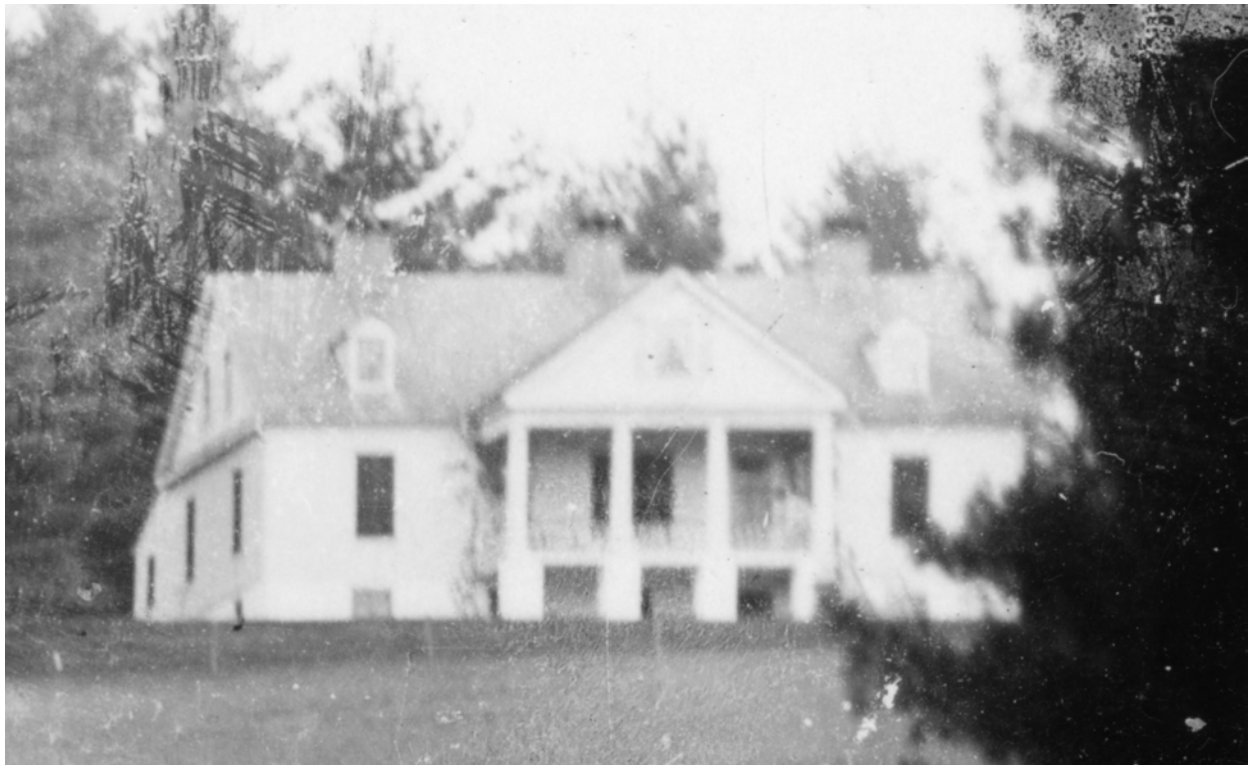
**FIGURE 63.** Detail from view of Rock Hill, taken prior to the late Victorian additions and alterations that were made around 1890, with Memminger’s antebellum addition partially visible at left. Note the absence of stairs to the front porch. (CARL3001/01/48P, photo by Baker Barber)

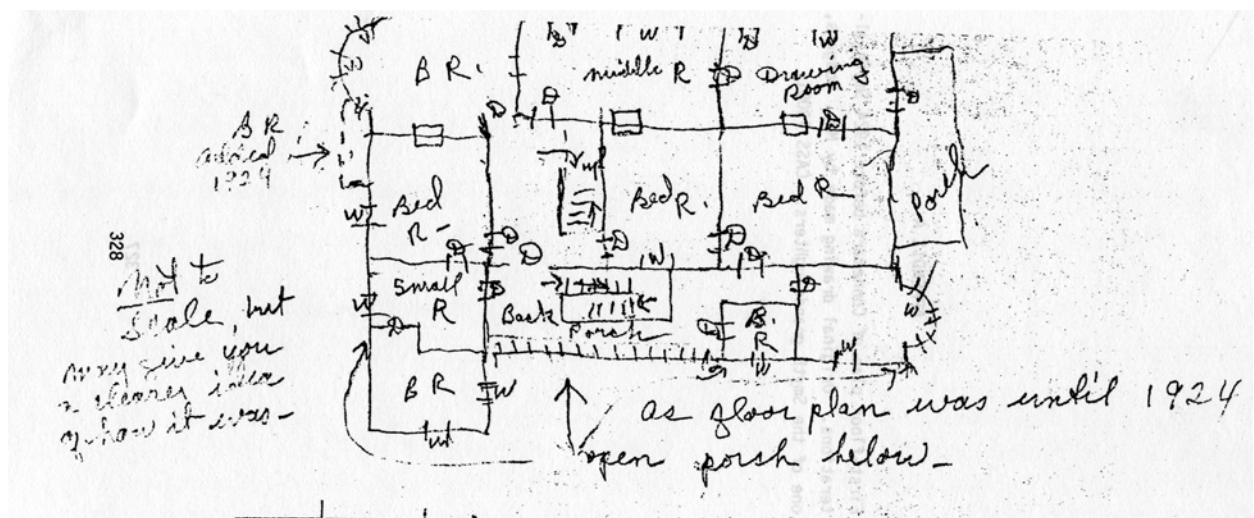
FIGURE 65. Sketch plan of house prior to 1924, as remembered by Mrs. Rogers, one of the Smyths' grandchildren, in the 1970s. (CARL 3001)

At the first floor level, the back porch was flanked by two rooms, one on each side and each with a door opening on to the porch and an internal connection to the original part of the house, probably where windows had originally been located. There

is no indication of how these rooms were used, although they could have been built as large dressing rooms for the adjacent bedrooms.

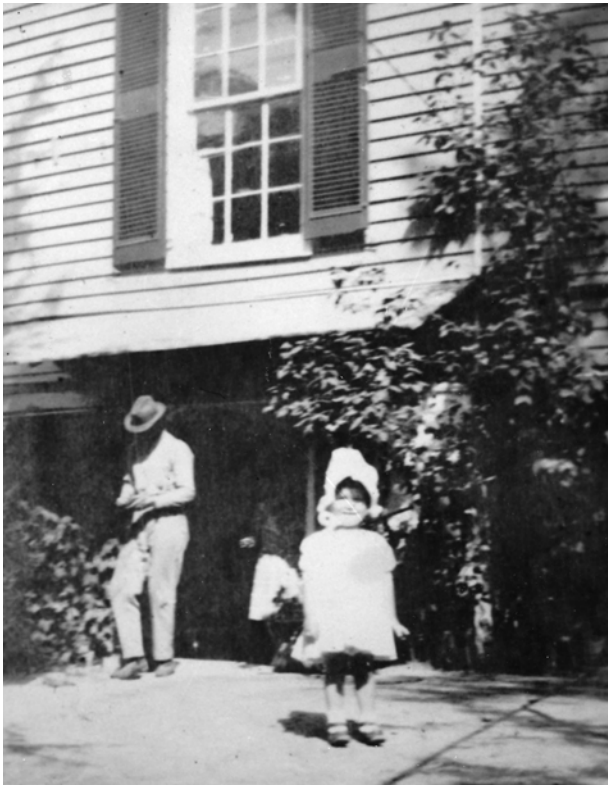
FIGURE 66. View at west end of Main House, showing window at west end of Memminger's addition, c. 1910. (CARL3001/01/30P)

**Characteristic Features.** In addition to the characteristic rusticated stone piers and retaining wall, the character of the addition's exterior was similar to the original house with 5"-lap siding and a wood-shingled roof. Windows were double-hung, nine-over-nine with louvered shutters, and although casing of the openings is not visible in historic photographs, it was probably a plain beaded casing like that used originally on the sides of the house.

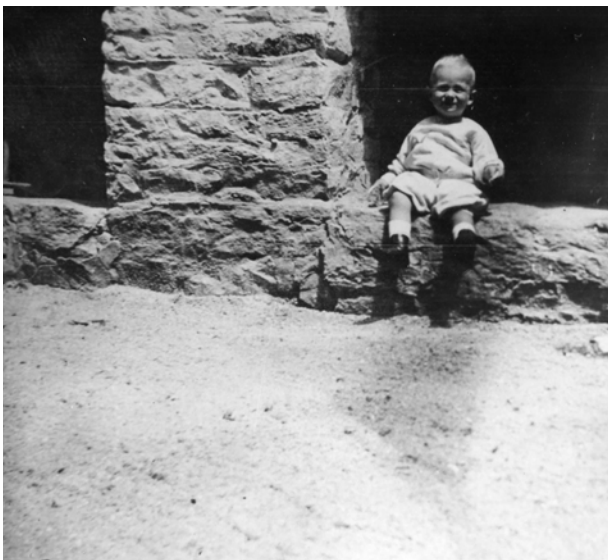
FIGURE 67. Smyth grandchild sitting on foundation wall of Memminger's rear addition to the first floor of the original building. (CARL3001/01/27P)

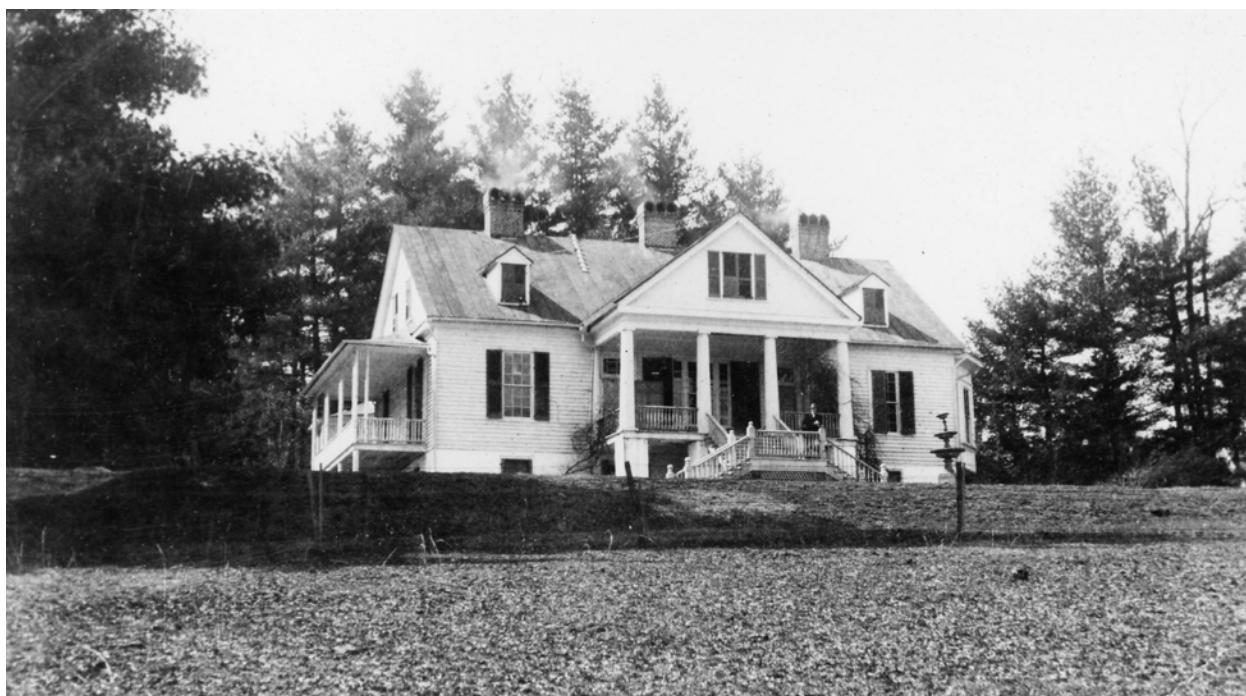
FIGURE 68. Connemara in the spring of 1901, with late nineteenth century alterations in place. (CARL3001/01/04P)

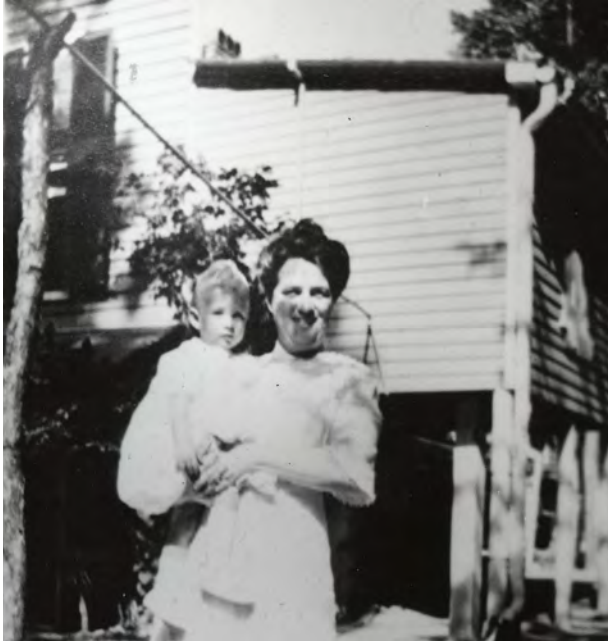
**FIGURE 69.** Mary H. Smyth and her son Joe, with a view of the room that was added to Memminger's addition, probably by the Greggs about 1890. (CARL3000/01/25P)

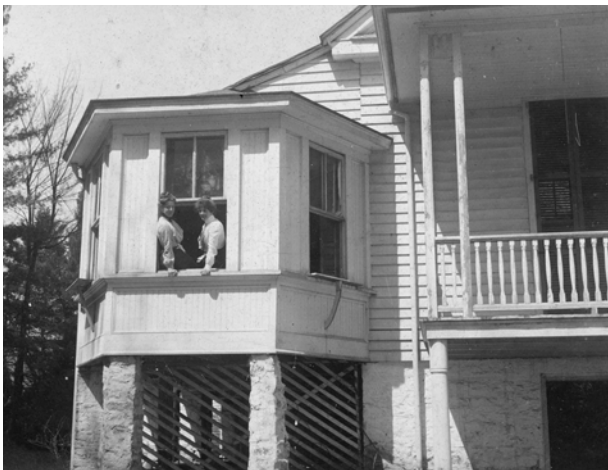
**FIGURE 70.** Olive Hill and Sarah Smyth, 6 April 1901, sitting in bay window added at the eastern end of Memminger's antebellum addition about 1890. (Collection of Julianne Heggoy, great-granddaughter of the Smyths)

because of its less prominent location, it was not as elaborate as the bay window on the west side of the house. Like the west bay, it featured two- over- two sash and was paneled on the exterior with beaded tongue- and- groove boards in much the same manner as the west bay. Several feet lower to the ground than the west bay, it had a straight base supported at its outside edge by a pair of stone posts.

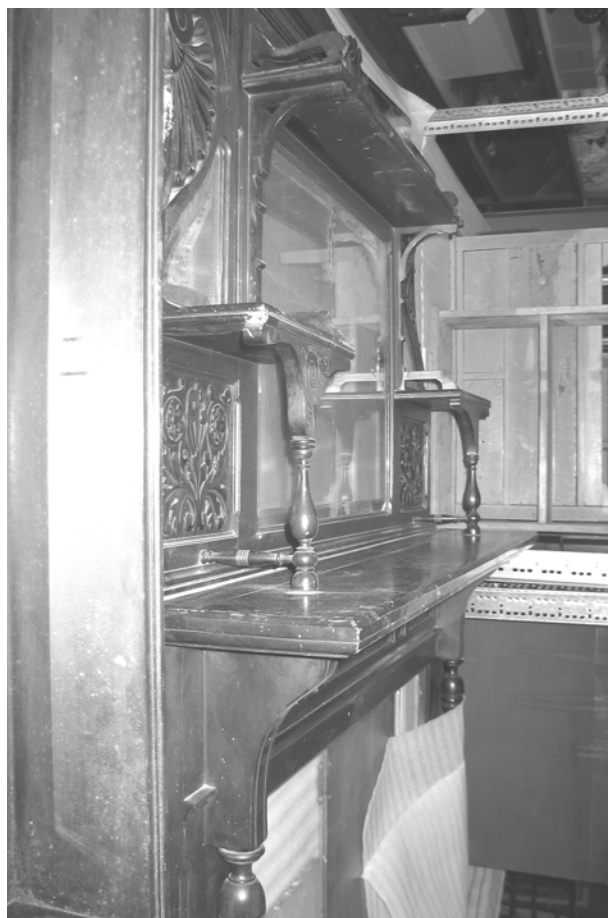
FIGURE 71. View of mantel now in storage, installed in the 1890s, probably in what is now Sandburg's Office (101). (T. Jones, NPS, 2004)

Two of the original mantels appear to have been replaced, probably around 1890, with mahogany-stained mantels in the so-called Eastlake style. Presumably these were installed at two of the three locations on the first floor where mantels are now missing (Rooms 101, 113, and 118).<sup>162</sup> The Smyths removed these mantels in the 1920s when central heating was installed and some fireplaces closed. The Ballards took the mantels and installed them in the Farm Manager's House, from which they were removed by the NPS and placed in museum storage.<sup>163</sup> Both are elaborately-decorated mahogany mantels with overmantels and beveled mirrors and most likely were located at the fireplaces in Rooms 101 and 113.

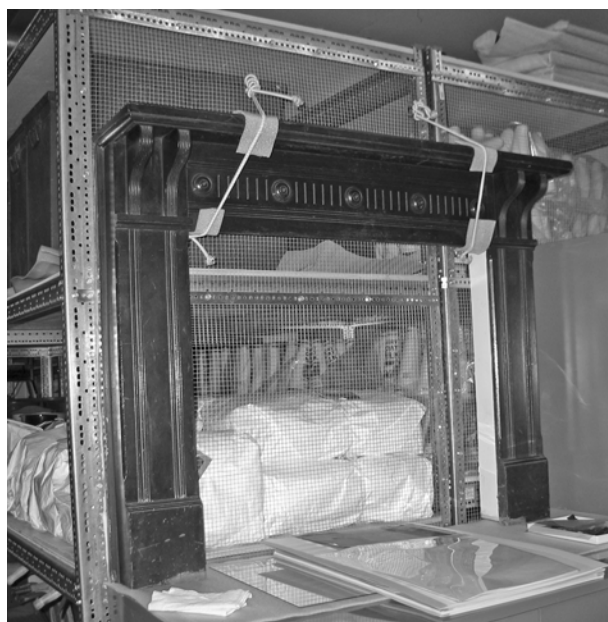
FIGURE 72. View of late-nineteenth century mantel, with overmantel detached, installed in the 1890s, probably in the Farm Office (113) or the Utility Room (118). (T. Jones, NPS, 2004)

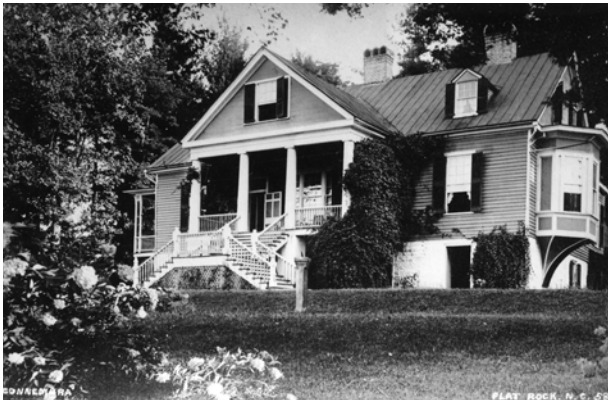
FIGURE 73. View of Connemara, perhaps around 1915, showing bay window added at west end of Main House in the 1890s. (Photograph by Baker Barber, CARL3001/01/06P)

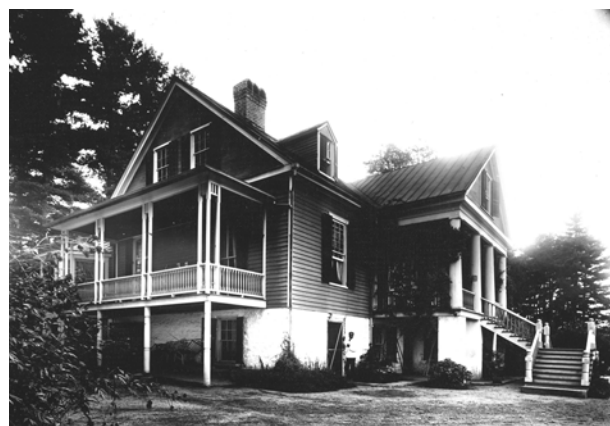
FIGURE 75. View of Connemara after it was painted green in the summer of 1901, showing East Porch and front steps added in 1890s. (CARL 30328, photo by Baker-Barber)

In addition, the front steps were finally replaced with a wooden T- shaped stairway, and the original sheaf- of- wheat balustrades on the portico were replaced with turned balusters like those used on the east porch. Although much larger, the turned newel posts at the foot of these stairs were similar to the turned posts on which the east porch was constructed.

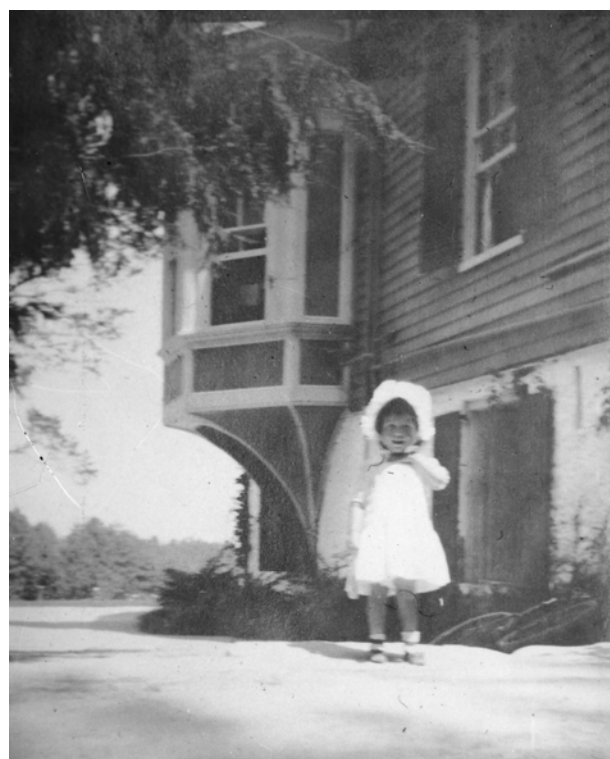
FIGURE 76. Smyth grandchild at west end of Main House, showing west bay and exposed waste lines and vent stacks for the lavatories in the Rooms 118 and 121. (CARL3001/01/32P)

166. It is possible the waste line was changed when the Sandburgs remodeled the house, and it was they who lowered the ceiling. However, there is no record of their having made changes to the waste line.

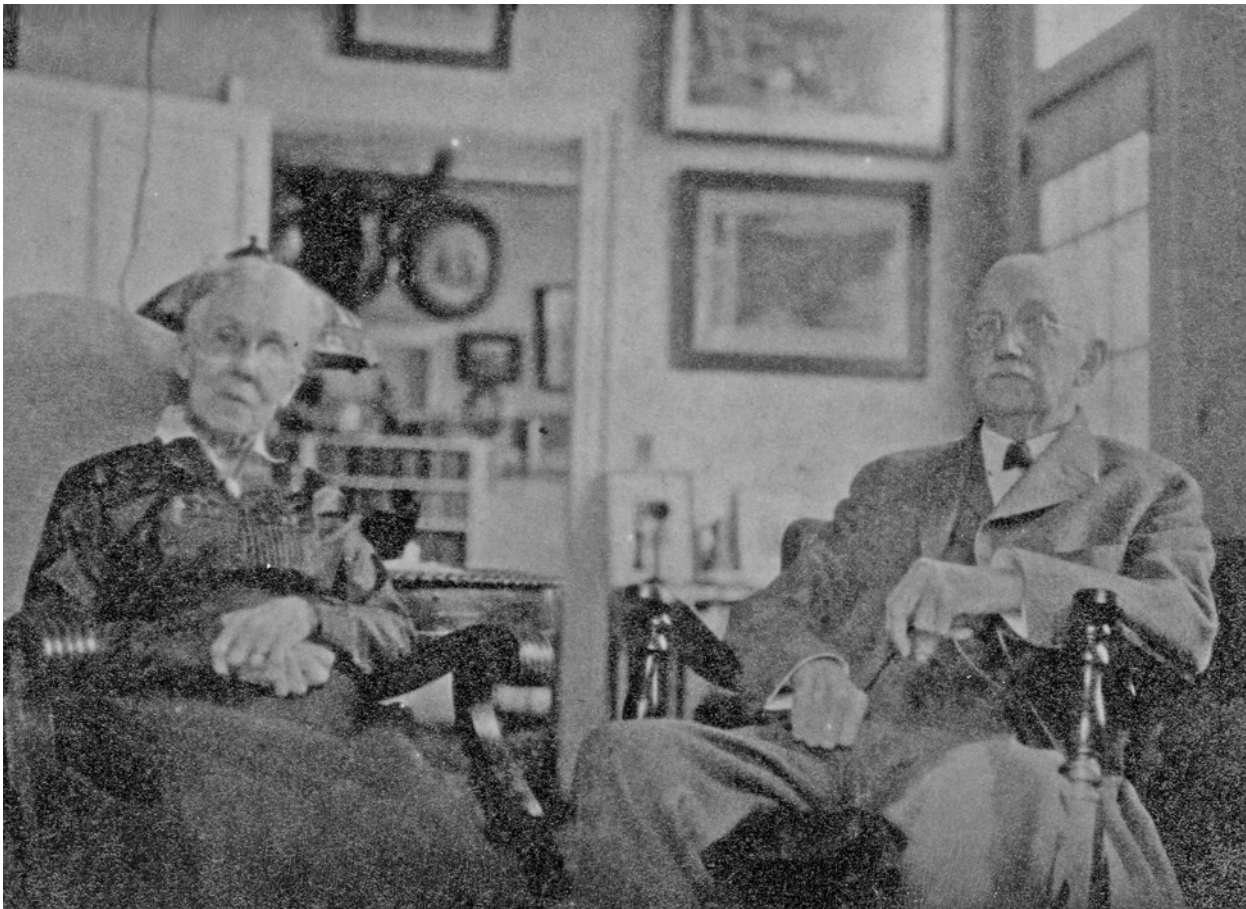
**FIGURE 77.** Captain and Mrs. Smyth in the Front Room in 1926. Note the electrical extension cord at upper left, trailing down from the overhead light, which is out of view, a common sight as lamps (one is on the table behind Mrs. Smyth) and other electrical devices proliferated in the 1920s. (Collection of Julianne Heggoy, great grand-daughter of the Smyths)

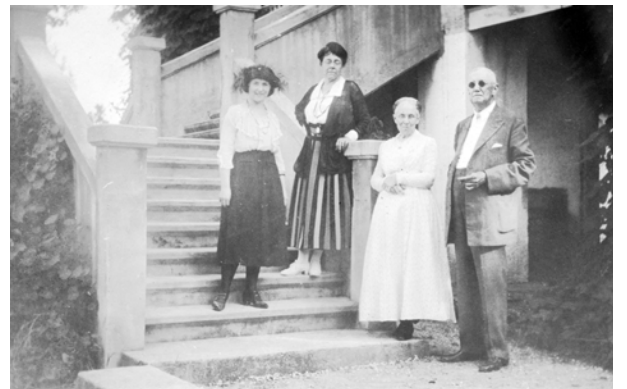
FIGURE 79. Captain and Mrs. Smyth, daughter Margaret, and unknown visitor on concrete front steps at Connemara, August 1921. (Collection of Julianne Heggoy, great granddaughter of the Smyths.)

**Front Porch.** Smyth also replaced the late- nineteenth- century stairs to the front porch with the present concrete staircase. A Smyth- era photograph dated August 1921 shows these concrete steps, and their condition at that time indicates that they had been in place for some time, perhaps as early as 1910

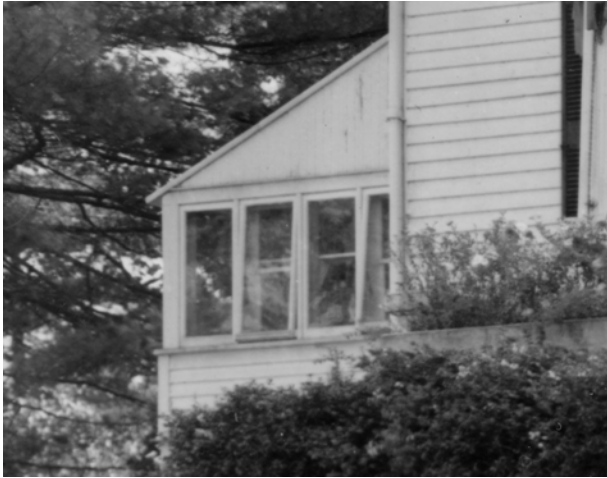
FIGURE 80. Detail of view of Connemara in 1938, showing Conservatory constructed by Smyth on east side of Front Room. (CARL3001/01/45P)

**Conservatory.** One of the last major alterations that Smyth made to Connemara was construction of a conservatory off the Front Room. Perhaps not occurring until after Mrs. Smyth's death in 1927, its construction necessitated removal of two-thirds of the 1890s porch. This conservatory was torn down by the NPS in 1969, and the present Conservatory is a mostly accurate reconstruction of the original.

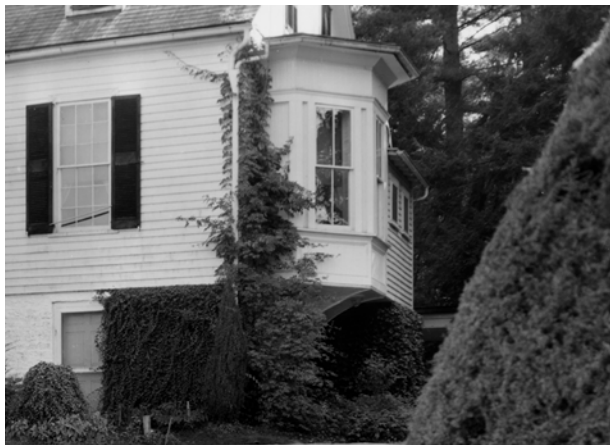
**FIGURE 83.** View of west end of house, c. 1938, with bathroom addition just visible beyond the bay window and a glimpse of the carport beyond that. (CARL3001/23/03P, photo by Bayard Wooten, Carolina Collection, University of North Carolina)

**Carport.** The origins of the carport on the west side of the house are obscure, but it appears that the present structure was built by the Smyths rather than by the Sandburgs. The earliest photograph showing the entire carport was taken in 1946, and it does not appear to be a new structure at that time. As noted above, one of the Smyths' grandchildren remembered a breezeway having been constructed in the 1920s to connect the kitchen with the main house, but it is likely that she remembered the carport rather than a breezeway. A photograph of the house taken in 1938 (Figures 83) provides a glimpse of a structure off the west side of the ground floor in

the location of the present carport. Magnification of the image shows that what little is visible of the structure closely resembles the present carport. The use of double-beaded tongue-and-groove paneling on the carport ceiling is perhaps the most conclusive evidence that the carport dates to the 1920s rather than the 1940s. Not only was such material almost never used in the 1940s, the double-beaded boards are identical to the boards used in Smyth's 1920s-era Barn Garage. In addition, the absence of charges for such material in the Anders invoices that document the Sandburgs' renovation lends additional cre-

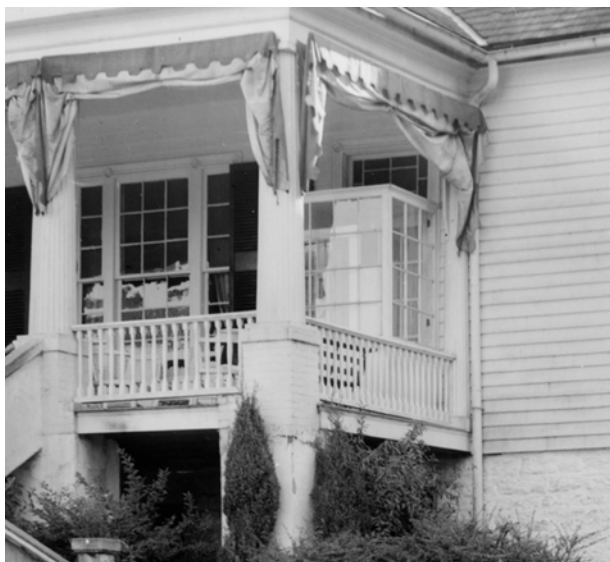
**FIGURE 84.** Detail of 1938 photograph by Bayard Wooten showing Smyth's glass-walled vestibule. (CARL3001/23/03P, Carolina Collection, University of North Carolina, Chapel Hill)
