Carl Sandburg Home National Historic Site  
Connemara Main House  
**Historic Structure Report**

September 2005

Historical Architecture, Cultural Resources Division

2005  
Historic Structure Report  
Connemara Main House  
Carl Sandburg Home National Historic Site  
Flat Rock, NC  
LCS#: 05146

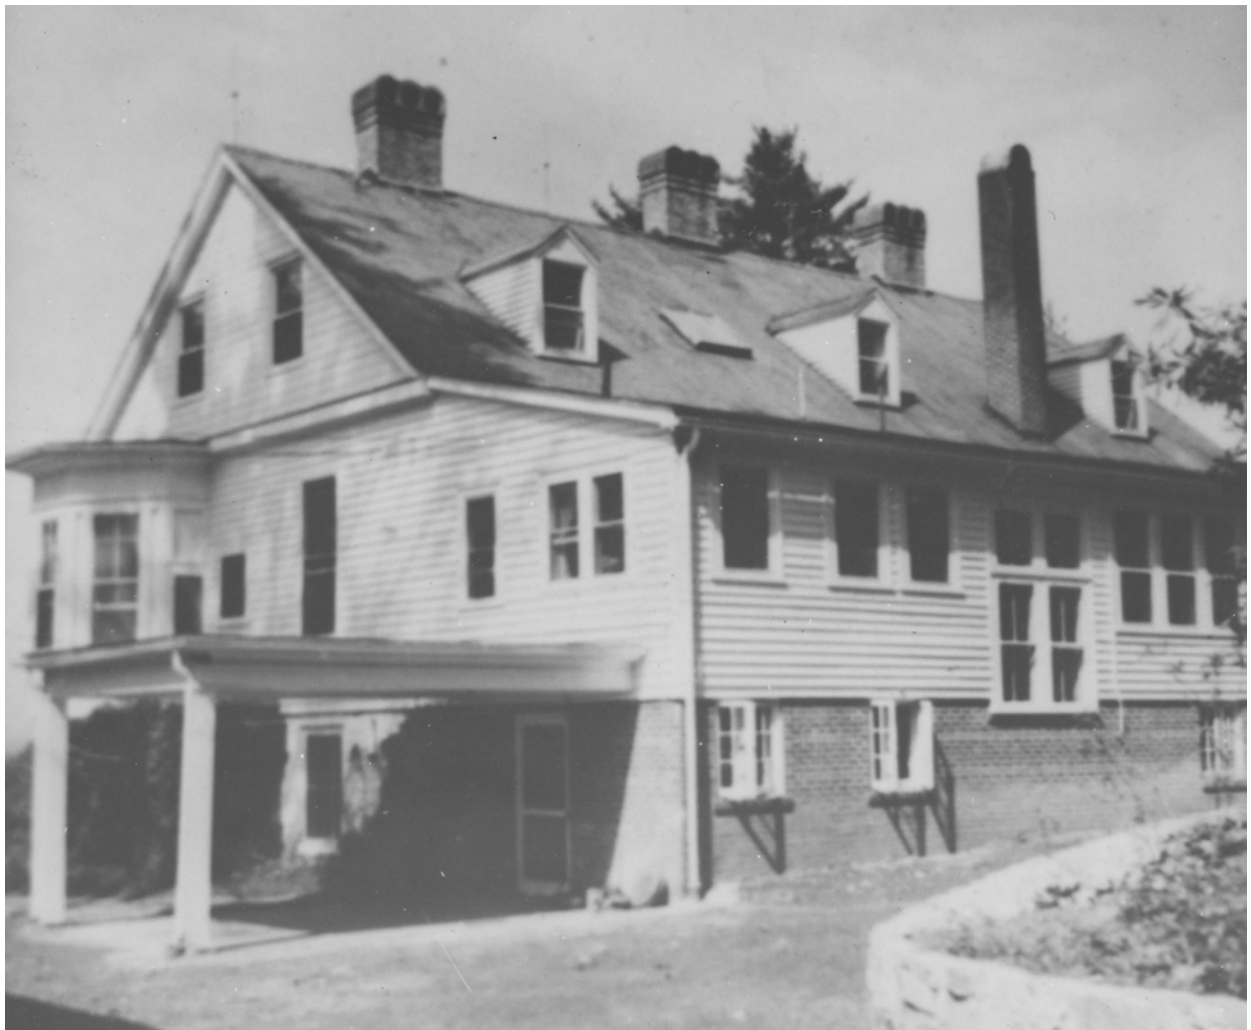
**FIGURE 85.** View of rear and west end of house in 1946 or early 1947. Aga stove chimney had not yet been built and the foundation remains unpainted. (CARL3000/15/26P)

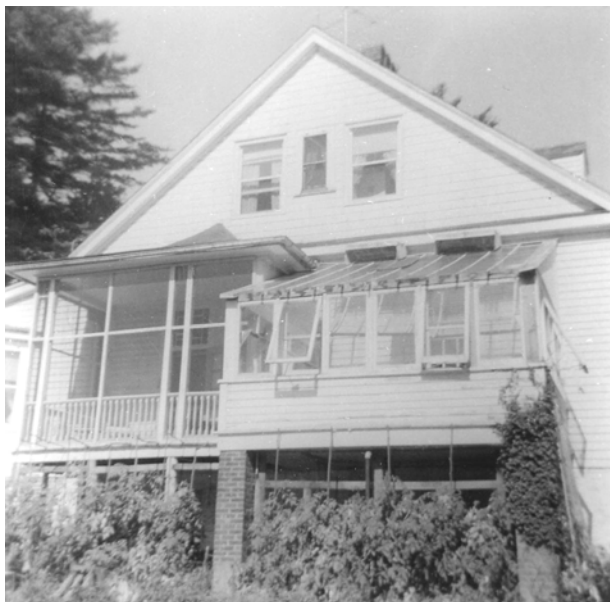
FIGURE 87. View of East Porch and Conservatory, showing window added in east gable for new bathroom on second floor. (CARL3000/15/28P)

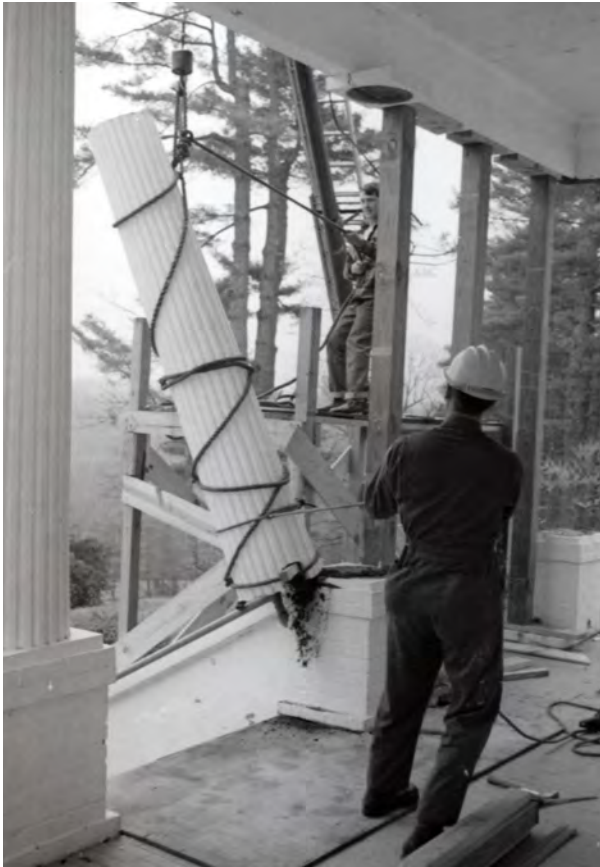
**FIGURE 103.** Removal of Front Porch columns in the spring of 1974. The only original column that remains intact is the one at left in this image.(CALO4008/01/048P)

In 1974, the front porch floor framing, flooring, and three of the four columns were replaced. This front porch framing and flooring were replaced again in 1996. The exterior was repainted in 1971, and again in 1979, 1985, 1990, and most recently in 2001- 2002.

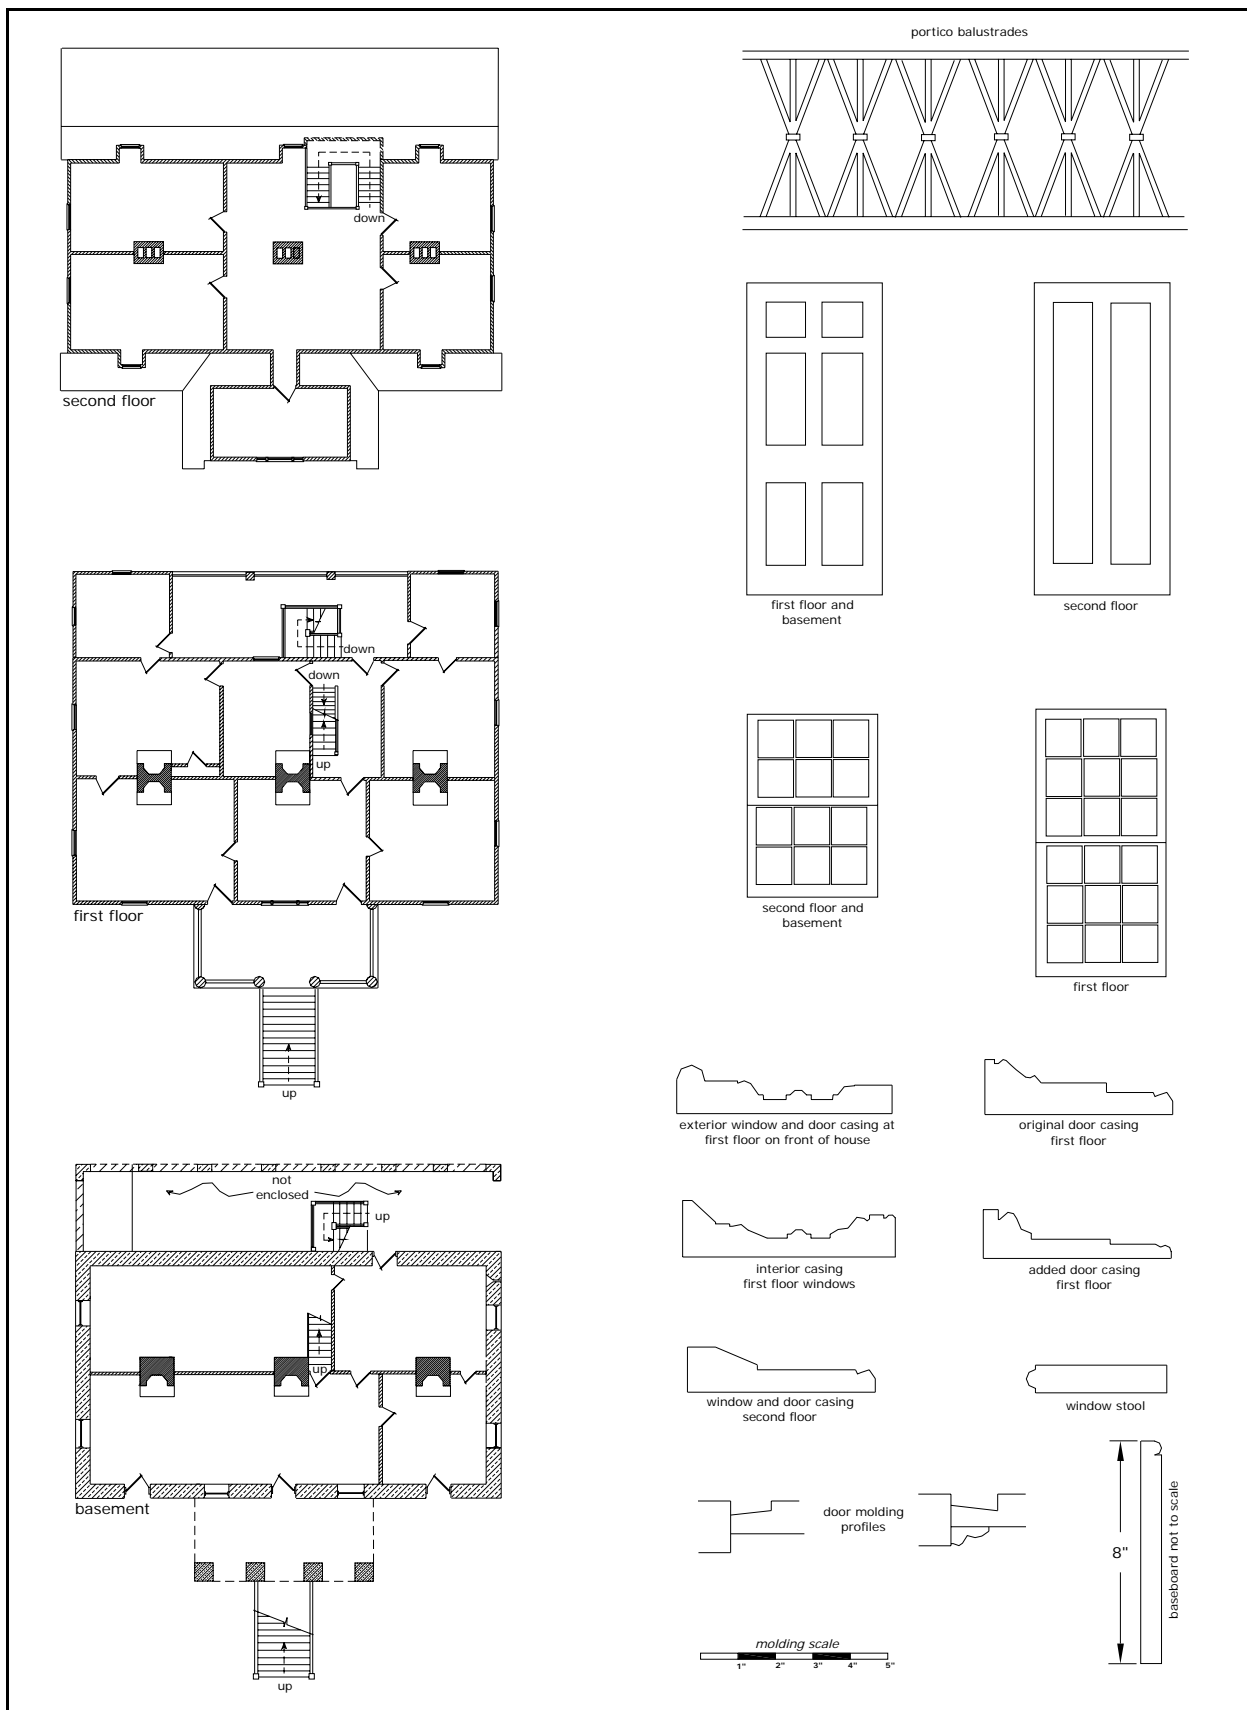
**Reconstructed Floor Plans and Details, c. 1850.**

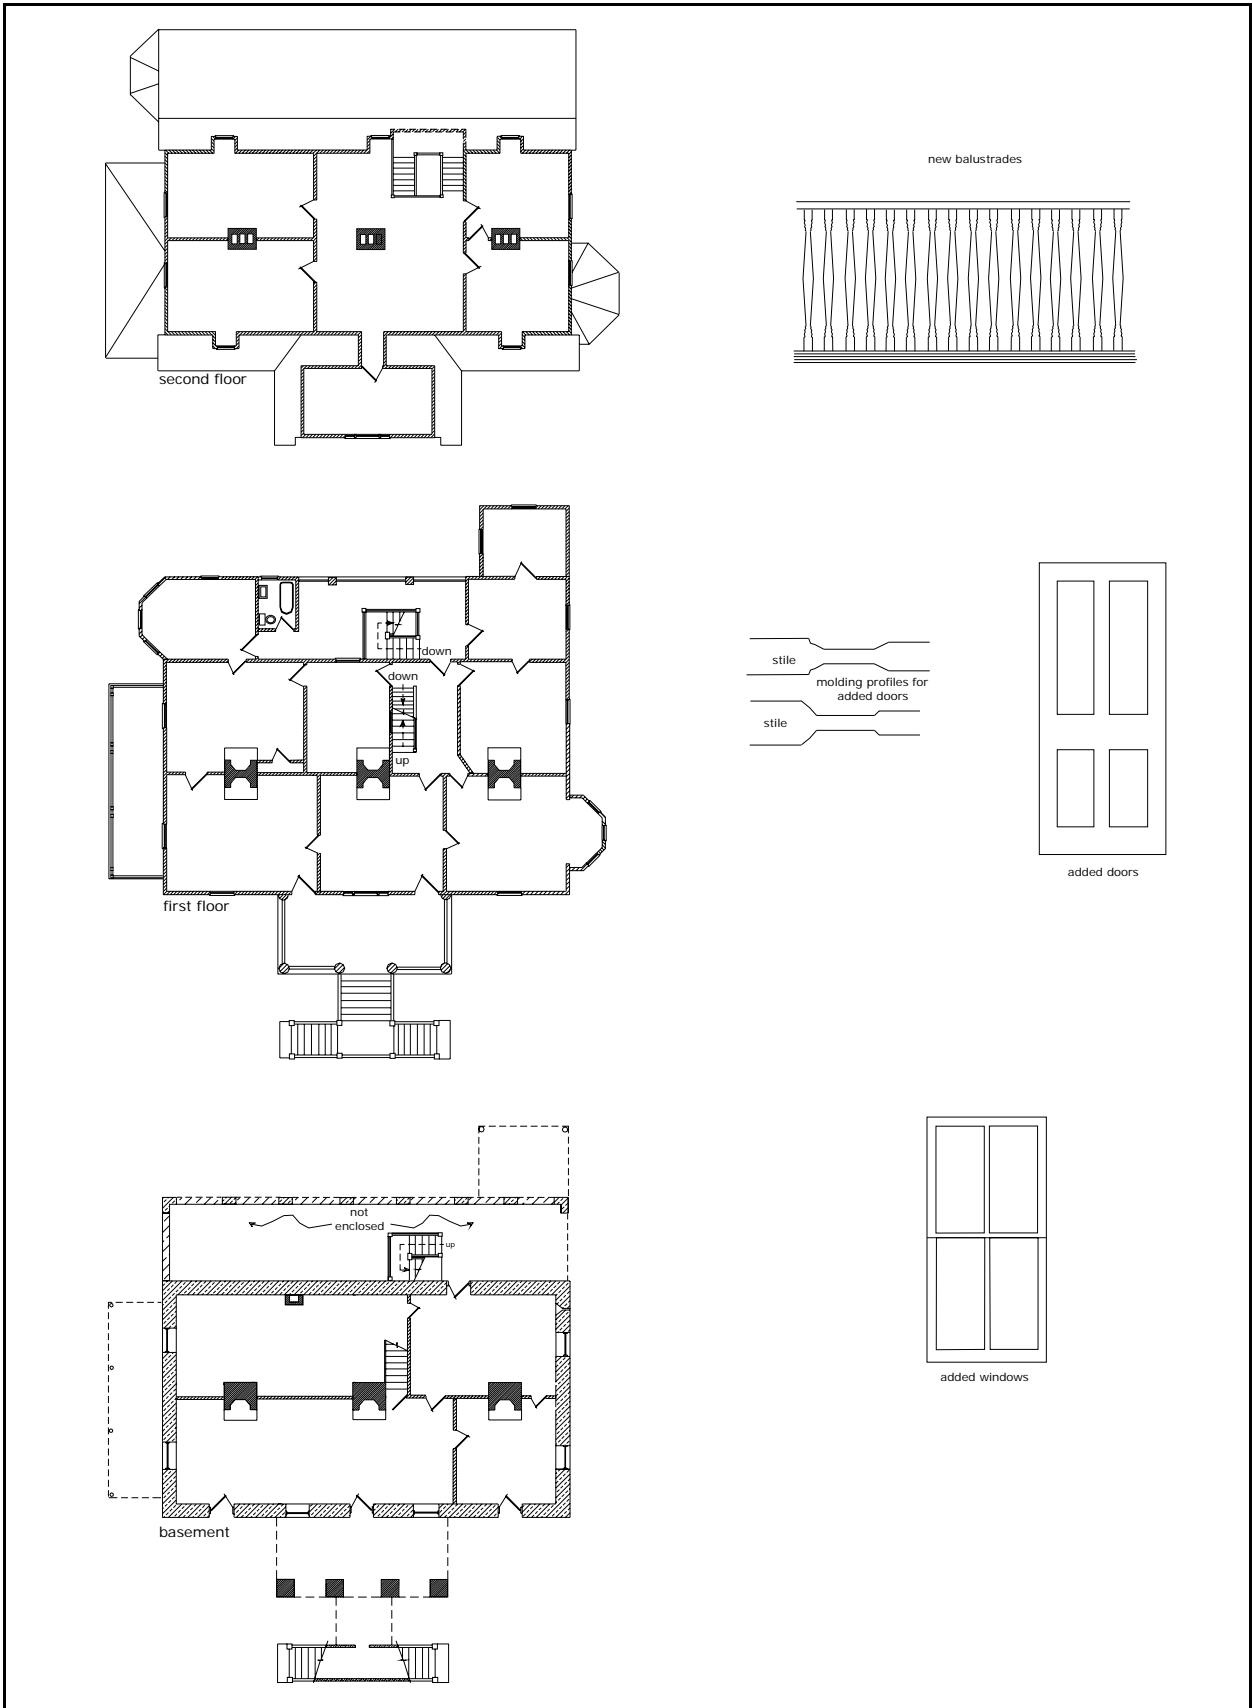
### Reconstructed Floor Plans and Details of Added Features, 1900

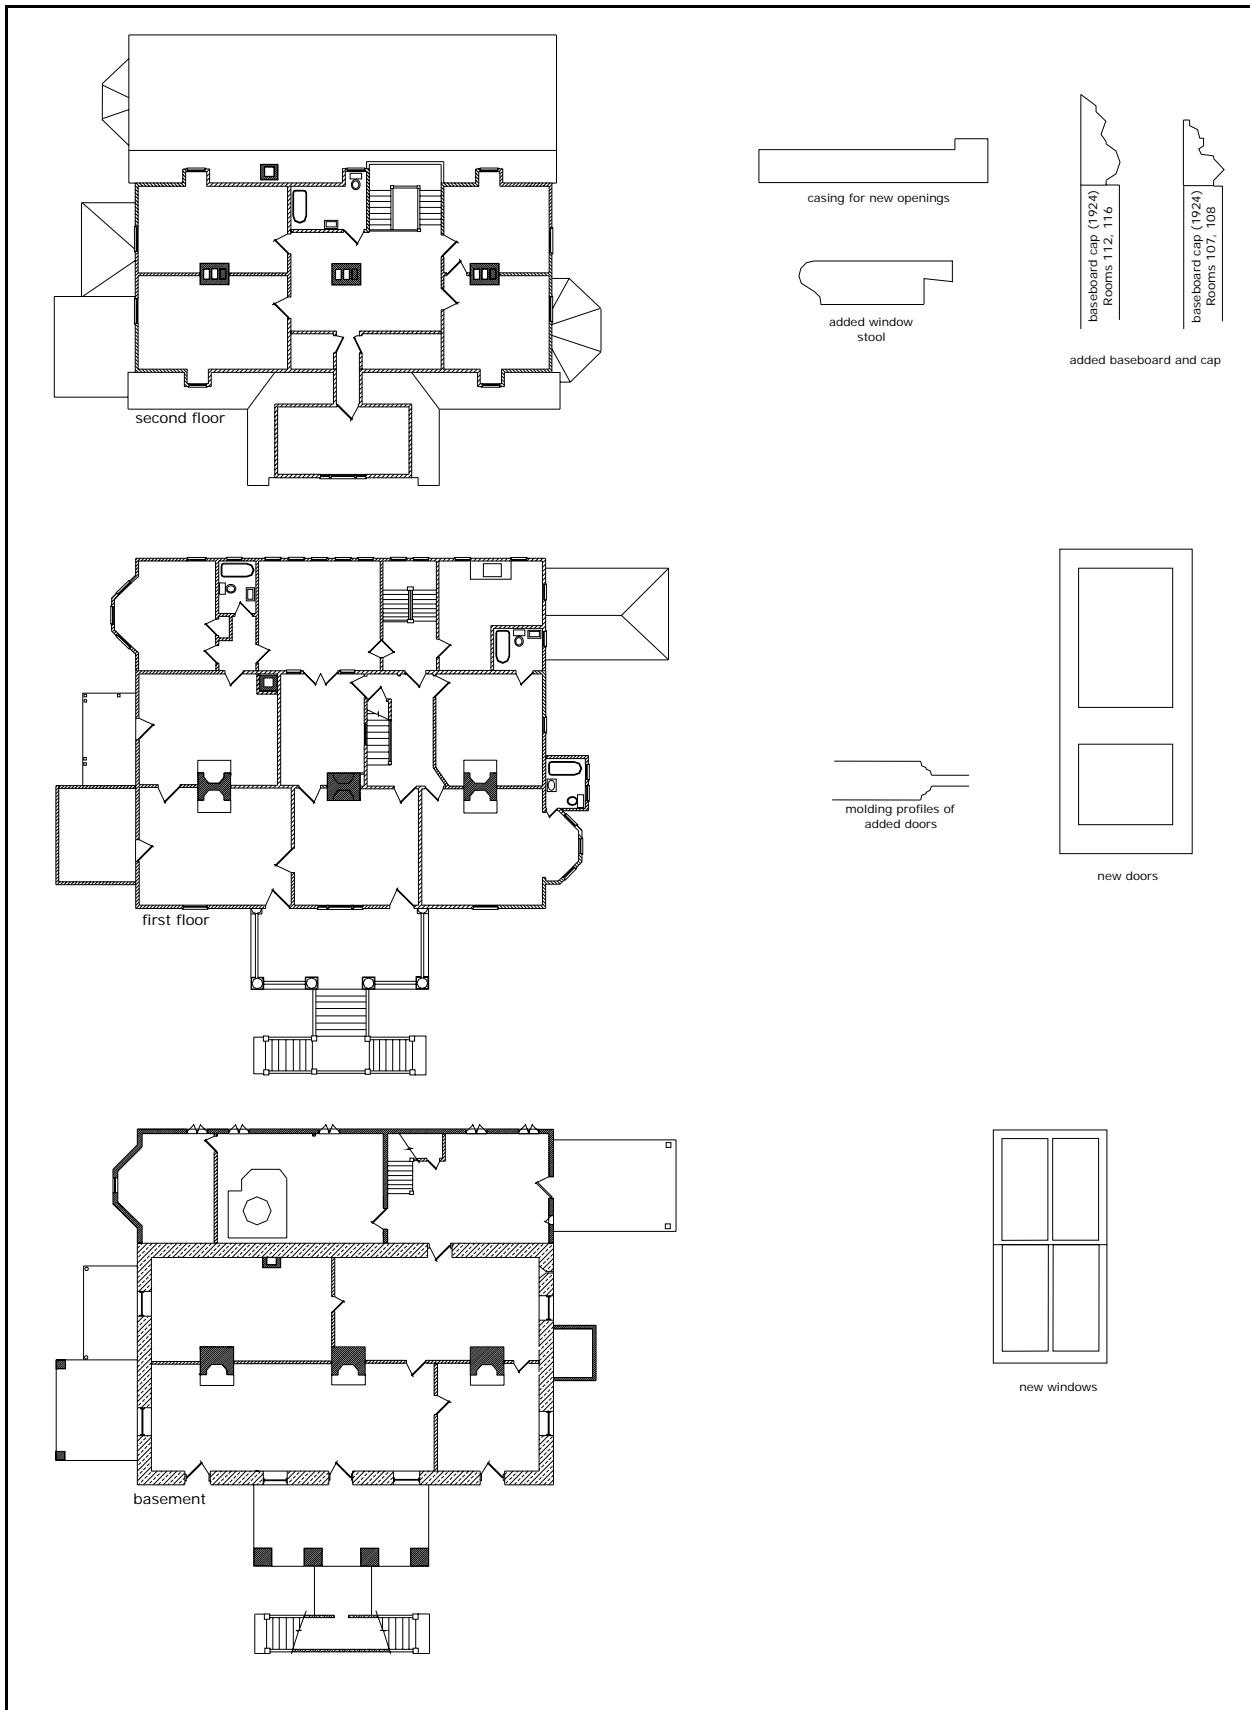
### Reconstructed Floor Plans and Details of Added Features, 1925

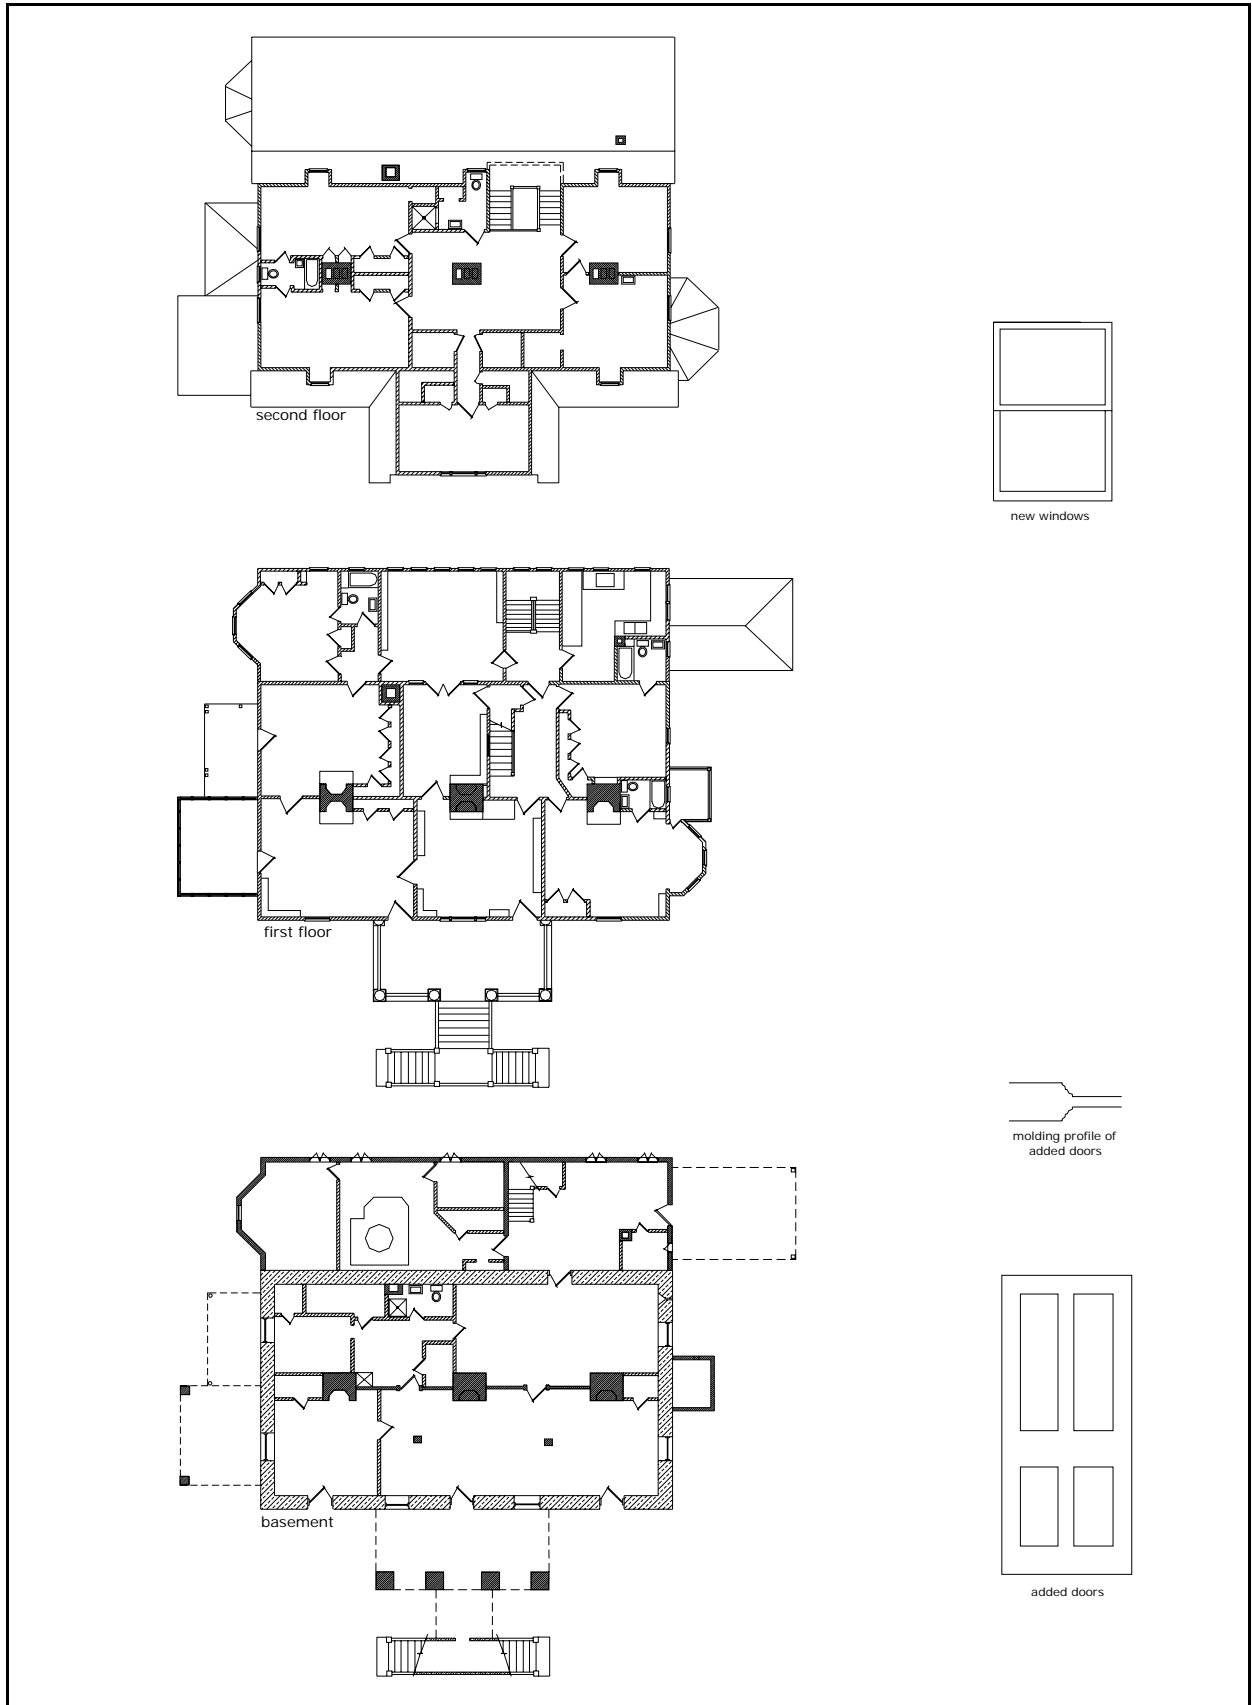
### Reconstructed Floor Plans and Details of Added Features, 1950

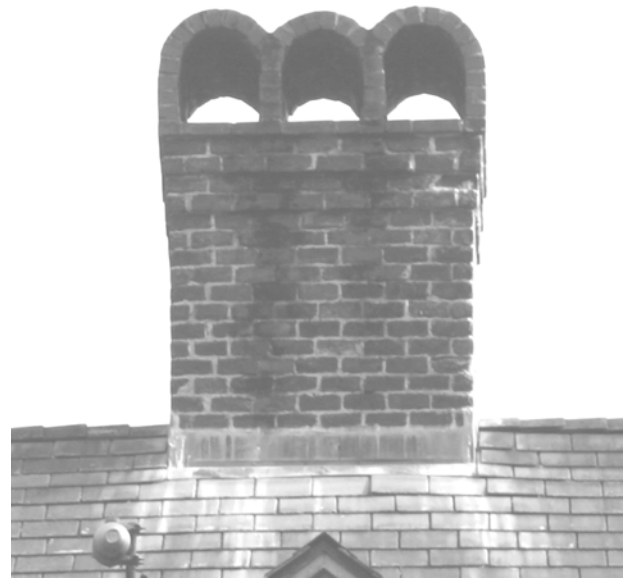
FIGURE 107. View of center chimney, as reconstructed in 1983. (T. Jones, NPS-SERO-CR,2004)

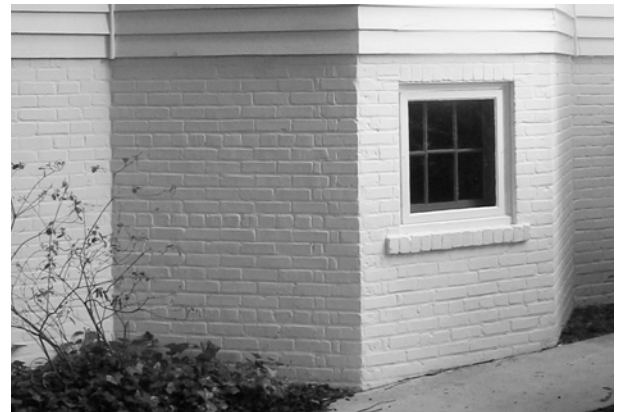
FIGURE 108. View of foundation at east end of 1920s rear addition. (T. Jones, NPS-SERO-CR, 2004)

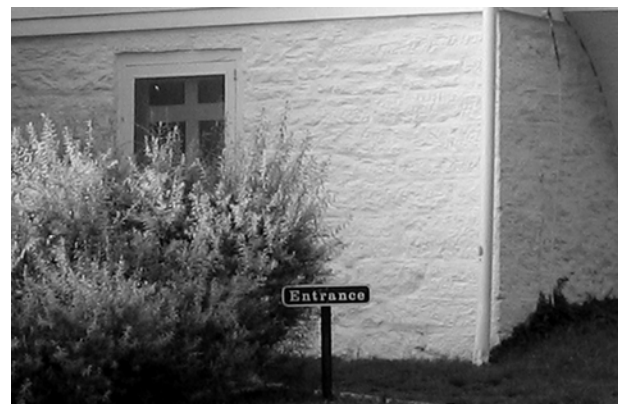
FIGURE 109. View of foundation at northwest corner of original house.(T. Jones, NPS-SERO-CR, 2004)

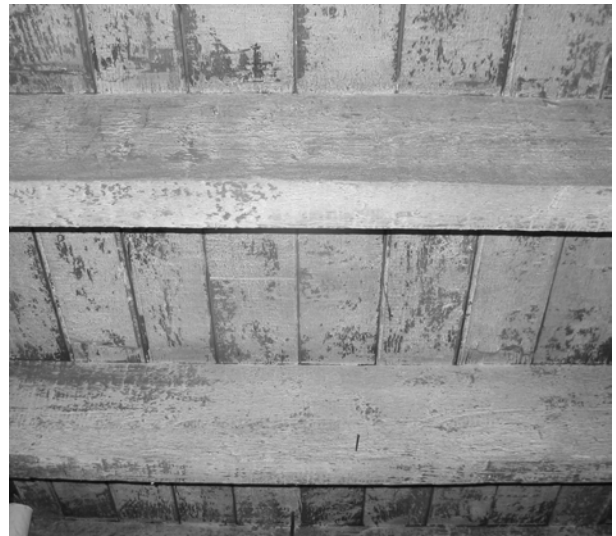
FIGURE 111. View of typical original first floor joists, as seen from Room 018. (T. Jones, NPS-SERO-CR, 2004)

**Floor.** First floor joists in the original part of the house are variable, ranging from 1-3/4" to 3" by 9-1/2" to 10", with most approaching the larger dimensions, and are set on centers ranging from 19-1/2" to 24" apart. Second floor joists in the original part of the house are generally 2-1/2" to 2-3/4" by 6-1/2" to 7-3/4" set on centers ranging from 21" to 27" apart. First floor joists in the original part of the house are connected by a relatively small mortise-and-tenon joint approximately 2-1/2" wide. Second floor joists are s lapped over the top plates and extend beyond the outside walls to provide "lookouts" for the house's boxed eaves. Floor joists in the rear addition are around 1-1/2" by 9-1/2", set on 16" centers and cross braced at mid-span with beaded tongue-and-groove boards that were salvaged from another location, probably from the ceilings of the antebellum rooms at the rear that were replaced in the 1920s. Diagonally laid subflooring around 8" wide was used in the rear addition, but no sub-floor is present in the original portion of the structure.

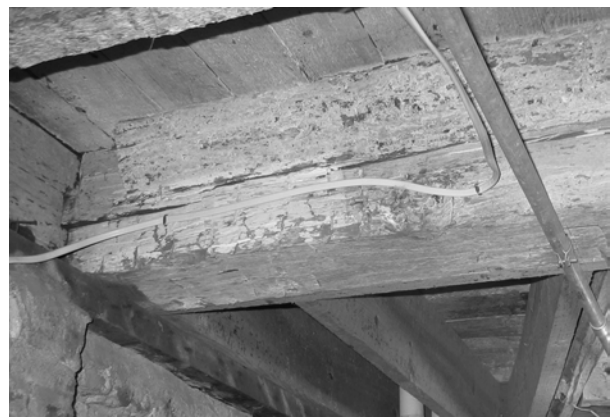
FIGURE 112. View of hand-hewn beam in Room 018. (T. Jones, NPS-SERO-CR, 2004)

Sills and beams in the original part of the house are hewn, approximately 7-1/2" by 9-1/2", and are in excellent condition. Top plates are sash sawn around 3-1/2" to 4" by 7-1/2" to 8".<sup>200</sup> Sills and beams in the rear addition, which date to the 1920s, consist of tripled members, each member around 1-1/2" by 9-1/2". Plates are doubled, with each member around 1-1/2" by 3-1/2".

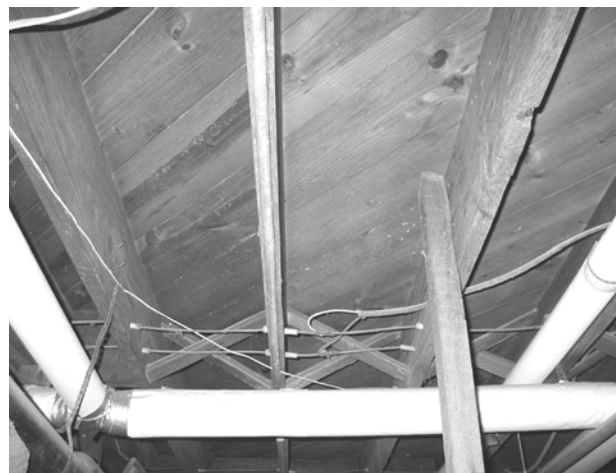
FIGURE 113. View of typical, cross-braced, floor joists and diagonally laid sub-floor in rear addition. (T. Jones, NPS-SERO-CR, 2004)

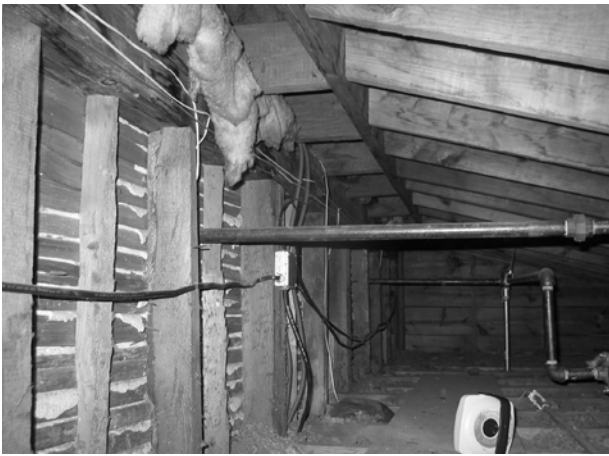
FIGURE 114. View east in attic of rear addition with framing of rear wall of original house visible at left. (T. Jones, NPS-SERO-CR, 2004)

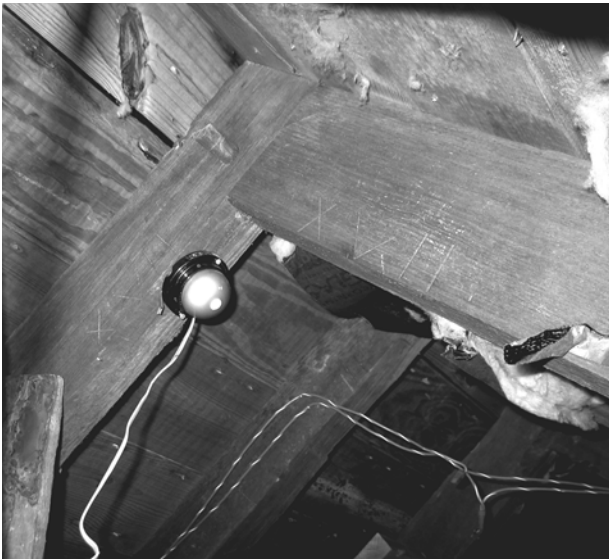
FIGURE 115. View of typical connection of rafters in main roof. Note inscribed Roman numeral XVII on face of right-hand rafter. (T. Jones, NPS-SERO-CR, 2004)

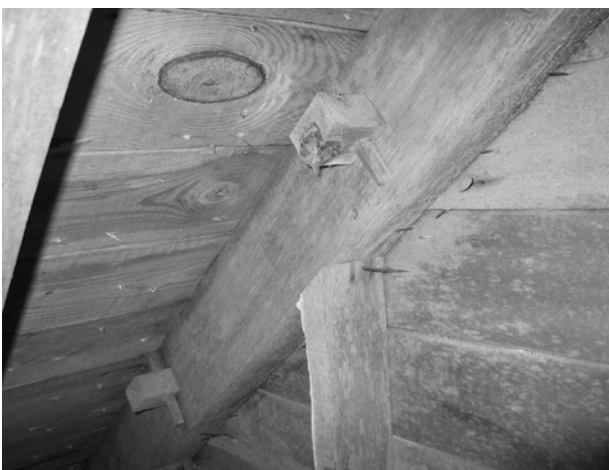
FIGURE 116. View of end rafter at west side of main roof, showing lookouts mortised and pegged in place. (T. Jones, NPS-SERO-CR, 2004)

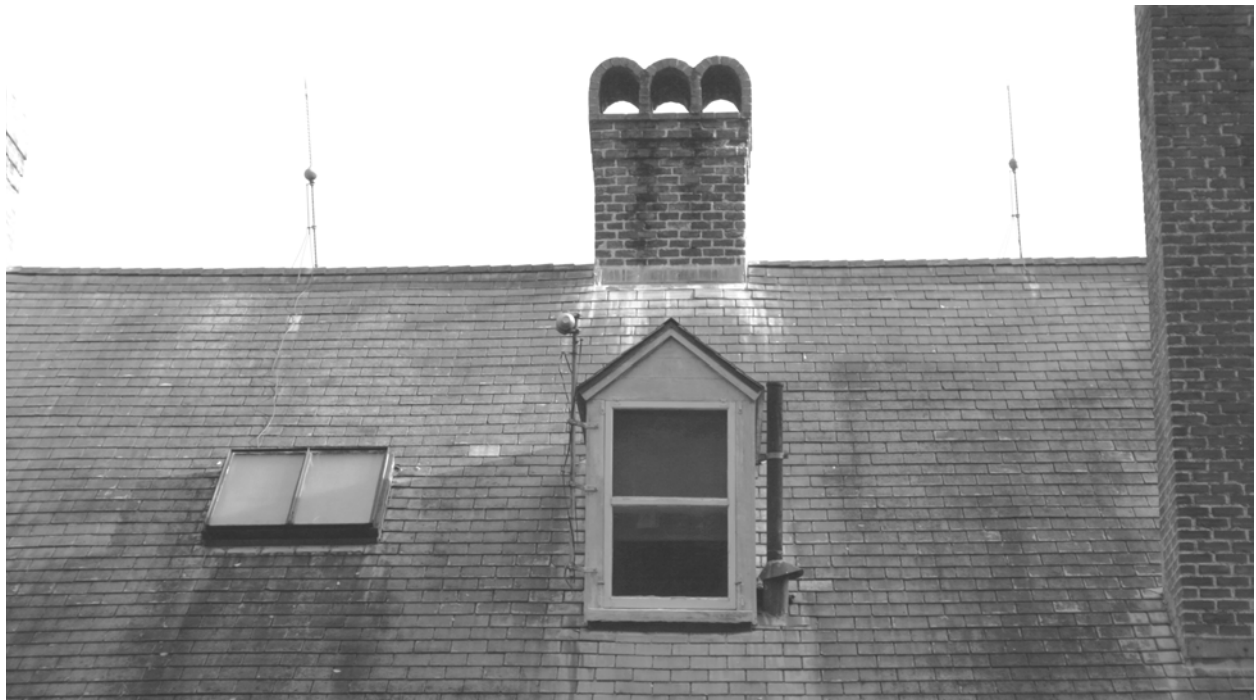
FIGURE 117. View of rear (south) shed of main roof, showing skylight, lightning rods, and typical dormer. (T. Jones, NPS-SERO-CR, 2004)

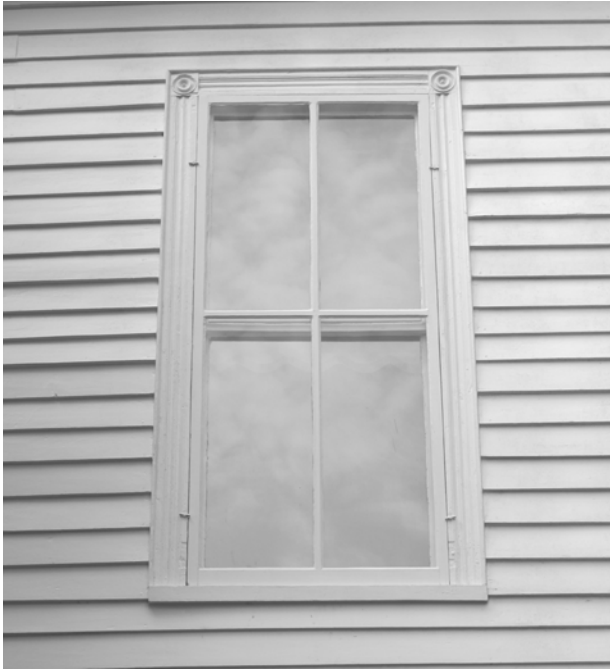
**FIGURE 118.** View of Window W-36, showing typical original casing and sill. Nine-over-nine muntins have been removed from original sash. A four-light, exterior storm sash is installed at the opening in this image. (T. Jones, NPS-SERO-CR, 2004)

The windows on the main floor of the house originally had nine- over- nine sash with six- over- six sash on the ground and second floors. Six- over- six sash were also used in the addition that Memminger constructed before the Civil War, but when a new door was created on the south side of Room 018 around the same time, the old door on the west side of that room was replaced with a double casement window (W- 13), which remains in the opening today.

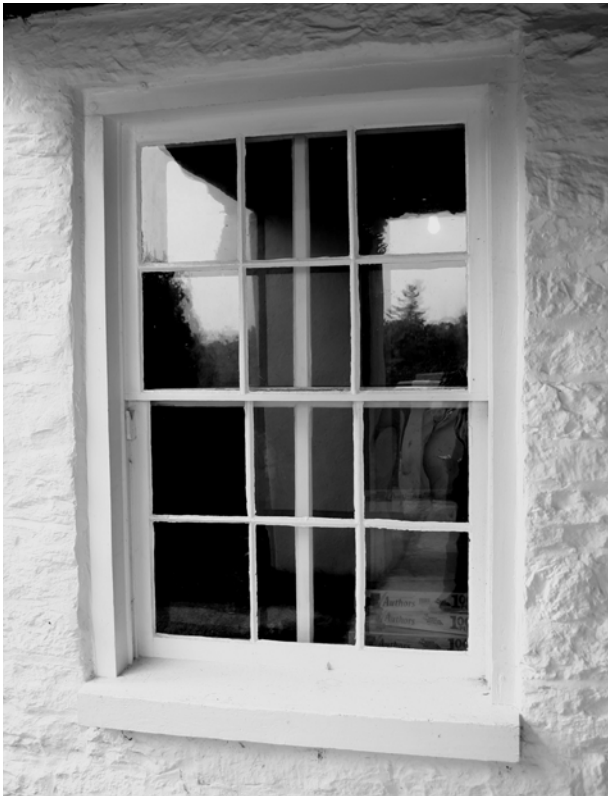
**FIGURE 119.** Window W-2, with original sash, in north wall of Room 001. Note wooden sash stop near upper left corner of lower sash. (T. Jones, NPS-SERO-CR, 2004)

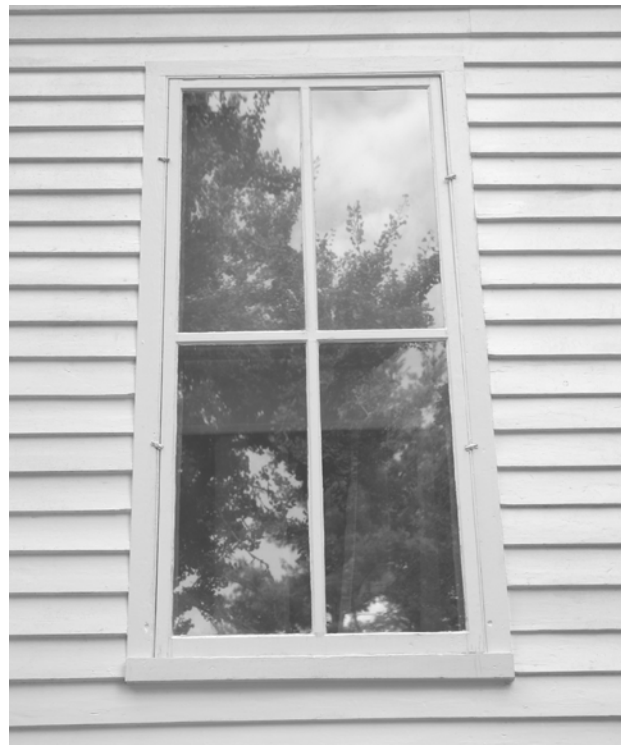
FIGURE 120. View of window (W-36), with original narrow beaded casing and thick sills used at openings on the sides of the original house. (T. Jones, NPS-SERO-CR, 2004)

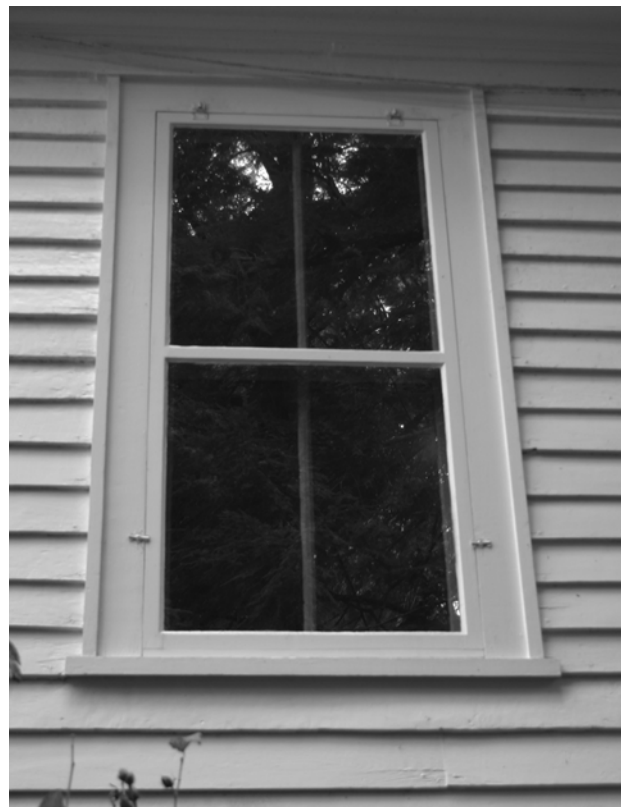
FIGURE 121. View of Window W-21, typical of rear addition (c. 1924), with two-over-two sash intact. A two-light, exterior storm sash is installed at the opening in this image. (T. Jones, NPS-SERO-CR, 2004)

rails are both around 2- 1/2" wide. Windows added in the late nineteenth and early twentieth centuries, including the 1920s, had two- over- two sash like those that remain in the bay windows and the back stair hall. Two generations of two- over- two sash can be distinguished by the thicker muntins (1- 1/4" vs. 1") in the sash from the 1920s. All of these windows were typically double- hung and counterbalanced.

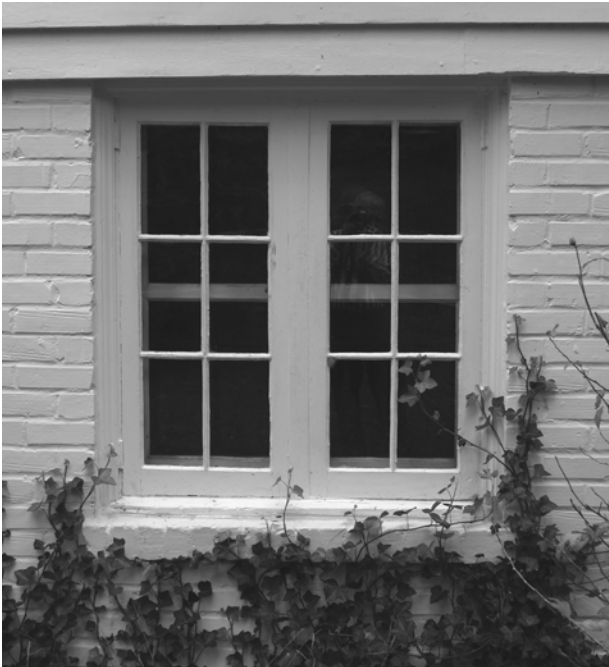
FIGURE 122. View of Window W-8, typical of ground floor windows in rear addition. (T. Jones, NPS-SERO-CR, 2004)

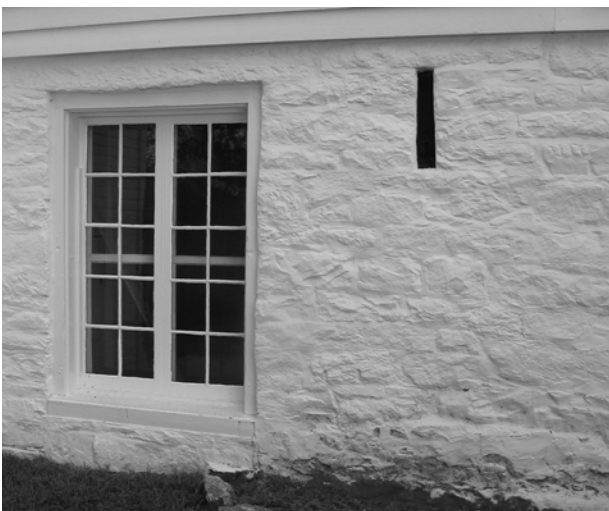
FIGURE 123. View of window W-13, which was originally a door opening, and the adjacent embrasure. (T. Jones, NPS-SERO-CR, 2004)

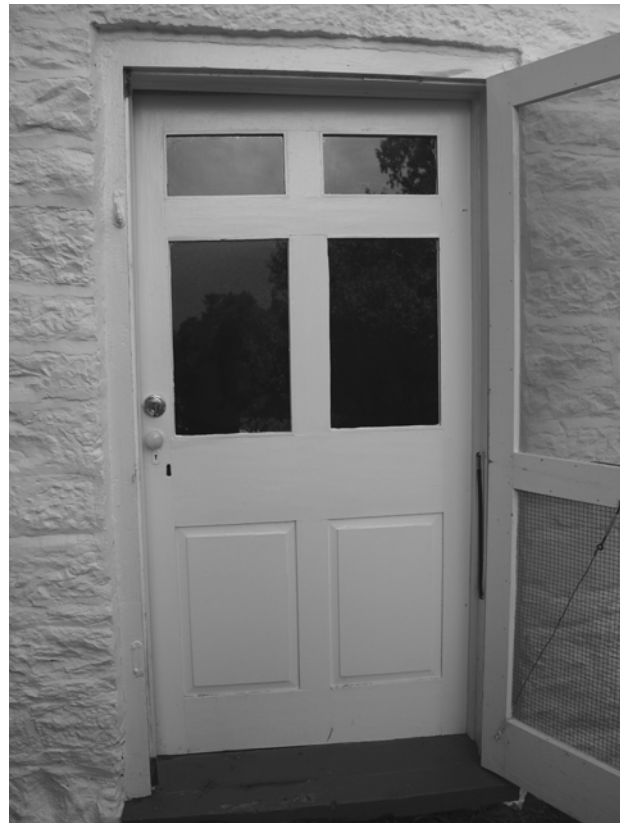
FIGURE 124. View of Door D-1, one of the house's original doors (c. 1838), altered by the Sandburgs in 1945. (T. Jones, NPS-SERO-CR, 2004)

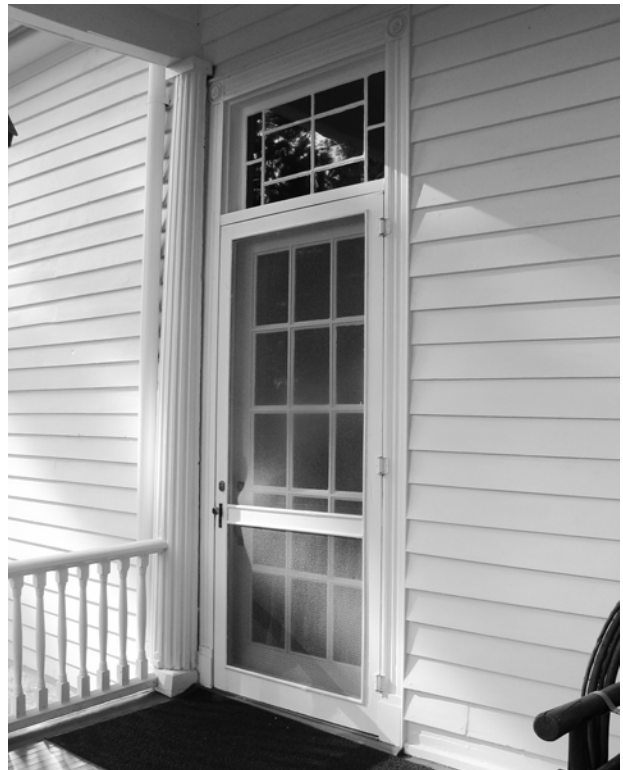
FIGURE 125. View of Door D-11, with original casing, mid-19th century transom, and c. 1924 French door and screened door. (T. Jones, NPS-SERO-CR, 2004)

In addition, divided- light transoms were installed above the four outside doors on the first floor. The ten- light transoms over the front doors were in place by the 1880s and may, at one time, have been glazed with colored glass in a manner typical of the period. The nine- light transoms over the doors to the conservatory and east porch were installed in the 1920s along with the French doors and have always been glazed with clear glass.

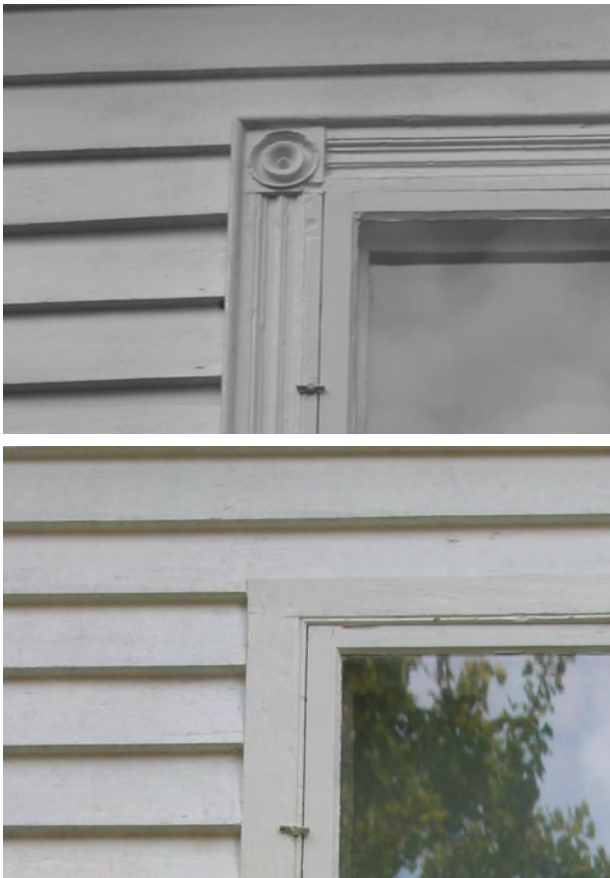
FIGURE 126. View of original (1838) exterior window casings. (T. Jones, NPS-SERO-CR, 2004)

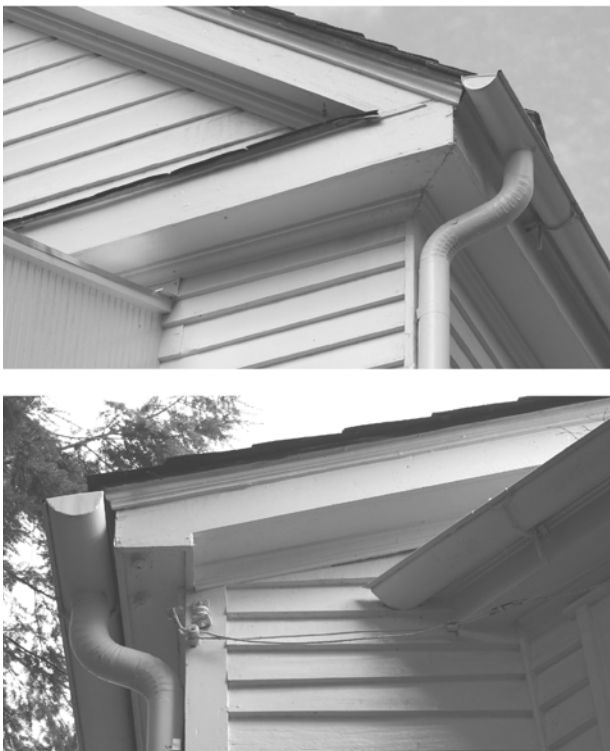
FIGURE 127. View of typical eaves on original house, top, and on rear addition, bottom. (T. Jones, NPS-SERO-CR, 2004)

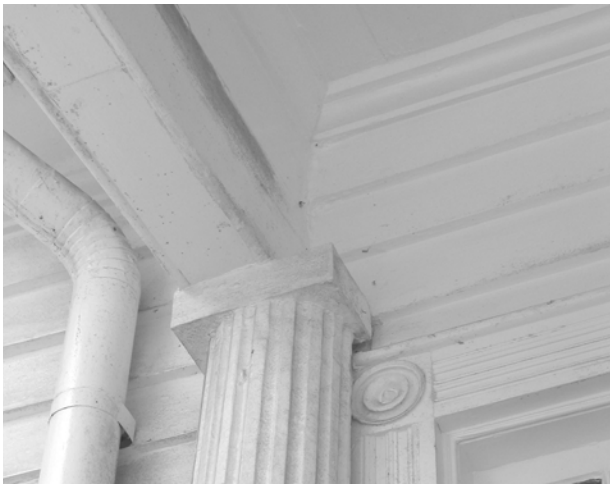
FIGURE 131. View of typical Portico details. (T. Jones, NPS-SERO-CR, 2004)

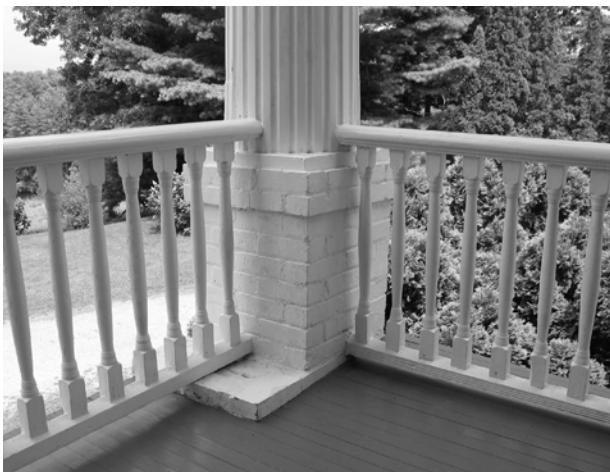
FIGURE 133. View of northeast corner of Portico showing typical balustrade (c. 1890) and brick pier (c. 1924). (T. Jones, NPS-SERO-CR, 2004)

**Piers.** Dating to the 1920s, the painted brick piers were built on top of larger antebellum foundation piers described earlier and are around 20" by 20" except for the top two courses which are corbeled out about an inch on all sides. A 2"- thick, painted, concrete cap around 22" by 22" and probably contemporaneous with the pier itself serves as a base for the wooden column. The masonry that projects through the floor at the two corner piers may be the result of a construction error. At the center columns, the wood floor system covers the change in dimension between the added brick piers above and the wider antebellum piers at the ground floor level. At the corners, however, new brick construction followed the wider dimension to floor level so that the transition between the two dimensions is exposed.

**Balustrade.** The existing balustrades date to the late Victorian renovation of the house and generally match the balustrades that survive on the East Porch. In relatively good condition, they replaced the original balustrades and were installed around 1890 with installation of the first wooden, T- shaped front steps, which featured similar balusters. The present balustrade is about 31- 1/2" high and includes a 4- 1/2" by 2- 1/2" oval top rail and a 2- 3/4" by 2- 3/4" bottom rail, reeded on both faces. The top of the bottom rail angles to a ridge down the center of the rail, with the baluster ends broadly notched to sit on the ridge. Turned balusters are around 1- 3/4" by 1- 3/4" but are extremely variable in their molding, indicating that the balusters were hand- turned, perhaps locally.

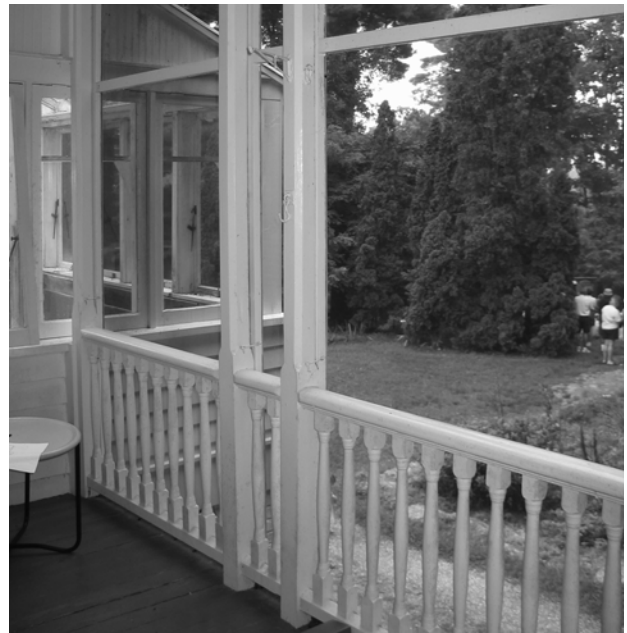
FIGURE 134. View of original posts and balustrades (c. 1890) on East Porch..(T. Jones, NPS-SERO-CR, 2004)

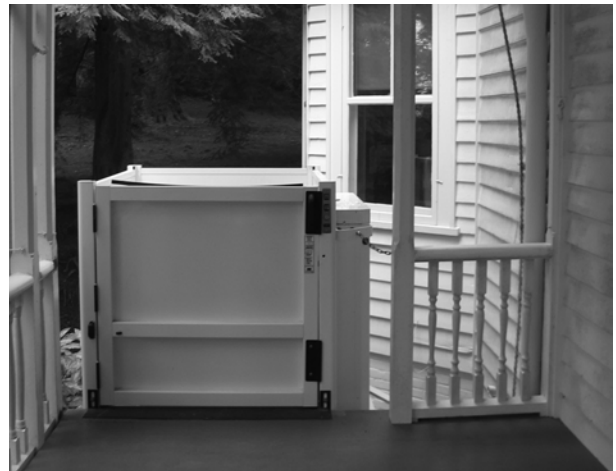
FIGURE 135. View of lift to East Porch..(T. Jones, NPS-SERO-CR, 2004)

The north half of the porch that was built on the east side of the house around 1890 was replaced by the Conservatory in the late 1920s or early 1930s, but the southern half of the porch remains intact. Designated Room 106 in earlier plans of the building, it retains many of its original features, and even the shortened roof maintains the concave ridges of the original hipped roof. The porch underwent significant alterations in 1991 when the NPS installed a mechanical lift at its south end.
