Carl Sandburg Home National Historic Site  
Connemara Main House  
**Historic Structure Report**

September 2005

Historical Architecture, Cultural Resources Division

2005  
Historic Structure Report  
Connemara Main House  
Carl Sandburg Home National Historic Site  
Flat Rock, NC  
LCS#: 05146

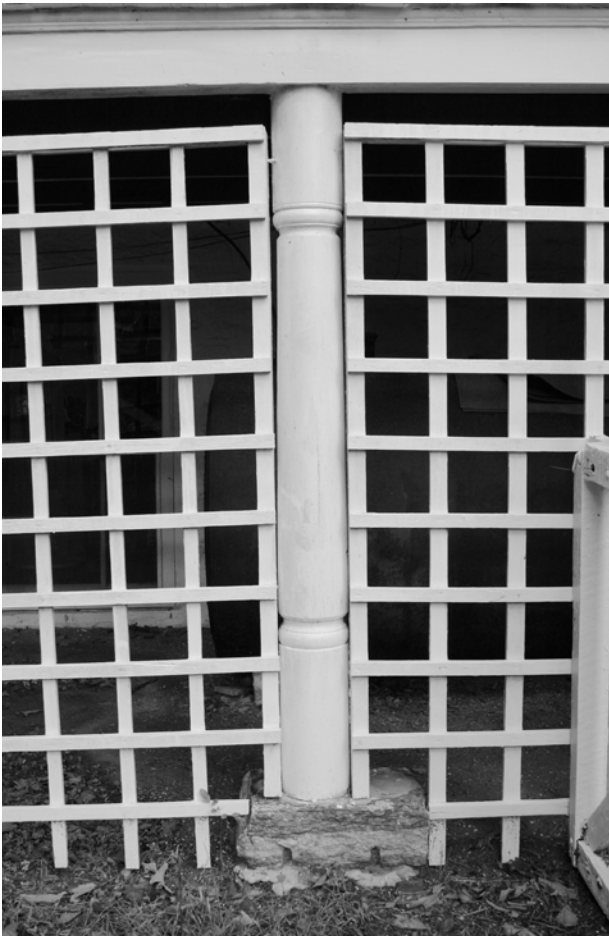
FIGURE 138. View of lattice under East Porch..(T. Jones, NPS-SERO-CR, 2004)

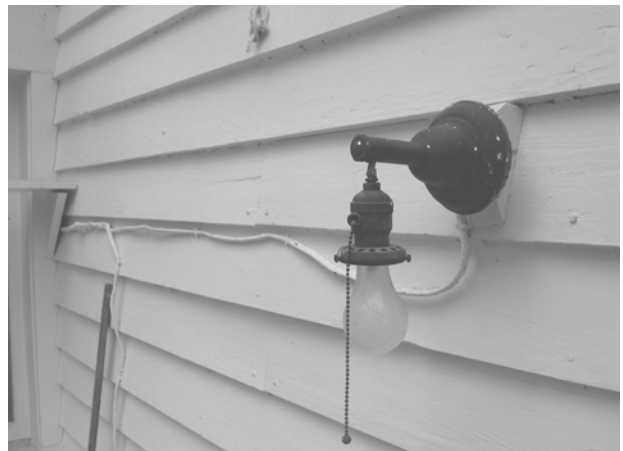
FIGURE 141. Light fixture, c. 1920, on west wall of conservatory. (T. Jones, NPS-SERO-CR, 2004)

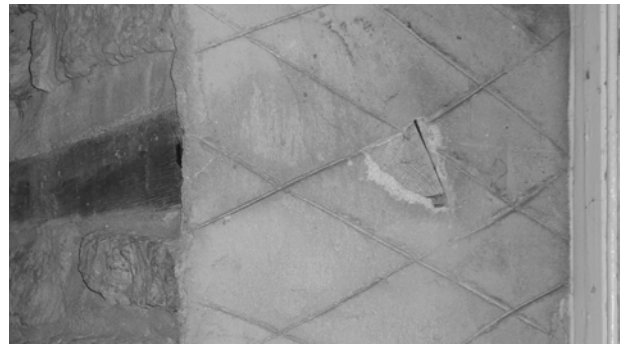
FIGURE 145. View of west jamb of Door D-1. Left of center is part of the wooden nailer inset into the masonry. (T. Jones, NPS-SERO-CR, 2004)

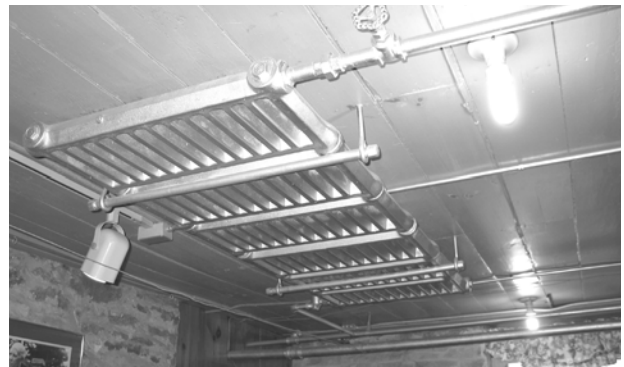
FIGURE 146. View of typical ceiling-hung radiator. (T. Jones, NPS-SERO-CR, 2004)

*Heating:* The fireplace on the north wall remains open but has undergone modifications similar to those evident in the fireplaces in Room 001, including installation of a cast- iron lintel that lowered the firebox opening to 31". The room is now heated by means of a typical, ceiling- mounted, cast- iron radiator, about 4- 1/2' long in four sections.

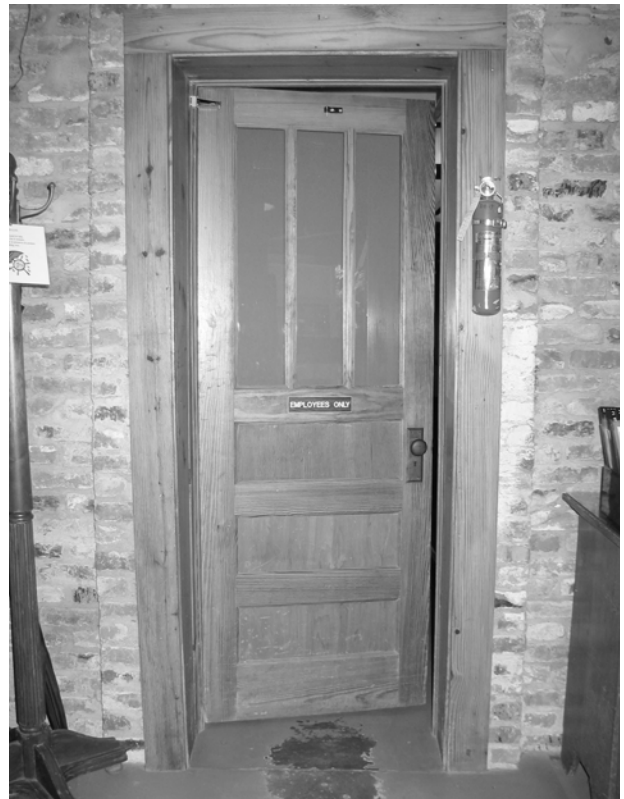
FIGURE 147. View of door from Room 001 into 005, typical of varnished fir doors installed by the Sandburgs around 1947. (T. Jones, NPS-SERO-CR, 2004)

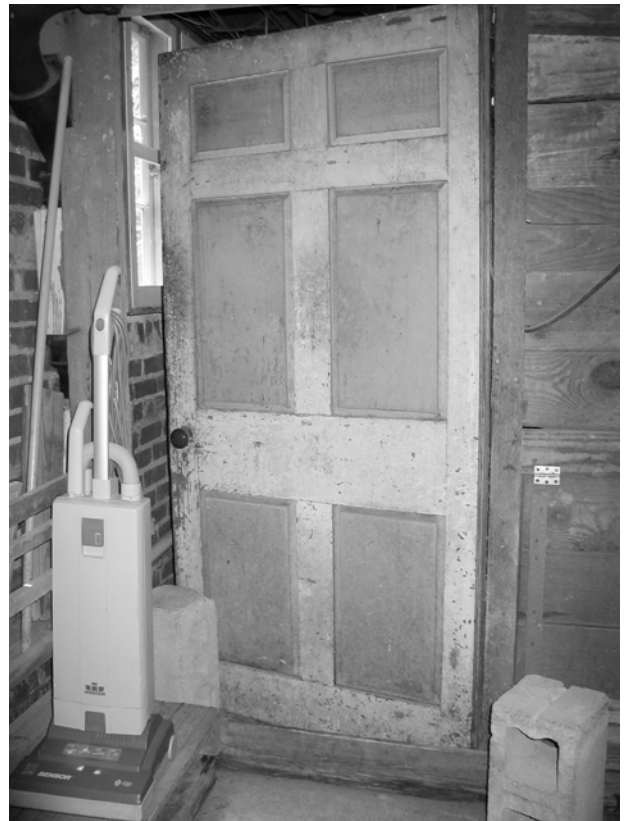
FIGURE 153. View of re-used antebellum door between Rooms 010 and 011. (T. Jones, NPS-SERO-CR, 2004)

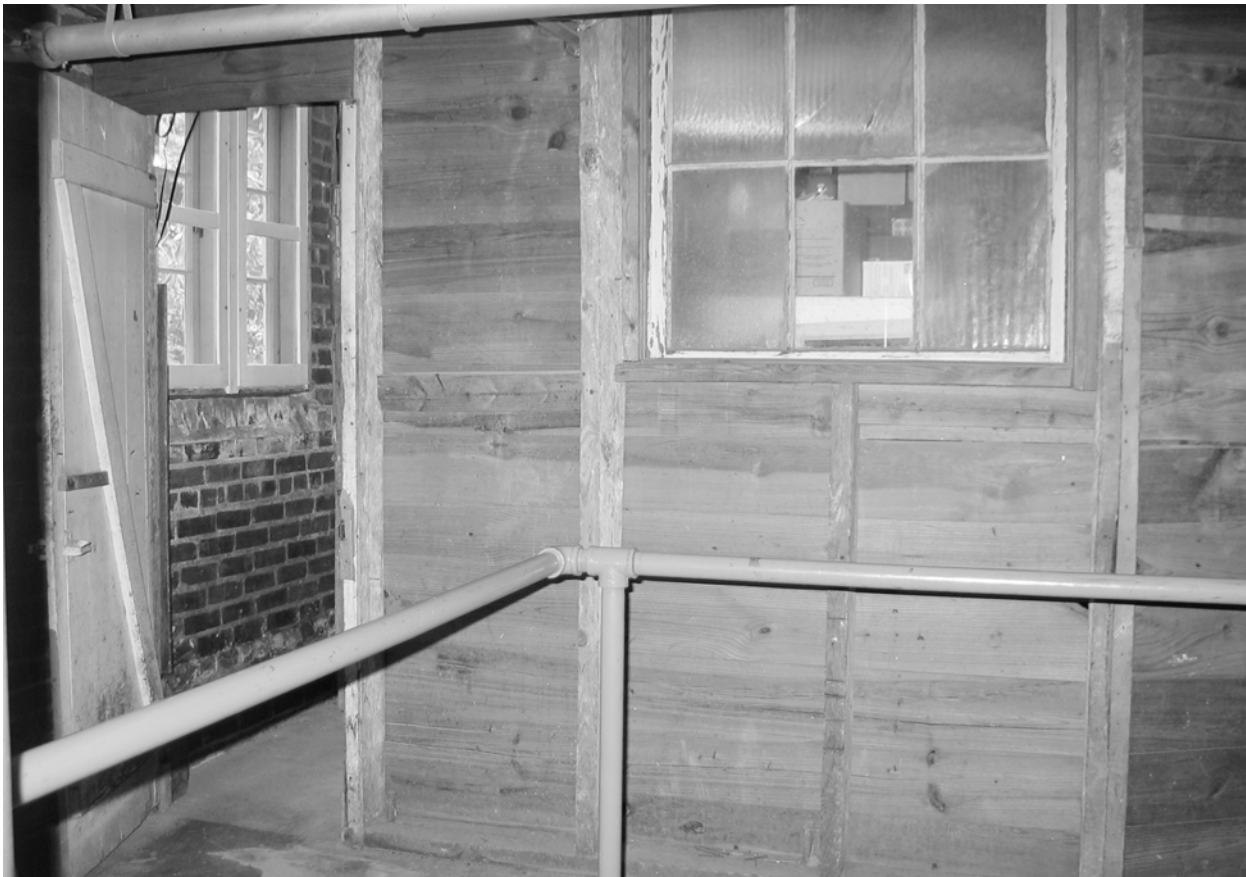
**FIGURE 157.** View southwest into Room 012. Window sash was probably salvaged by the Sandburgs when they demolished Smyth’s master bathroom where the west Porch is now located (T. Jones, NPS-SERO-CR, 2004)

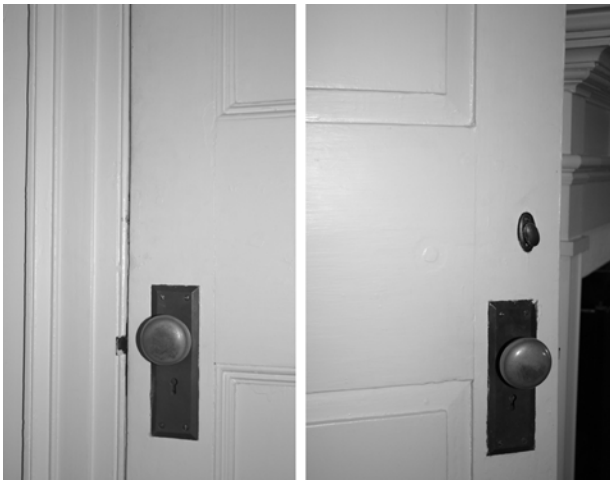
FIGURE 161. Both faces of D-36, presumed to be typical of original first-floor doors, but with hardware installed in 1924. (T. Jones,

*Doors:* Doors on the first floor include several six-panel doors dating to the antebellum period (D- 31, 32, 36, 46, and 48), although some of these are not in their original location. All of these have square-edged, raised panels with molded flat panels on the reverse side, but differences in molding suggest that they are from different antebellum eras. It appears that the double-ogee molding (e.g., D- 36) represents the original type and the simple ogee molding (e.g., D- 31) represents the type added as part of Memminger's alterations in 1848. Although the door between Rooms 102 and 104 (D- 36) has lost its original rim lock, the original hinges, door frame, and casing have survived. There are also three four-panel doors that date to the late nineteenth century (D- 26, D- 43, and D- 45). The several French doors date to 1924. Doors in the rooms added in the 1920s are generally two-panel as are the doors added by the Sandburgs, with a slight difference in the molding of stiles and rails distinguishing the two (see molding profiles at the end of this section).

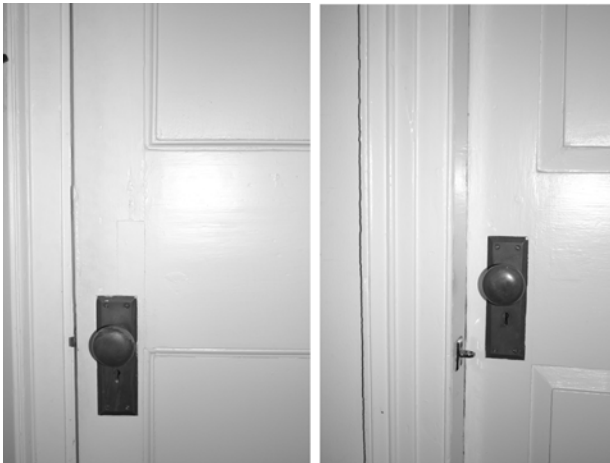
FIGURE 162. Both faces of D-48, antebellum but with slightly different panel molding (T. Jones, NPS-SERO-CR, 2004)

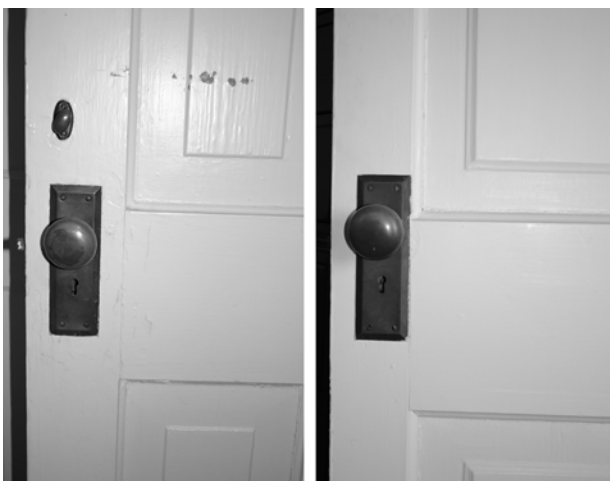
FIGURE 163. View of late nineteenth-century, four-panel doors D-43 (left) and D-26 (right) (T. Jones, NPS-SERO-CR, 2004)

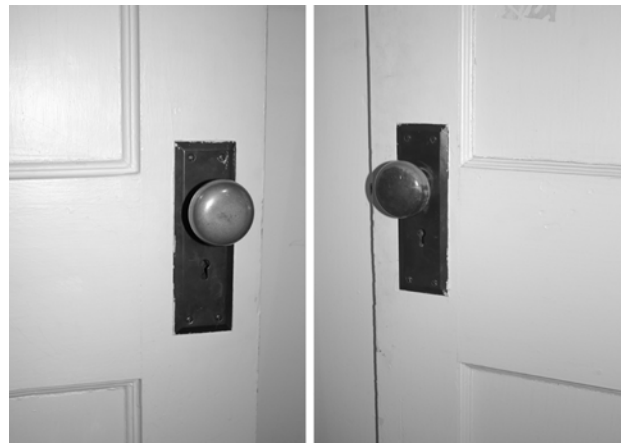
FIGURE 164. Left, view of typical door dating to 1924 and, right, typical door dating to 1945. (T. Jones, NPS-SERO-CR, 2004)

All of the nineteenth-century rim locks were replaced with the present brass mortise locks in 1924. Mortise locks added in 1945 were of very similar design. All feature a rectangular escutcheon measuring 2-1/4" by 7". Antebellum hinges are generally 3" by 4" with fixed pins. Twentieth century hinges are slightly larger and have loose pins with ball top.

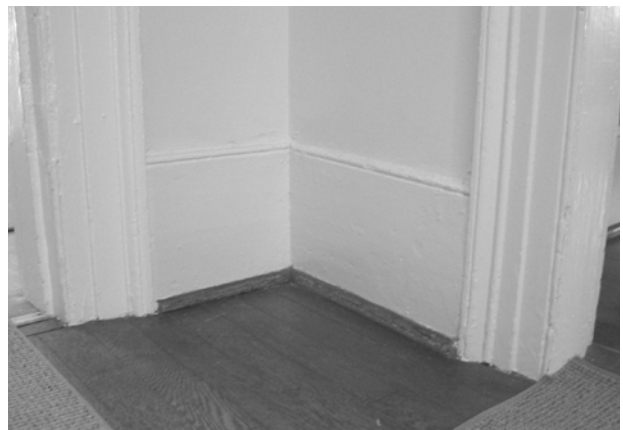
FIGURE 165. View of baseboard and casing at southwest corner of Hall (115). Casing at right is assumed to be original (1838) while casing at left dates to Memminger's remodeling in 1848. (T. Jones, NPS-SERO-CR, 2004)

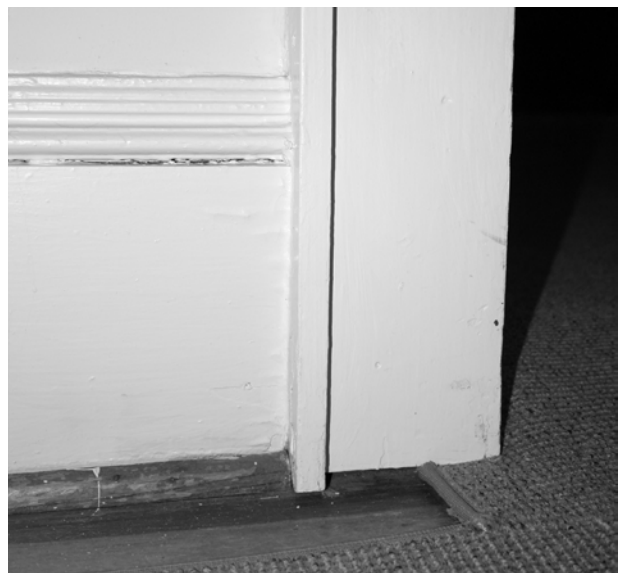
FIGURE 166. View of baseboard and casing typical of 1924 additions. (T. Jones, NPS-SERO-CR, 2004)

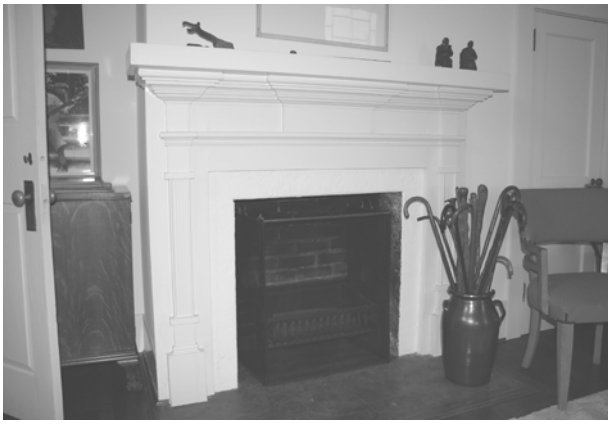
FIGURE 167. View of mantel in Front Room (102). (T. Jones, NPS-SERO-CR, 2004)

ment of the pilasters flanking the firebox. In the late nineteenth century, two of the original mantels, probably those at the fireplaces in Rooms 101 and 118, were replaced by Eastlake-style mantels, which were themselves removed by Smyth in the 1920s. At that time, Ballard installed both Victorian mantels in the farm manager's house, from which they were removed and placed in storage by the NPS. In oral interviews, Frank Ballard stated that the mantels had been shipped from England and "hauled up from Charleston by ox cart," but the late-Victorian style of these mantels contradicts that tale. Quite probably they were manufactured in Charleston around 1890 and installed as part of the Greggs' remodeling.

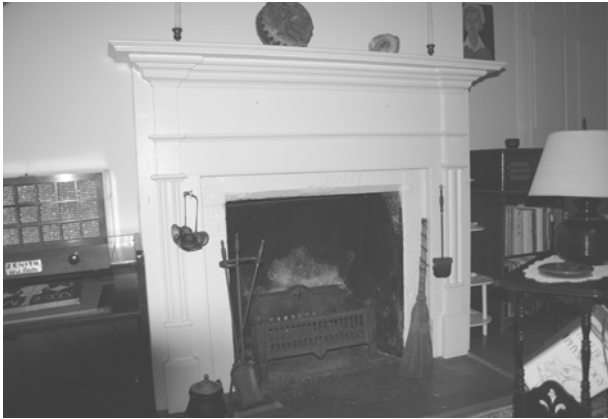
FIGURE 168. View of mantel in Room 104. (T. Jones, NPS-SERO-CR, 2004)

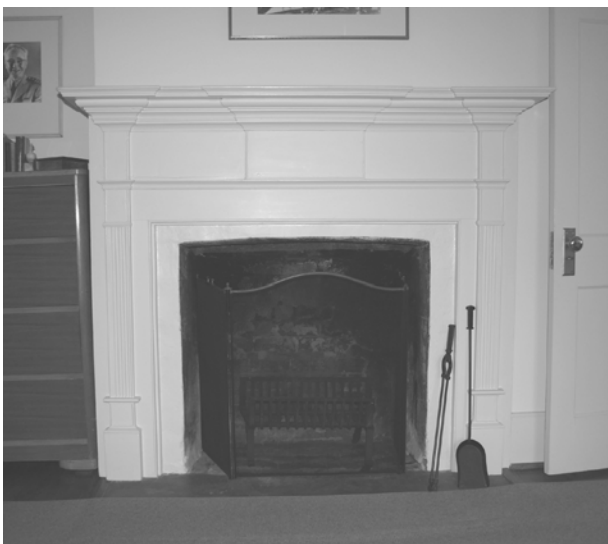
FIGURE 169. View of mantel in Mrs. Sandburg's Bedroom (121). A similar mantel was removed from the house, probably from Room 113 or 118, and is now stored in the wood shed. (T. Jones, NPS-SERO-CR, 2004)

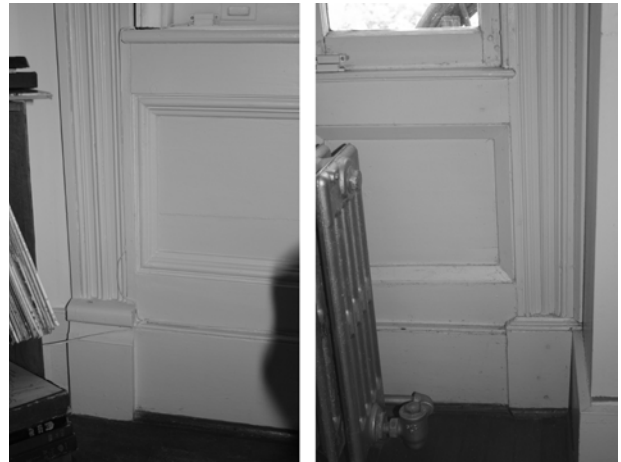
FIGURE 170. View of original window panels, right, and panels added c. 1890, left. (T. Jones, NPS-SERO-CR, 2004)

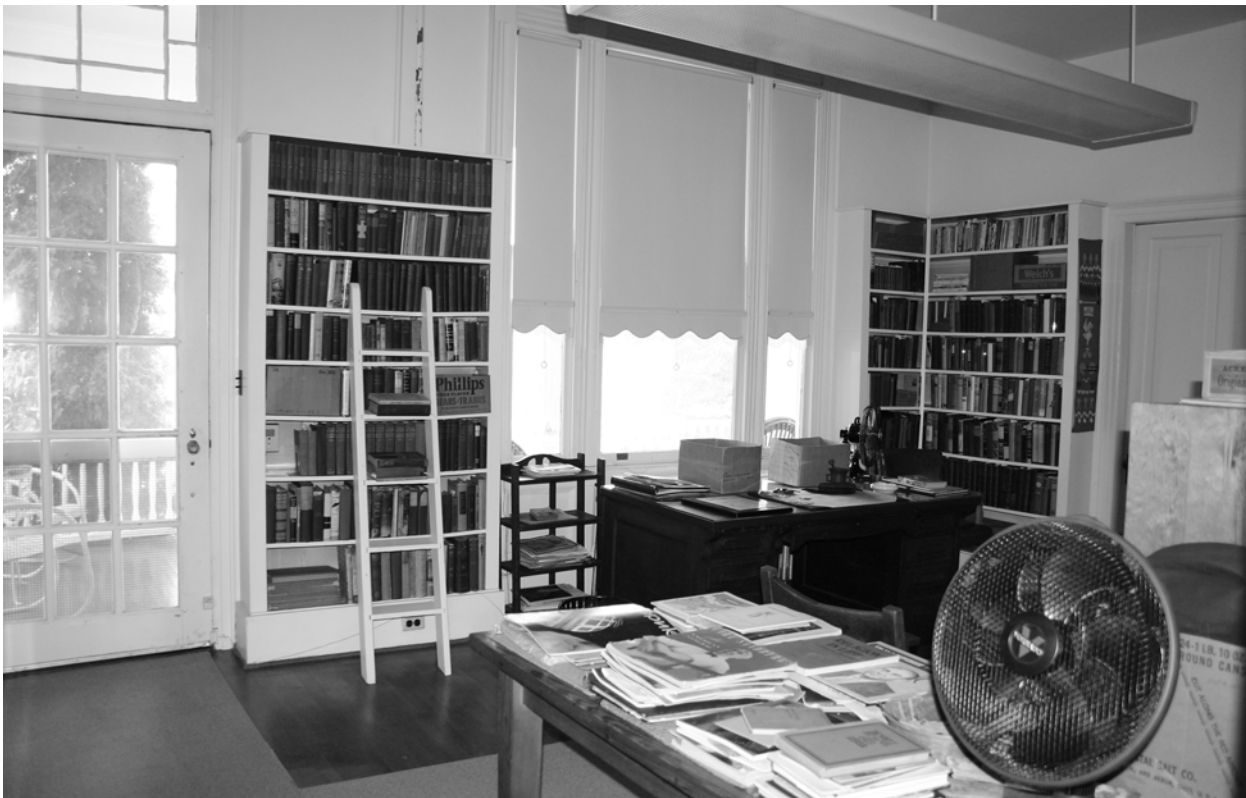
FIGURE 172. View northeast in Sandburg's office (101). (T. Jones, NPS-SERO-CR, 2004)

teenth and early twentieth centuries. Although Sandburg used the room as a work room for a period in the late 1950s and early 1960s, it was otherwise used as a parlor or living room. The Sandburgs primarily used it as a family room, for entertaining visitors, and as a music room, and it is likely that the Memmingers did as well. In September 1839, Memminger paid twenty dollars for tuning their piano, which had been imported from Europe and delivered to the house in the spring of that year.

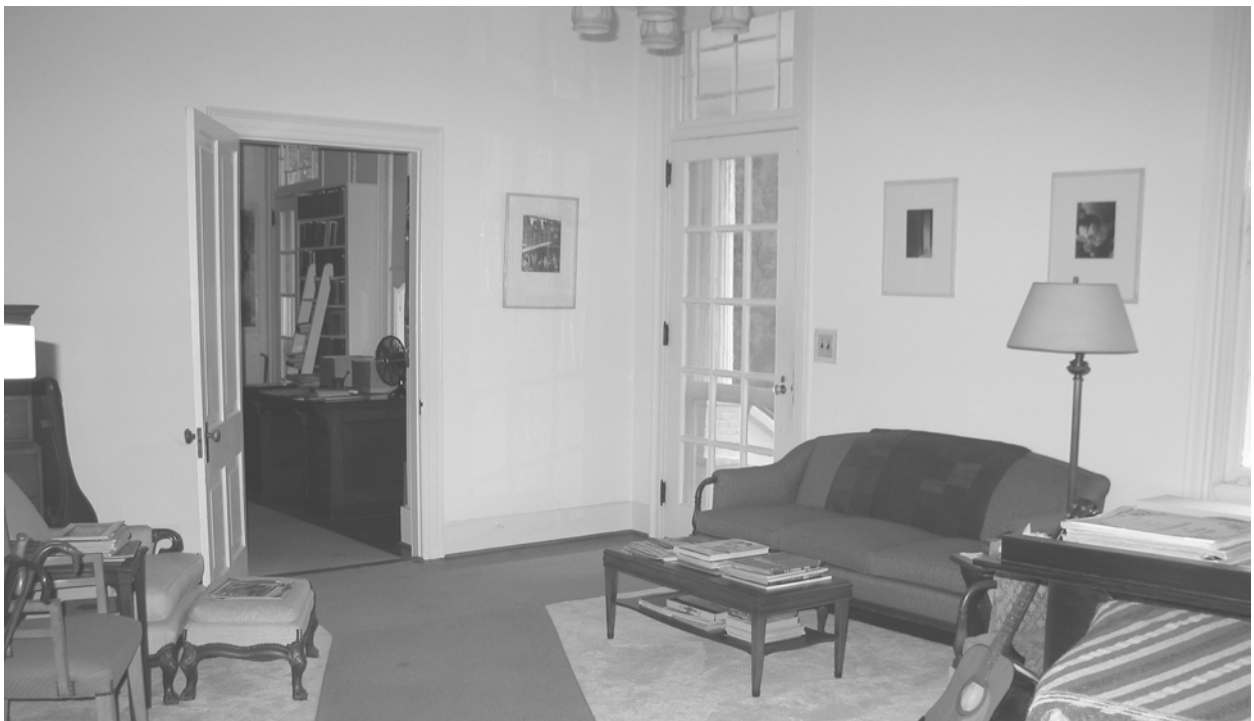
FIGURE 173. View northwest in Front Room (102). (T. Jones, NPS-SERO-CR, 2004)

*Lighting:* The room has a ceiling-hung, four-light chandelier with tulip-shaped, frosted-glass, down-lighting shades, with each light individually switched. It is one of the few light fixtures that survive from Smyth's wiring of the house in the early twentieth century.

*Heating:* A 32"-long radiator is located under the north window. The fireplace has a firebox about 33" high, 33" wide, and 16" deep, with a cast-iron lintel and a concrete hearth, the latter probably dating to the 1920s. The Federal-style mantelpiece with its fluted pilasters and elaborated ogee moldings is nearly identical to the mantelpiece in Mrs. Sandburg's bedroom (Room 121), both presumably original features. The top of the mantel is at 57" but the original mantel shelf has been replaced by a much-thicker, boxed shelf dating to the 1920s.

*Miscellaneous Features:* The small closets (103) on the west side of the fireplace were added by the Sandburgs in 1945-1946. A pair of two-panel doors, 2'-0" by 6'-0", open the closets proper, while plywood doors, 2'-0" by 3'-0", open the cabinets located above the closets.

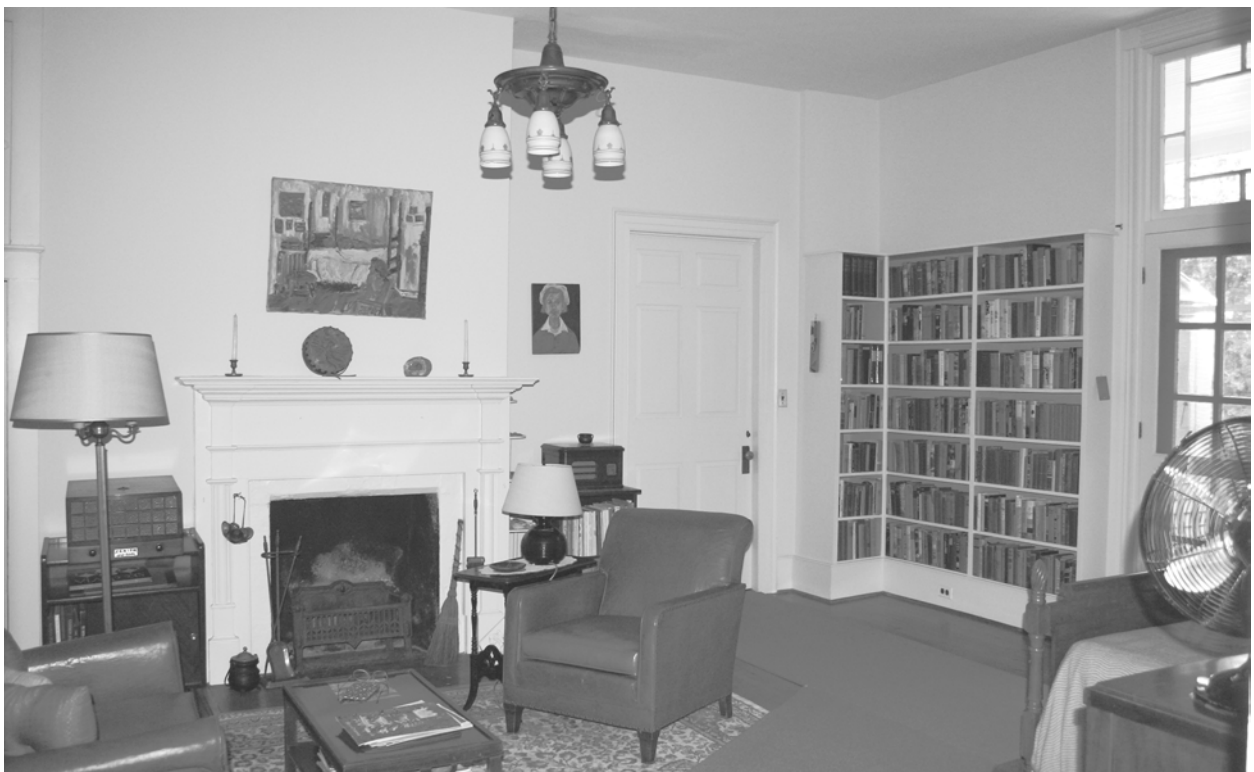
FIGURE 175. View northeast in Margaret's/Helga's Room.(T. Jones, NPS-SERO-CR, 2004)

*Lighting:* The room has a ceiling- hung, four- light chandelier with tulip- shaped, frosted- glass, down- lighting shades with painted details and with each light individually switched. It is one of the few light fixtures that survive from the 1920s.

*Heating:* The fireplace is an original feature as is the Federal- style mantelpiece. The fire box, which has a cast- iron header, may have been reduced in size for burning coal but that is not certain. A typical cast- iron radiator, 36" long, sits under the north window.

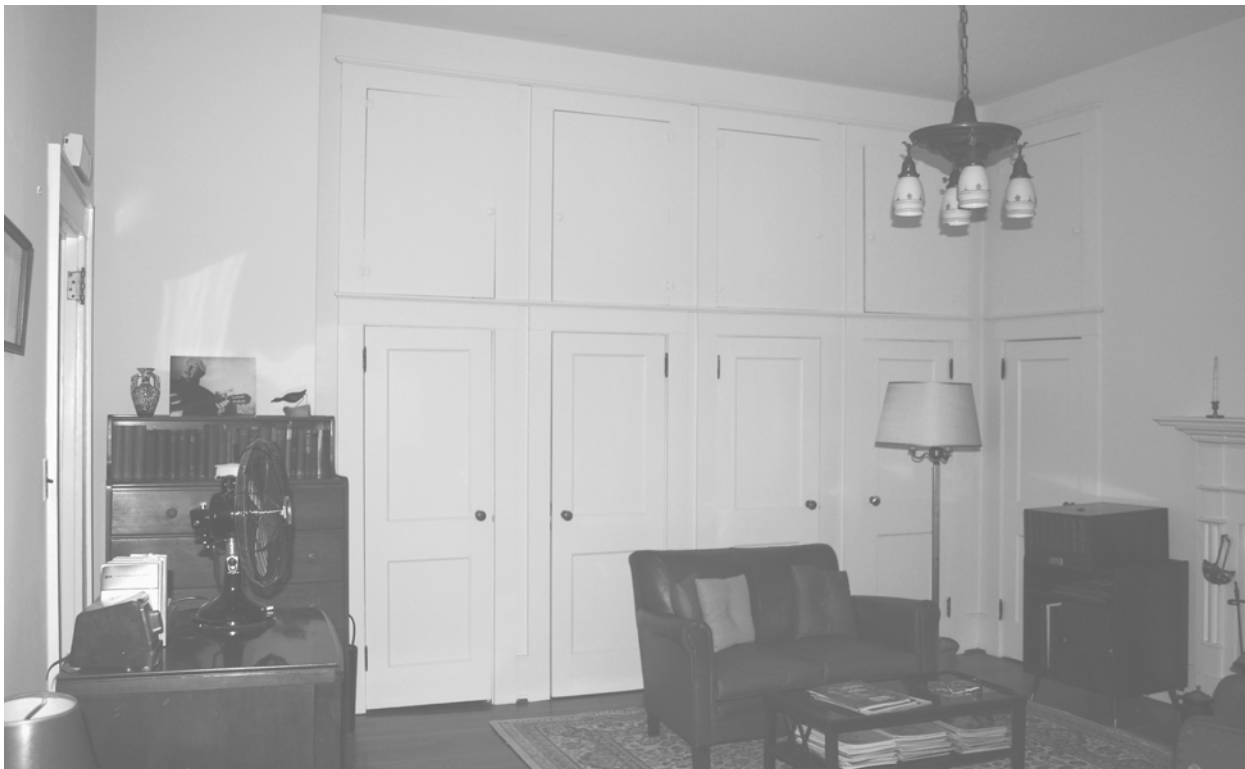
**FIGURE 176.** View west in Margaret's/Helga's room (104). Similar banks of closets were added in most of the other bedrooms.(T. Jones, NPS-SERO-CR, 2004)

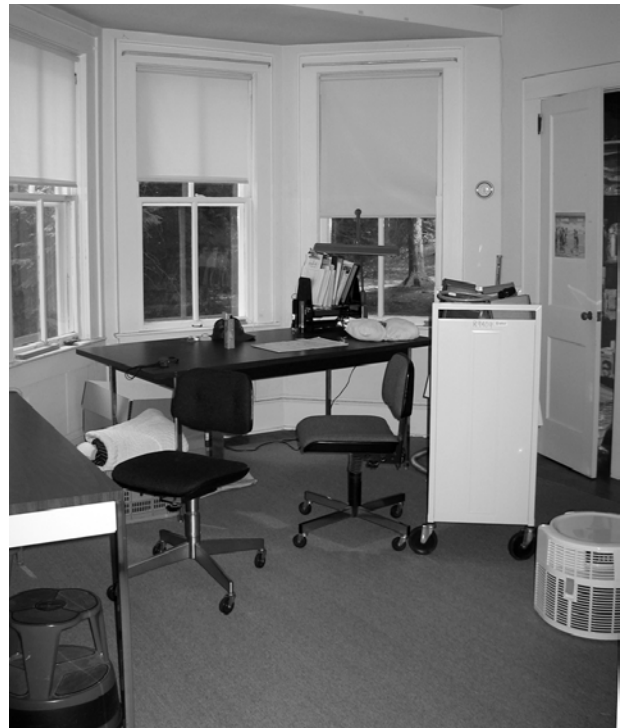
FIGURE 177. View southeast in Children's Room (108). (T. Jones, NPS-SERO-CR, 2004)

*Windows:* The room has four windows, one on the south wall and three in the bay window on the east. All date to the 1920s and are among the few sash which retained their muntins after the Sandburgs' remodeling in 1945. Windows are two-over-two, double-hung, counter-weighted, measuring 2'-9" by 5'-5". Each window has a single, cupped, brass lift mounted at the center of the bottom rail of the lower sash. Muntins in the sash in the bay windows are 1-1/4" thick; muntins in the other two-over-two

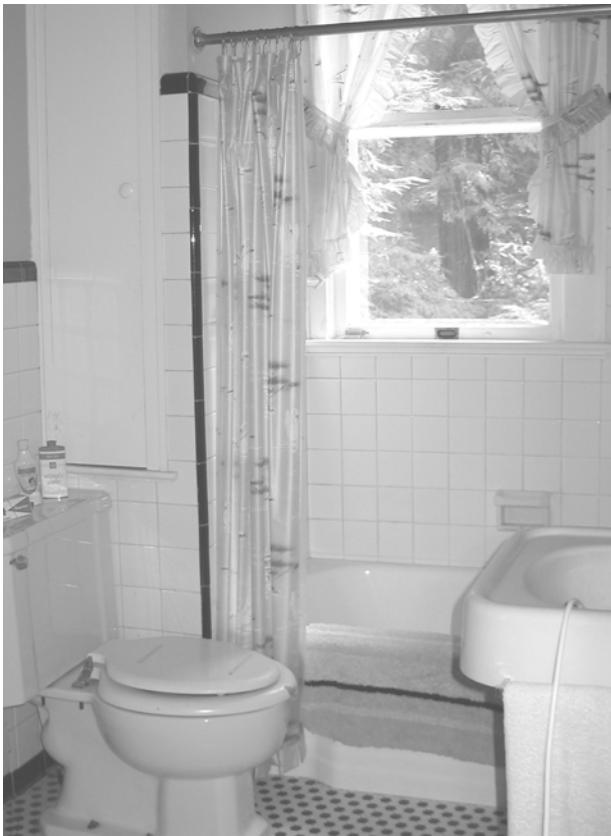
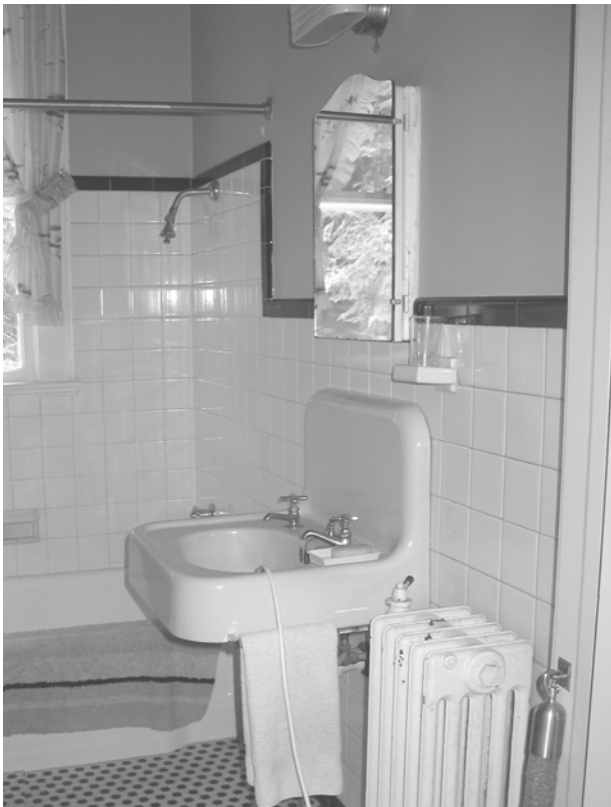
FIGURE 179. View of Bathroom (111). (T. Jones, NPS-SERO-CR, 2004)

**Bathroom (111).** This bathroom was part of the 1920s addition and replaced an earlier bathroom that had been added, probably around 1900, off the old back porch. The Sandburgs removed the old footed tub, built a cupboard in the southeast corner of the room, and installed a built-in tub, 4-1/2' long. They also installed the ceramic tile and created a door opening into the adjacent bedroom.<sup>220</sup>

*Walls:* Walls are tiled to a height of 52" with a 4-1/4" white tile with a narrower black border and a black base tile. Walls are plaster above the tile and were most likely replaced when the Sandburgs remodeled the room in 1945.

*Ceiling:* The ceiling, which is around 9' high, is plaster on wood lath, dating to the 1920s, but it has undergone significant repairs by the NPS.

*Lighting:* Lighting is provided by a single-light fixture, probably installed in 1945 or 1946. The fixture is mounted above the medicine cabinet and has a chrome-plated base and a frosted glass shade that appears to be original.

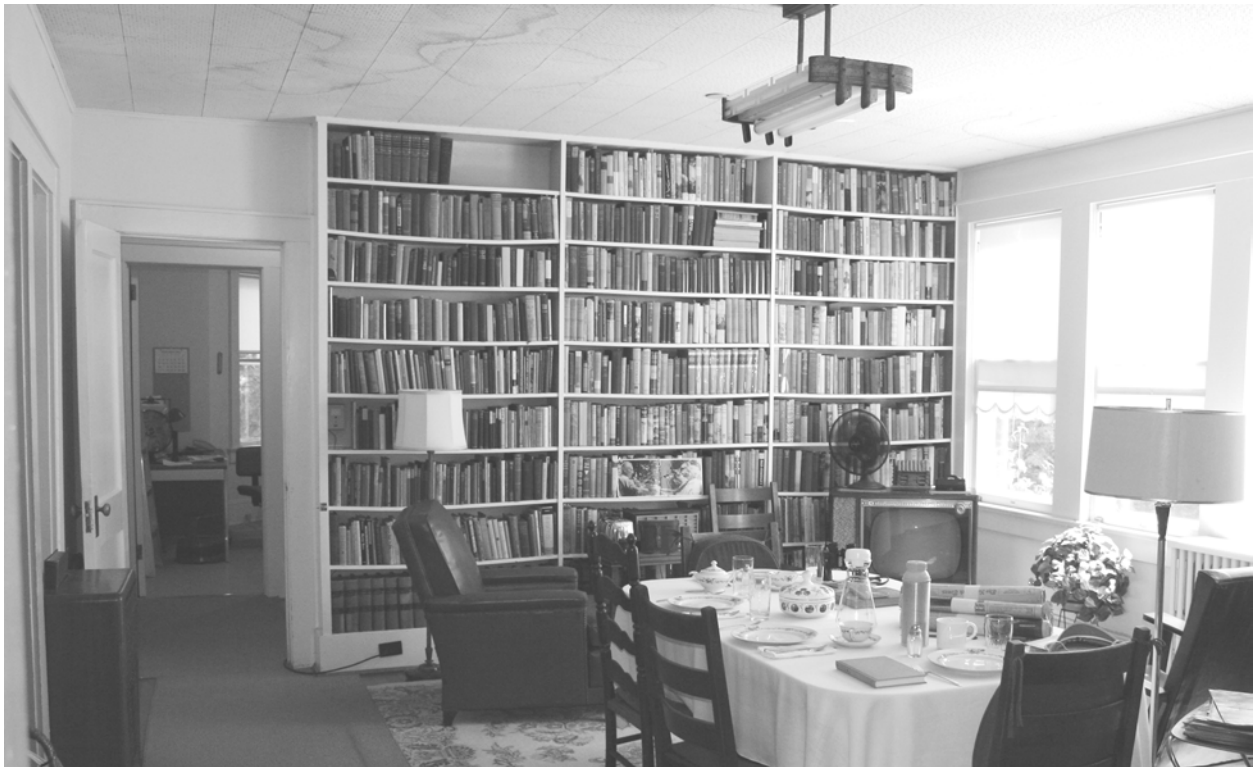
FIGURE 181. View east in Dining Room (112).

*Ceiling:* Set 8'-11" above the floor, the acoustical tile ceiling, which is probably Celotex brand, was installed prior to 1960 on 1" by 4" furring strips nailed against the original 1920s plaster ceiling, which had been damaged by a persistently leaking roof. Although the roof has long since been repaired, the damaged tiles, which existed during Sandburg's lifetime, have been preserved in place.<sup>224</sup>

*Lighting:* The Sandburgs replaced the Smyths' 1920s light fixture with the present 36"-long fluorescent fixture. In early January 1946, Anders billed the Sandburgs for three of these fixtures at \$15.50 each. Two are located in the kitchen.

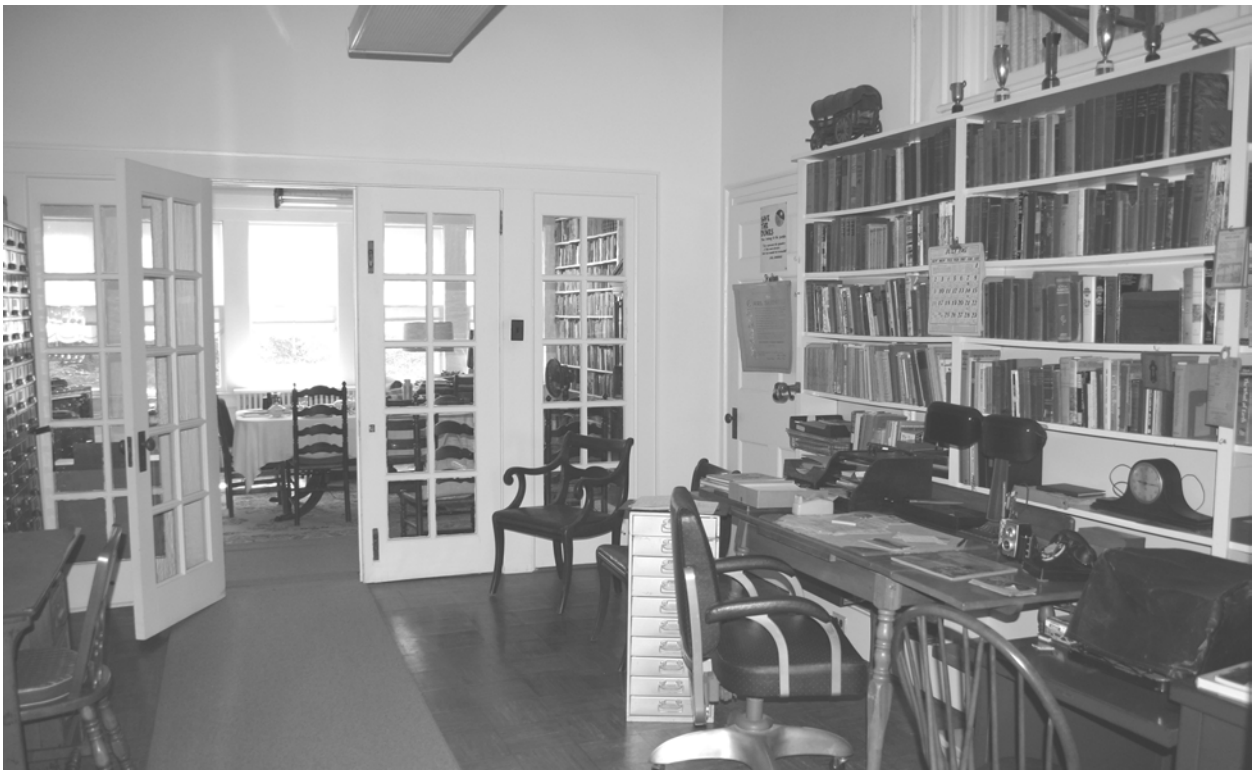
FIGURE 183. View south in Farm Office. (T. Jones, NPS-SERO-CR, 2004)

*Windows:* The room originally had a window on the south wall, but it was replaced by the present door and sidelights in the 1920s. On the west wall is a transom-like "borrow light" that provides light from the stair well. Paint evidence suggests that this window was created by the Smyths. The opening is 2' by 4' with a 2-light sash with a 1-1/4" muntin like those in the windows in the east bay.

*Trim:* The room has a typical 8" beaded baseboard, typical of the nineteenth century. The door on the west wall to Room 114 is cased with a 5"-wide casing typical of what appears to be the casing used as part of Memminger's 1848 alterations. Casing of the borrow light on the west wall is similar. Casing of the French doors and sidelights is typical 5" casing with straight backband, while casing of the door to Sandburg's Office is plain 1" by 5" boards.

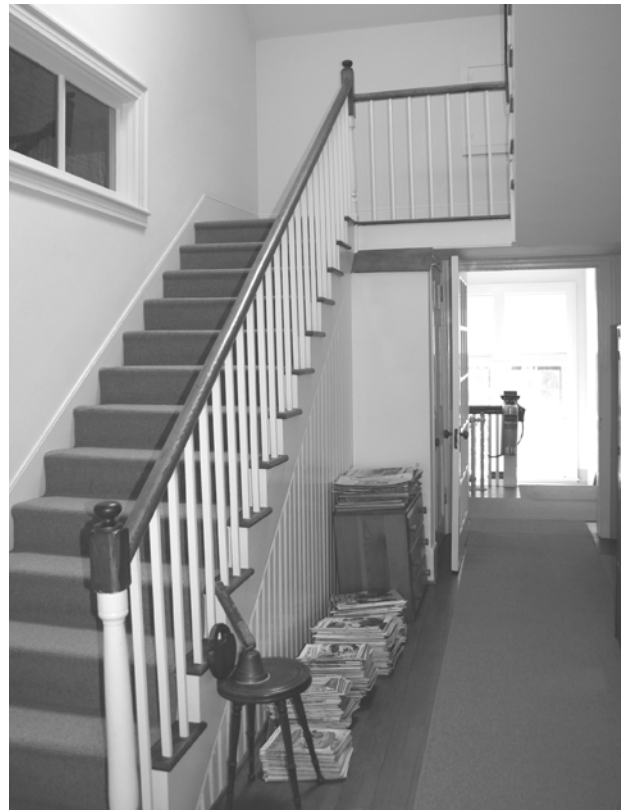
FIGURE 185. View south in Front Hall (115). (T. Jones, NPS-SERO-CRD, 2004)

*Lighting:* A ceiling- hung, three- light metal chandelier, c. 1924, is located at the north end of the hall.

*Staircase:* The U- shaped stairway, which is apparently not the original staircase, rises in two flights, with one flight to a landing at about 8' above the floor and then a second, shorter flight returning in the opposite direction to the second floor. Steps generally have a rise of 7- 1/2" and a run of 10- 1/2". The balustrade has a plain, circular railing and 3/4" by 1" balusters. The stair is cased below the stringer with 3- 1/2" tongue- and- groove boards with qua-

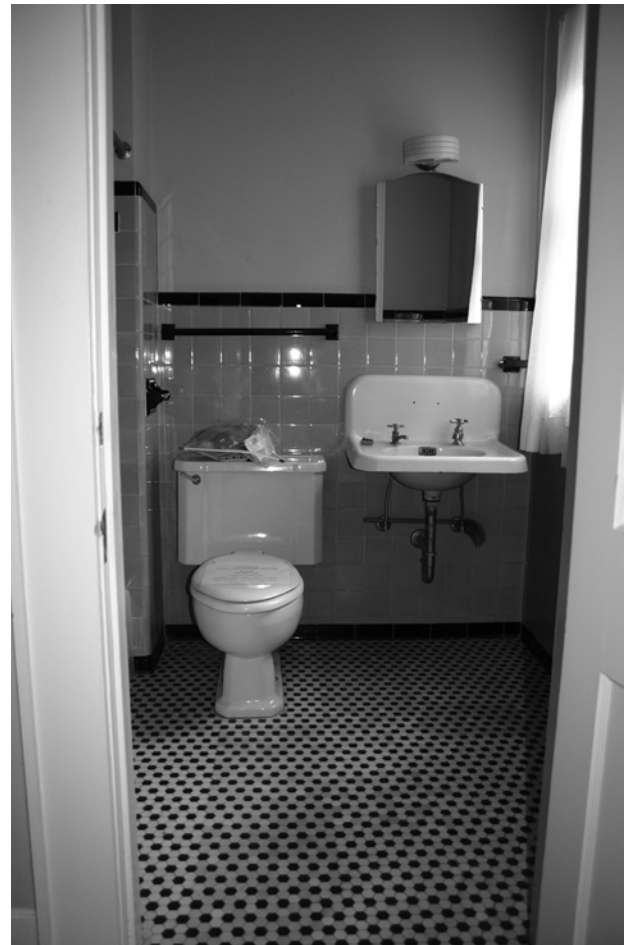
FIGURE 191. View of Bathroom (120) off of Utility Room. (T. Jones, NPS-SERO-CR, 2004)

**Room 120 (Bathroom).** This was one of the bathrooms installed by Captain Smyth, perhaps as early as the 1920s. The Sandburgs removed the old footed cast- iron tub and replaced it with an enameled steel tub. As they did elsewhere, they retained the original enameled, cast- iron sink. There was a delay in obtaining the tubs, and this bathroom was not completed and tiled until 1947, after construction of the stove chimney that rises in the southeast corner of the room.

*Window:* The window is one- over- one, double-hung, 2'- 4" by 4'- 6", dating to the 1920s, although it was originally six- over- six until the Sandburgs removed the muntins.

*Lighting:* Lighting is provided by a simple fixture with a curved glass shade mounted above the medicine cabinet.

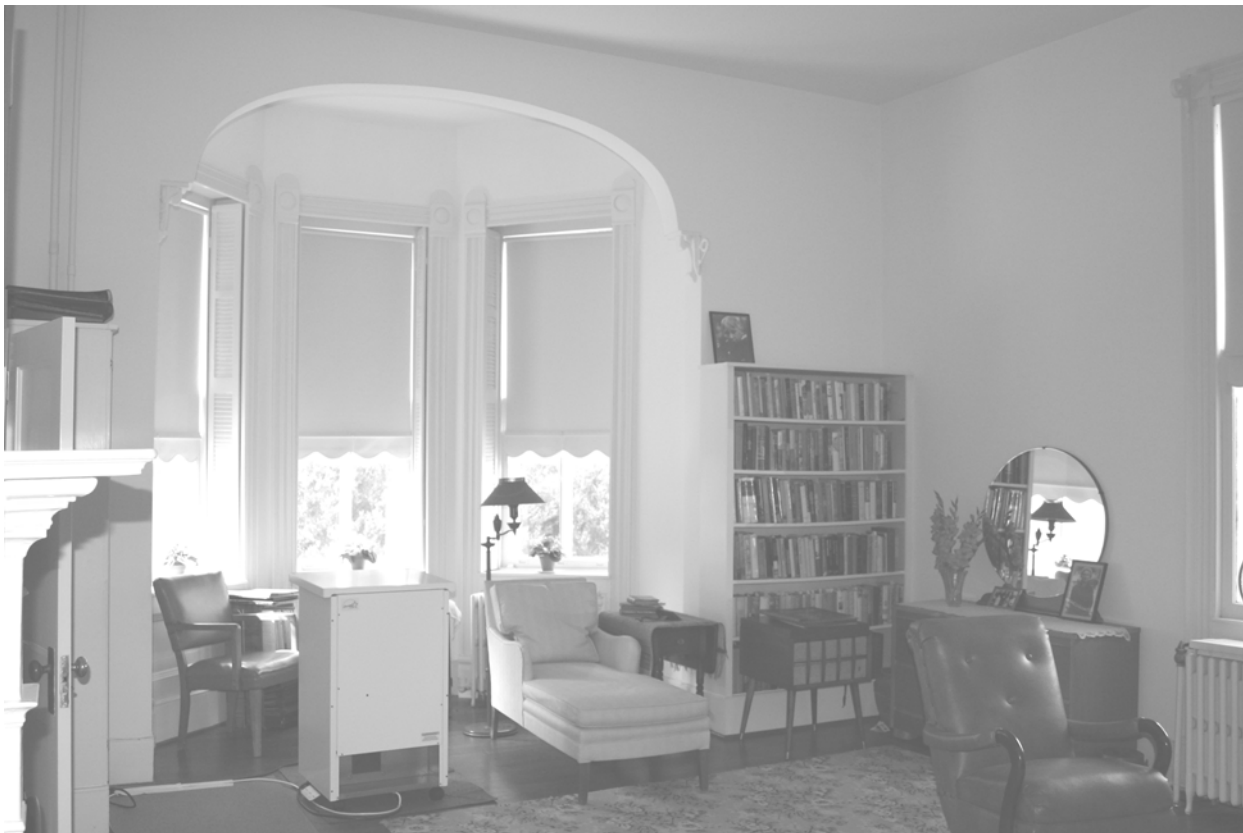
*Ceiling:* Like all of the ceilings, except in the Front Hall (115), the ceiling in this room was lowered by the Sandburgs and now stands at 11”- 10”. Unlike the other ceilings, this one was lowered less than a foot, probably because a lower ceiling height would have spoiled the aesthetics of the arched opening to the bay window on the west wall.

**FIGURE 192.** View of northwest Mrs. Sandburg’s Room (121). The free-standing cabinet left of center is a dehumidifier installed by the NPS on a temporary basis. (T. Jones, NPS-SERO-CR, 2004)

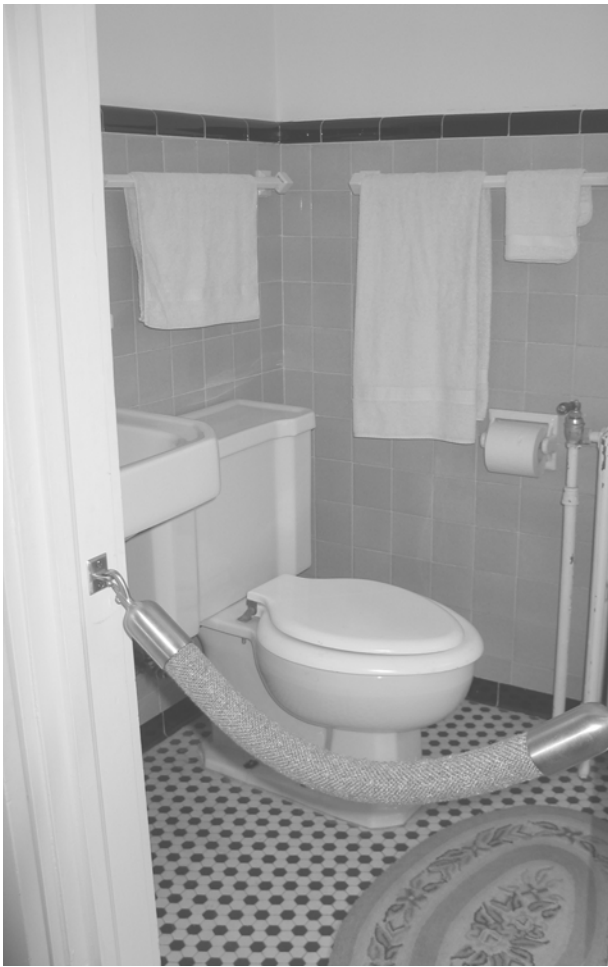
FIGURE 194. View southeast in Master Bathroom (123). (T. Jones, NPS-SERO-CR, 2004)

**Bath Room (123).** This bathroom was constructed by the Sandburgs to replace the bathroom that Smyth had constructed on what is now the adjacent West Porch. It was created out of space from both Room 118 and Room 121. This and the bathroom between the bedrooms on the second floor (Room 213) were both constructed new by the Sandburgs, while the other bathrooms on the first and second floor were rehabilitations of earlier, Smyth-era bathrooms.

*Flooring:* The floor is tiled with the same unglazed, black- and- white, hexagonal tile used in the other bathrooms.

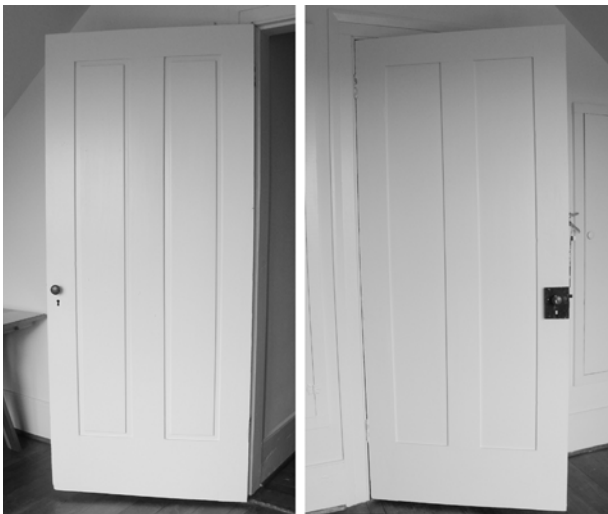
FIGURE 195. View of door at Crow’s Nest (207), typical of original bedroom doors on the second floor. (T. Jones, NPS-SERO-CR, 2004)

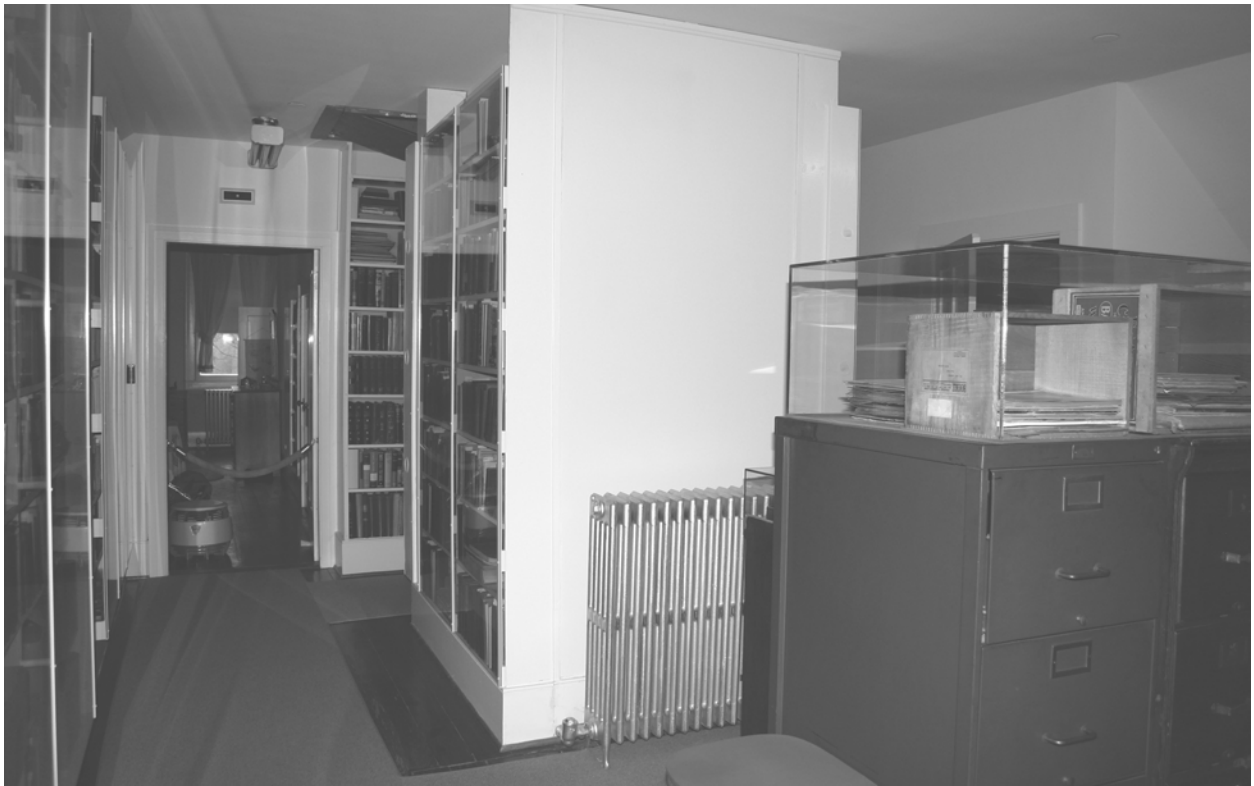
FIGURE 196. View east in Upstairs Hall (200). (T. Jones, NPS-SERO-CR, 2004)

*Flooring:* The original tongue- and- groove flooring remains in place and in good condition. Widths ranging from 5- 1/2" to 8" wide, unlike the first floor, where widths were generally around the smaller dimension.

*Doors:* The five doors opening into the bedrooms appear to have been part of the original construction of the house. All are around 3'- 0" by 6'- 8" by 1- 1/4" with two vertical, square- edged, raised panels, and except for the door to Mr. Sandburg's Study (201), all have what must be their original Carpenter & Co. rim locks, 4" by 5" with small brass knobs. The original lock on the door to Sandburg's office was replaced in the late nineteenth or early twentieth century by the present 3- 1/4" by 4" rim lock with brown mineral knobs.

*Skylight:* The metal- framed skylight is around 3'- 6" square, divided into two lights glazed with wire- reinforced plate glass. A simple beaded molding about 1" wide trims the otherwise plainly finished skylight shaft.

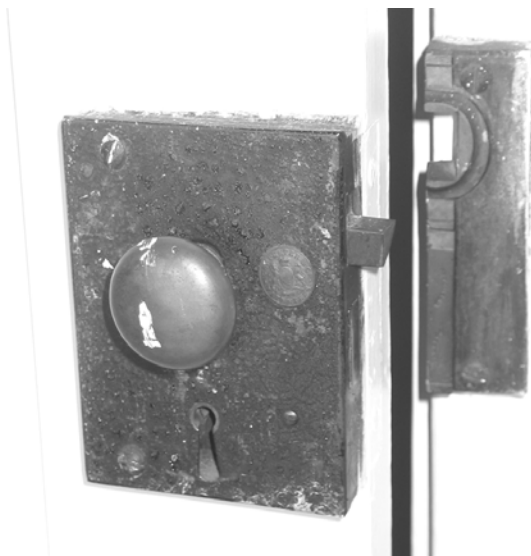
FIGURE 198. View of Carpenter & Co. rim lock, typical of original locks on second floor. (T. Jones, NPS-SERO-CR, 2004)

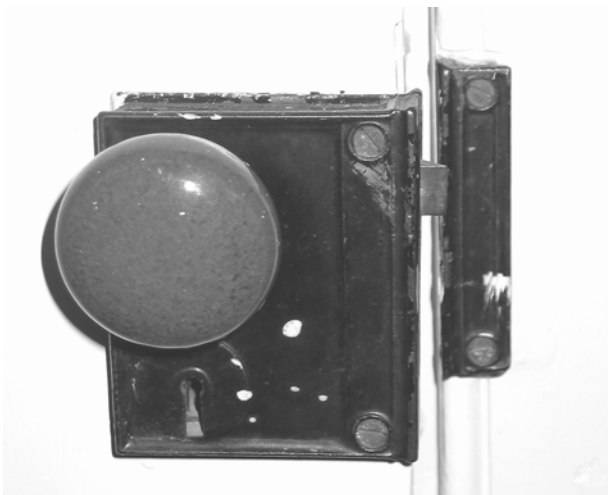
FIGURE 199. View of typical late-nineteenth century rim lock in Sandburg's Study (201). (T. Jones, NPS-SERO-CR, 2004)
