Carl Sandburg Home National Historic Site  
Connemara Main House  
**Historic Structure Report**

September 2005

Historical Architecture, Cultural Resources Division

2005  
Historic Structure Report  
Connemara Main House  
Carl Sandburg Home National Historic Site  
Flat Rock, NC  
LCS#: 05146

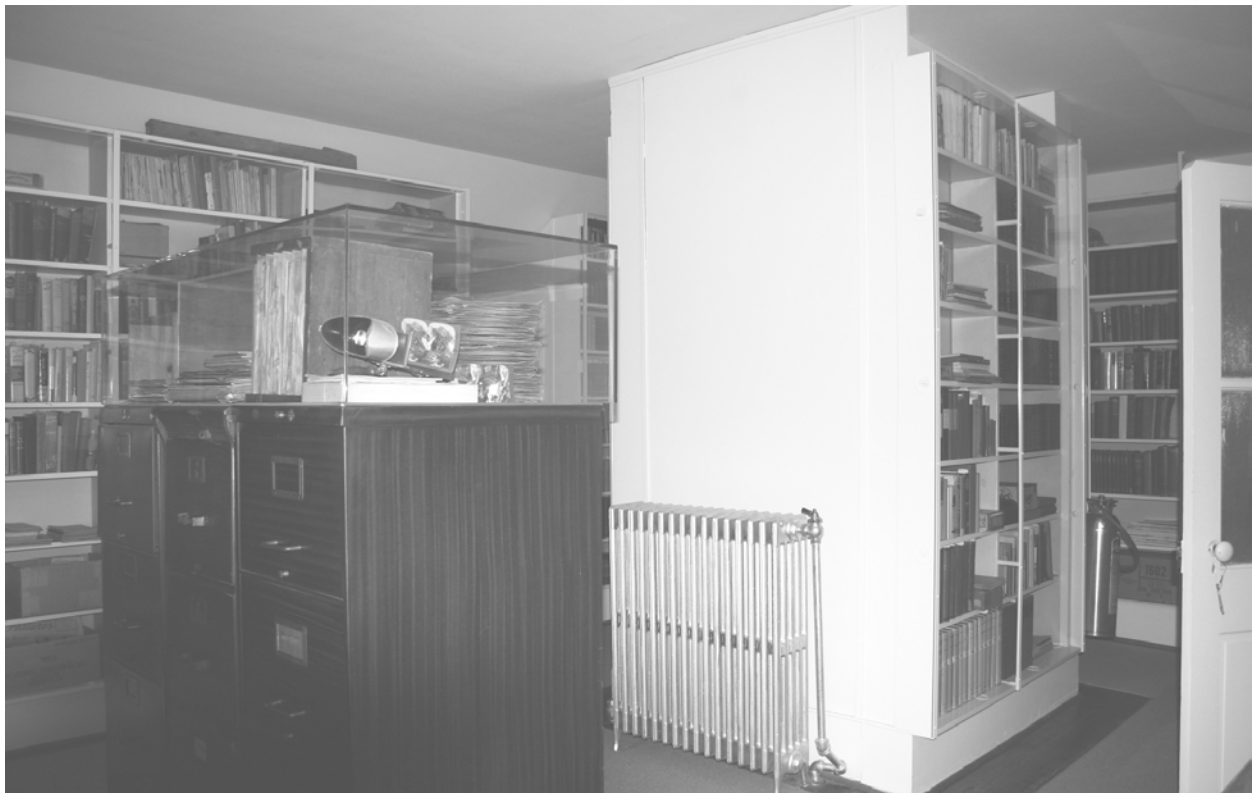
FIGURE 200. View northeast in Upstairs Hall. (T. Jones, NPS-SERO-CR, 2004)

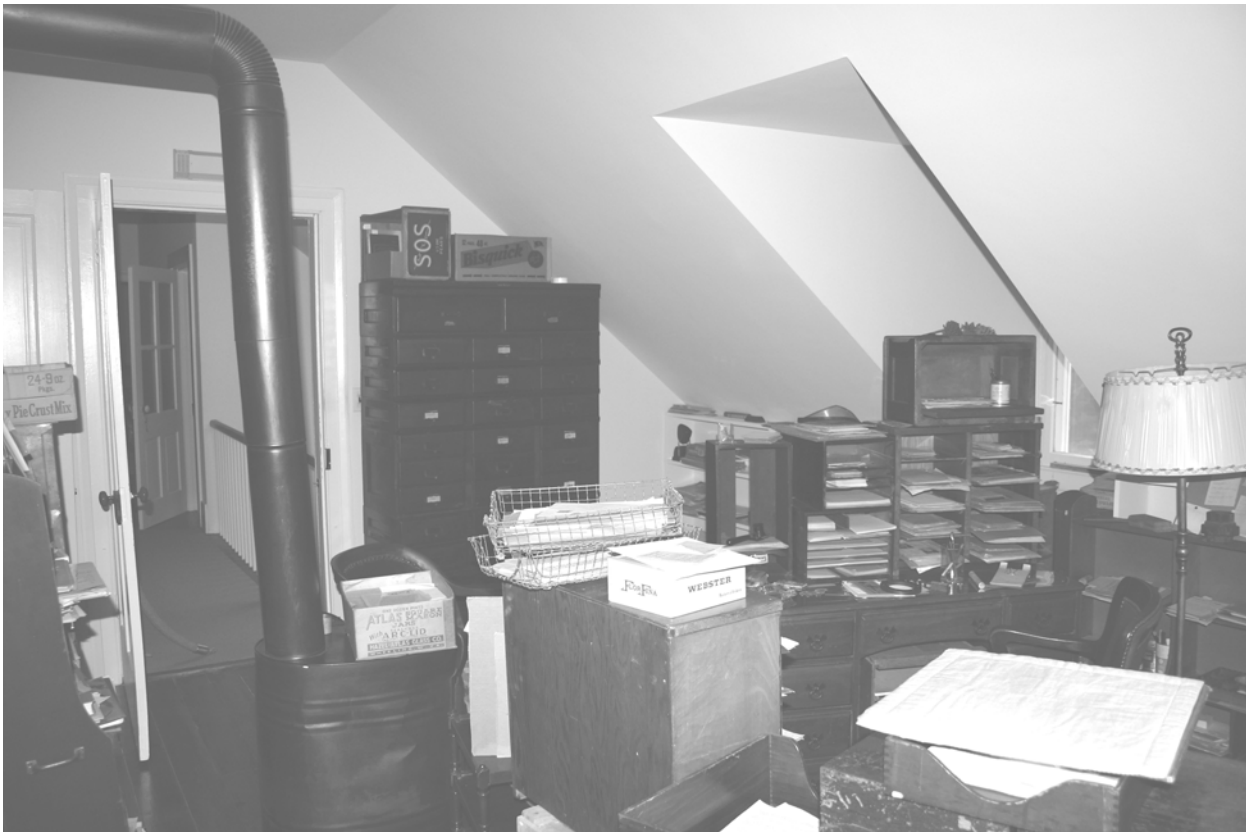
FIGURE 201. View east in Sandburg's Bedroom (202). (T. Jones, NPS-SERO-CR, 2004)

*Windows:* Windows are similar to those in Room 201 with one on the west wall and a dormer window on the north. The west window is 3'- 4" by 5'- 2" and has its original sash, minus the original six- over- six muntins which the Sandburgs had removed in 1945. The dormer window is 2'- 10" by 4'- 6" and its original six- over- six muntins were also removed in 1945.

*Trim:* The 9" beaded baseboard is original. The casing of the door to the hall and the casing of the windows are typical original casing for the second floor. Window stools are around 5/8" thick with a wide, half- round bead along the facing edge. Aprons are around 3- 3/4" with a bead across the lower edge. Casing of the door into Sandburg's office (201) is similar to that found at the door to one of the closets (204) on the north side of the hall. The closet door opening is cased with plain 4- 1/2" boards without a backband. A 2- 1/4" molding similar to the base cap used in the dining room and elsewhere in the 1920s addition is used in place of a baseboard in the closet.

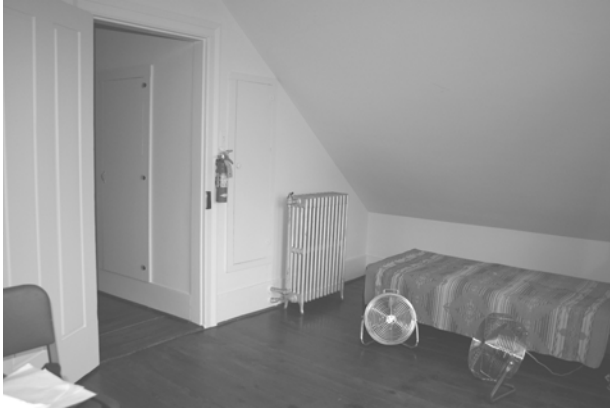
FIGURE 203. View southwest in Crow's Nest (207). (T. Jones, NPS-SERO-CR, 2004)

wood doors are present on the south wall. Both doors are 3/4" plywood, 26" by 63".

**Trim:** The room has a typical 9" beaded baseboard and door and window casing and trim like that found in the other bedrooms on this floor. All of the trim is original except for the small closet doors, which are cased with plain 1" by 3" boards.

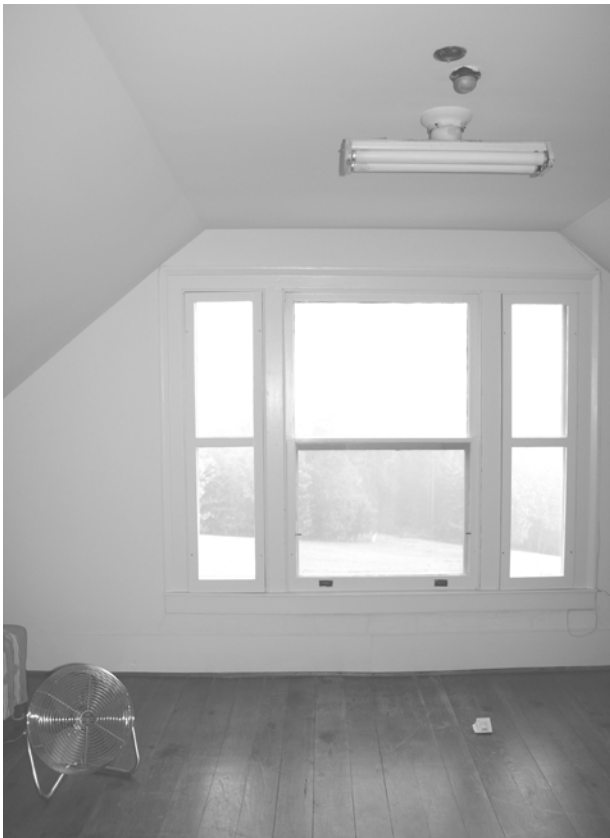
FIGURE 204. View north in Crow's Nest (207). (T. Jones, NPS-SERO-CR, 2004)

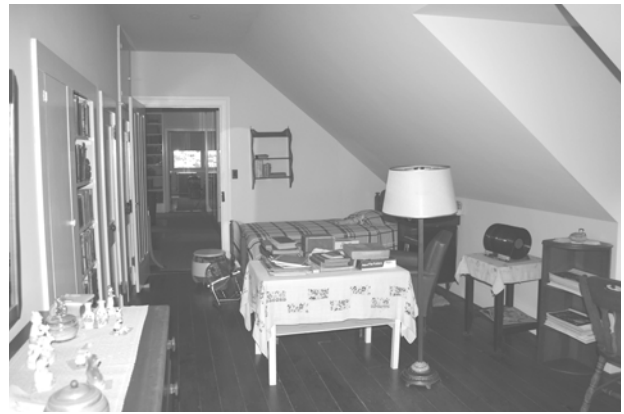
FIGURE 205. View west in Janet's Room (211). (T. Jones, NPS-SERO-CRD, 2004)

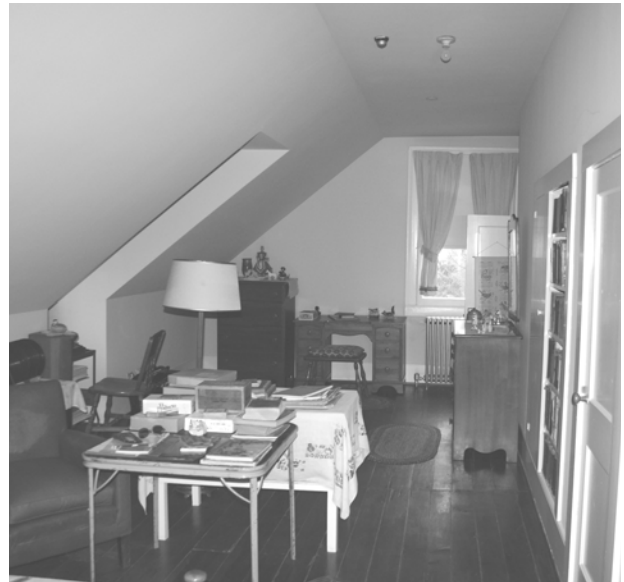
FIGURE 206. View east in Janet's Room (211). (T. Jones, NPS-SERO-CRD, 2004)

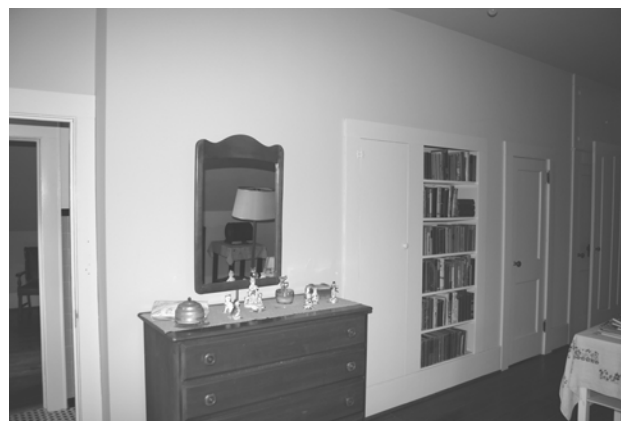
FIGURE 207. View southwest in Janet's Room (211). (T. Jones, NPS-SERO-CRD, 2004)

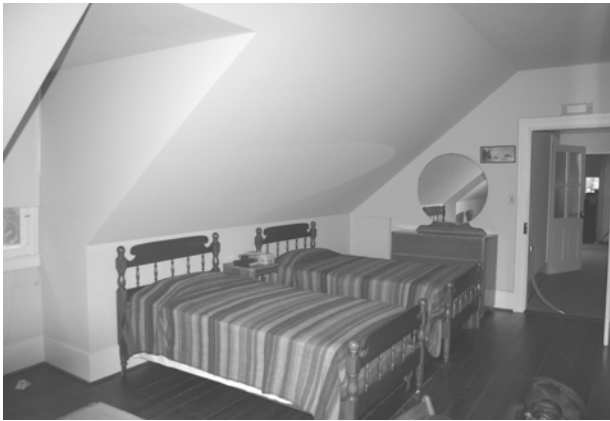
FIGURE 208. View southwest in Guest Room (214). (T. Jones, NPS-SERO-CR, 2004)

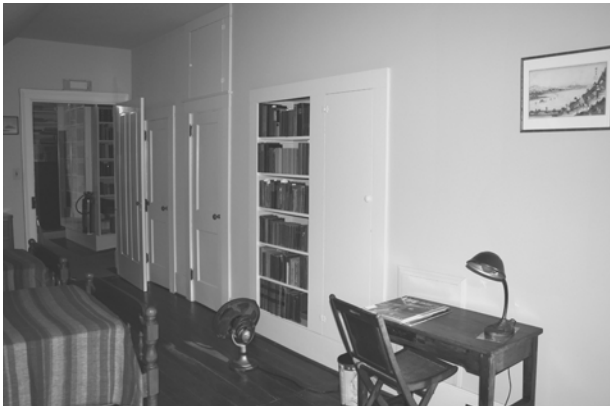
FIGURE 209. View northwest in Room 214. (T. Jones, NPS-SERO-CR, 2004)

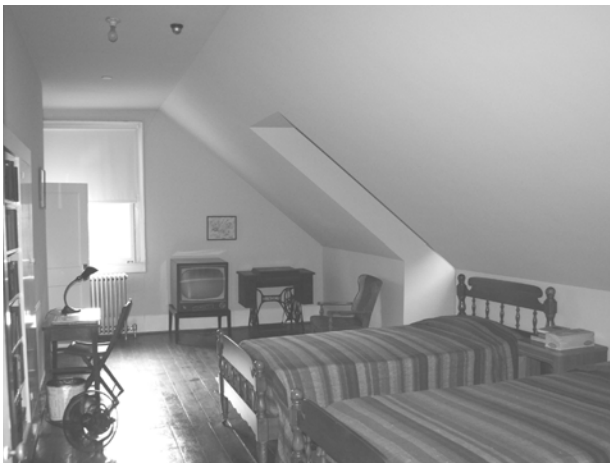
FIGURE 210. View southeast in Guest Room (214). (T. Jones, NPS-SERO-CR, 2004)

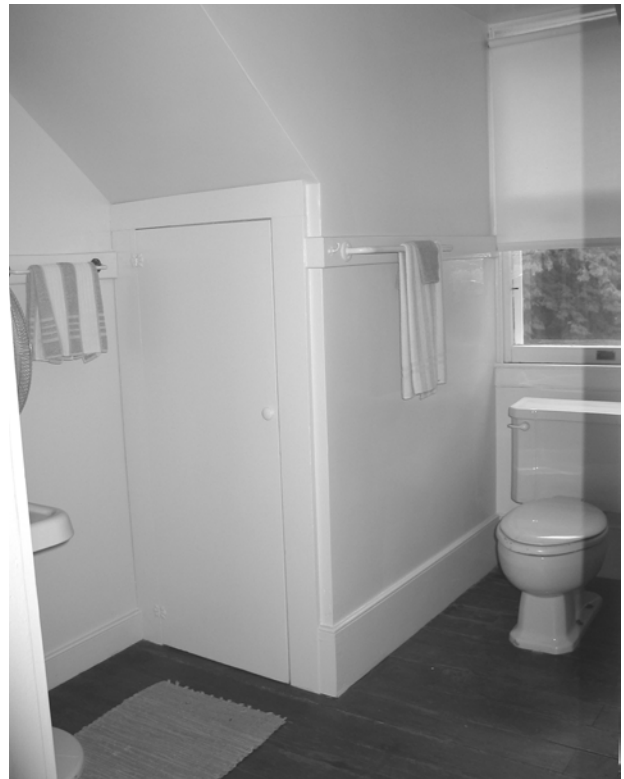
FIGURE 211. View southeast in Room 217. (T. Jones, NPS-SERO-CR, 2004)

*Trim:* A 9" beaded baseboard runs along the south wall while a 4- 1/2" beaded baseboard was used along the west and north walls. Window casing is typical antebellum casing. The door is cased with plain 4- 1/2" boards.

*Fixtures:* The wall- hung, enameled, cast- iron sink is apparently original to the room (c. 1912). Similar to the lavatory in Sandburg's bedroom, it has retained all of its original fittings. The metal shower surround is about 30" by 30" and dates to the 1940s. The original toilet was replaced in 1945 by the present unit, which bears a date of 8/22/45.

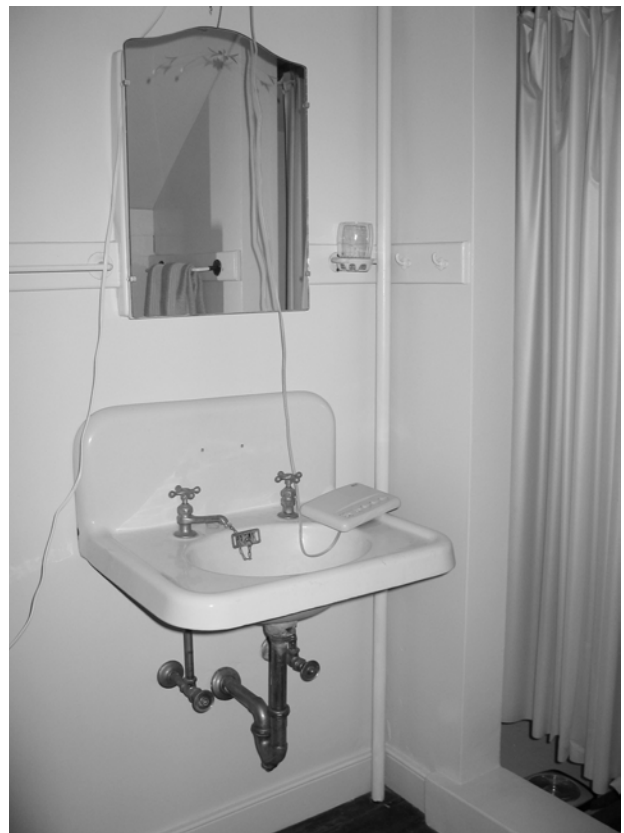
FIGURE 212. View northeast in Room 217. (T. Jones, NPS-SERO-CR, 2004)

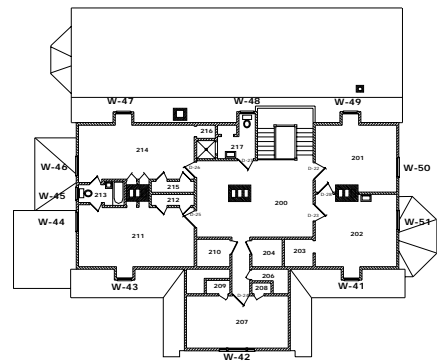
Repair to working order windows W-41, W-42, W-43, W-45, W-47, W-48, W-49

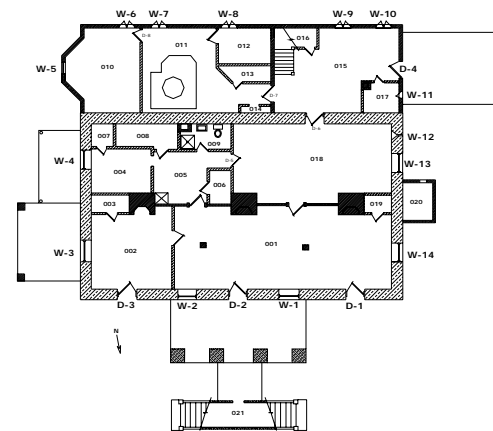
Repair to working order all doors as well as windows W-3, W-4, W-6, W-7, W-8, W-9, W-10, W-14
